# Nebraska State Penitentiary Useful Life Engineering Study

Lincoln, Nebraska

Alvine No. 2021 8777 January 2022

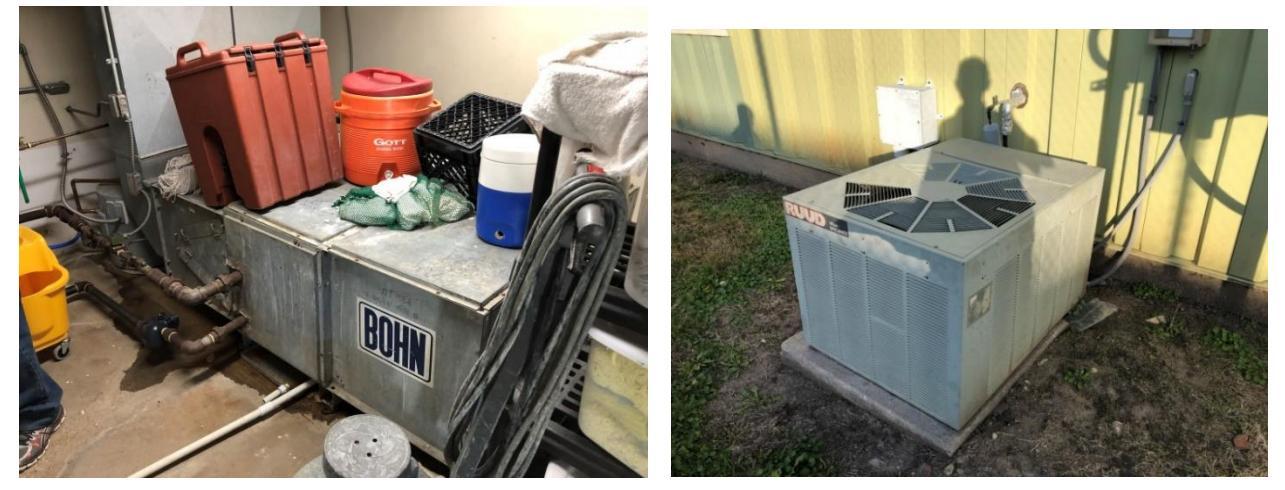
Photo ACT-M2: Existing AHU

The HVAC system is composed of one air handling unit (AHU), one air-cooled condensing unit (ACCU), a thermostat, direct-buried underfloor supply air ductwork serving floor registers along the perimeter of the building, and two restroom exhaust fans. The AHU is original from 1975 and has a steam heating coil and a direct expansion (DX) refrigerant cooling coil. See Photo ACT-M2.

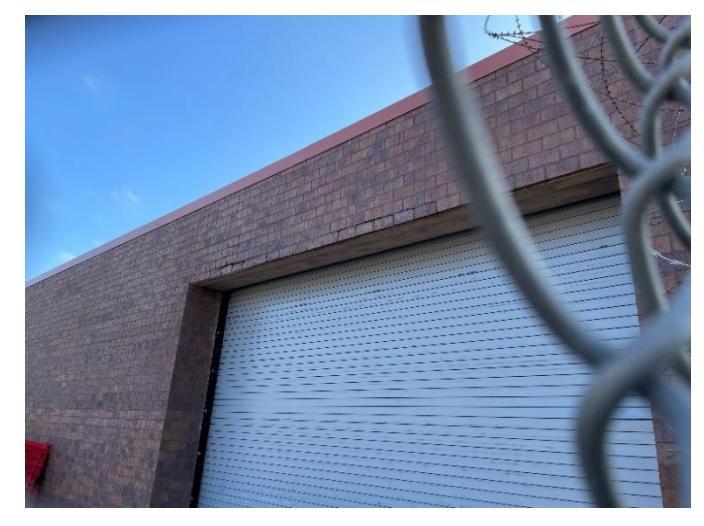
Brick above the kitchen receiving door was damaged, most likely from vehicular impact. The concrete curb around a floor drain in Mechanical Room 2B68 is severely cracked and deteriorating.

Photo ANC-S3: Damaged Brick at Kitchen Receiving

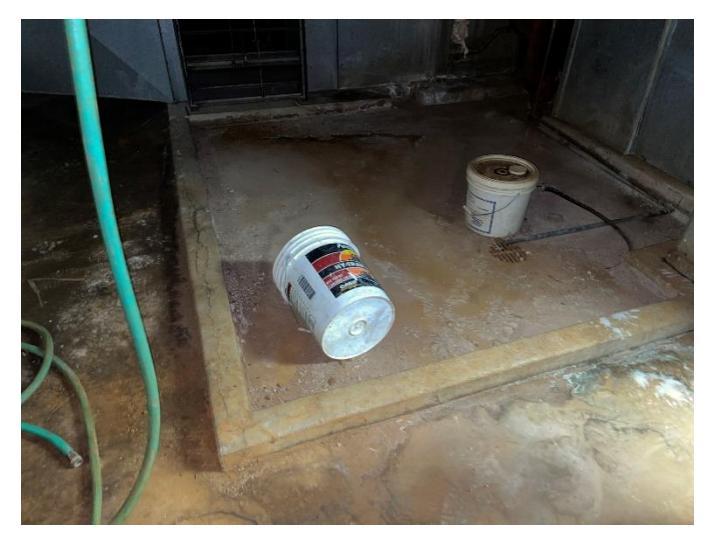
Photo ANC-S4: Deteriorated Curb in Mech Room 2B68 <u>Foodservice</u>

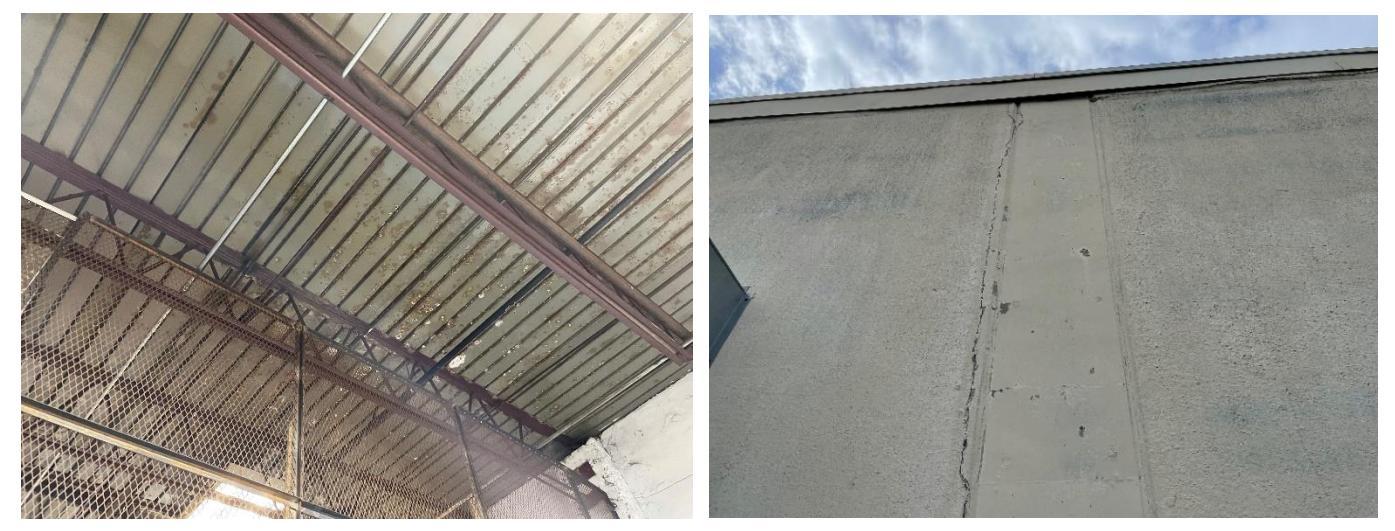
CW-S2: Rusted Roof Deck Installed Upside Down

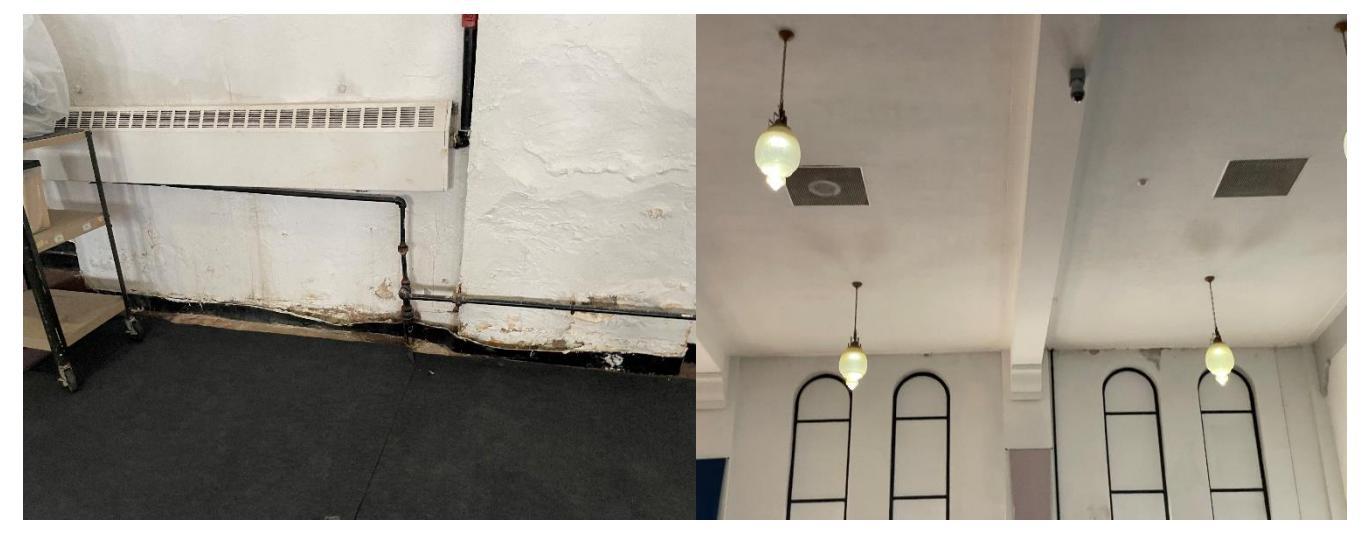
There is evidence of moisture infiltration in some of the exterior walls. This appears to be a long-term problem. See Photo CHAP-S1.

CHAP-S1: Moisture Damage at Lower and Upper Wall

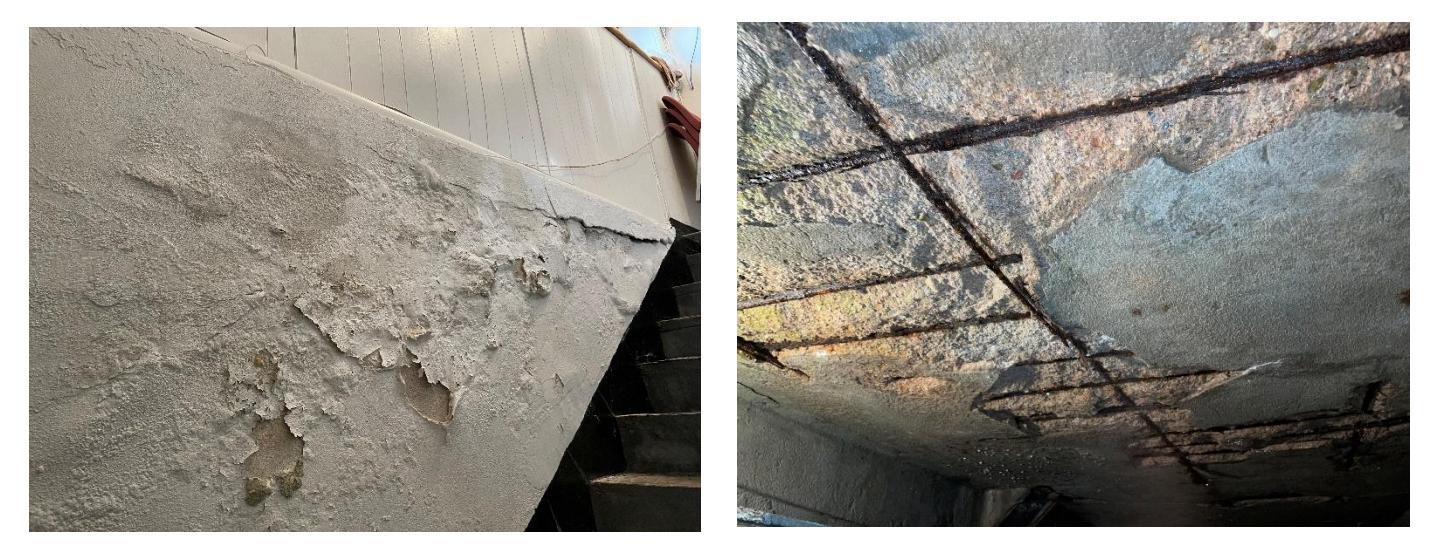
CHAP-S2: Moisture Damage at Tunnel Stair

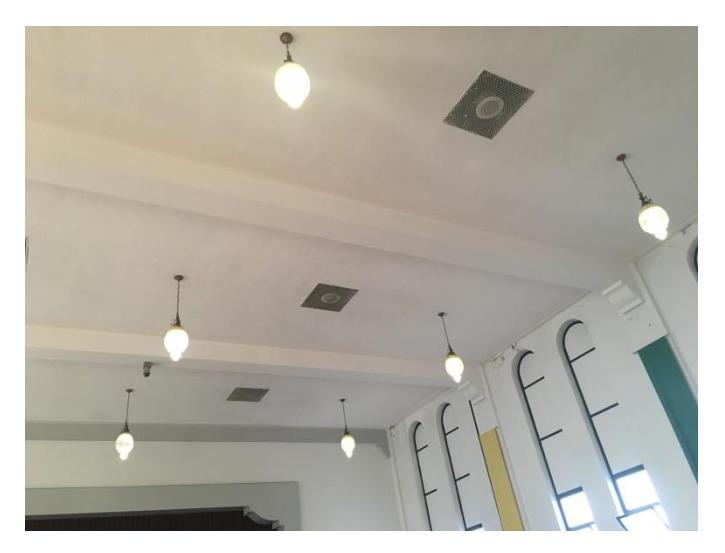
bulbs. See Photo CHAP-E2. The remainder of the lighting has served beyond its useful service life and needs to be replaced. Emergency and exit lights appear to be newer vintage and are in serviceable condition.

Photo CHAP-E2: CHAP Sanctuary Lighting

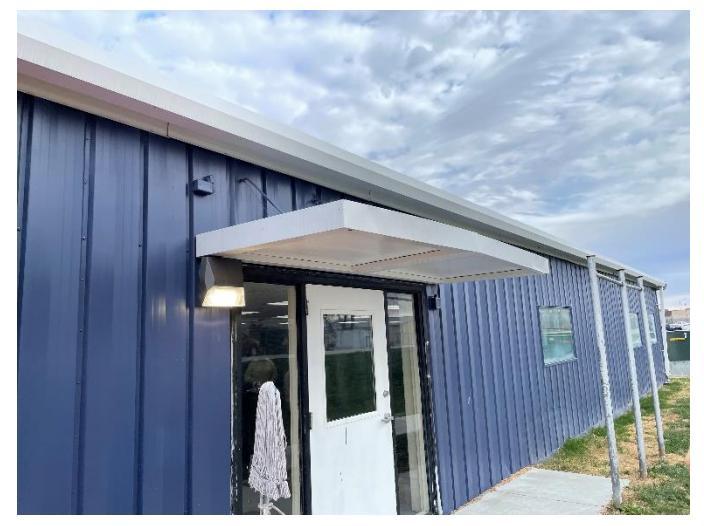
The building is a pre-engineered metal building manufactured by Armco. There is damage to canopy over the main door that appears to be from impact. There is also damage to the exterior metal wall panels at various locations around the building that also appear to be from impact.

Photo CERT-S1: Damaged Canopy

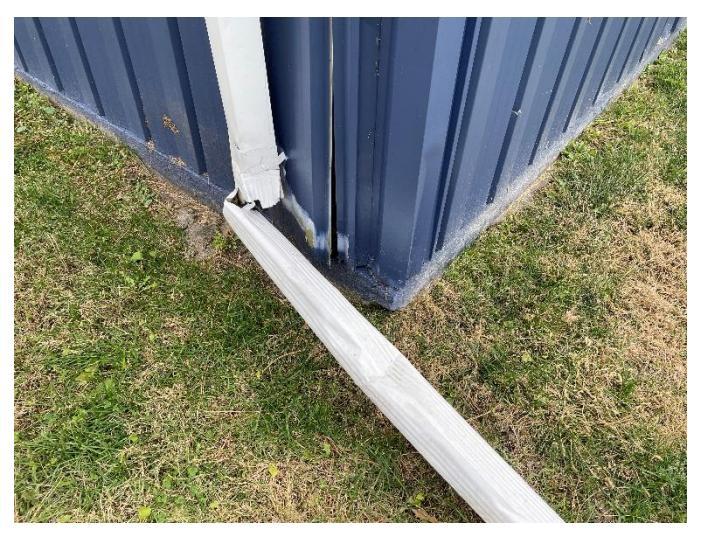
Photo CERT-S2: Example of Impact Damage to Exterior Panels

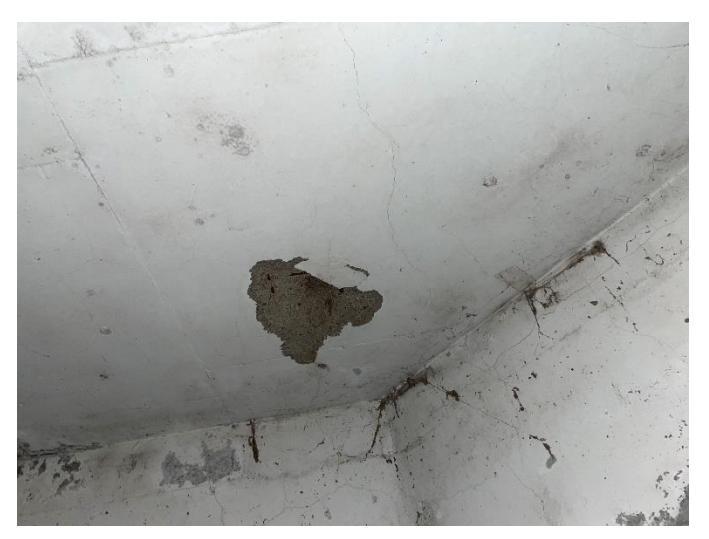
GT4 is a concrete structure. Spalling is present in small areas on the bottom of the observation level floor.

Photo GT4-S1: Spalled Slab

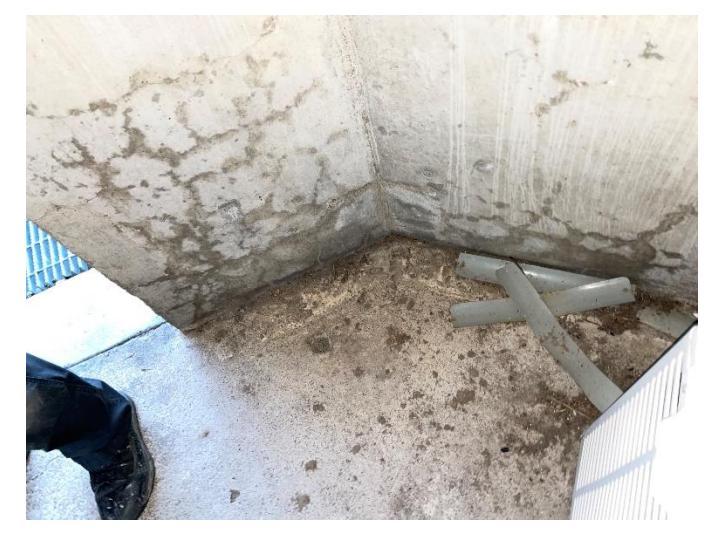
Photo GT4-S2: Map Cracking

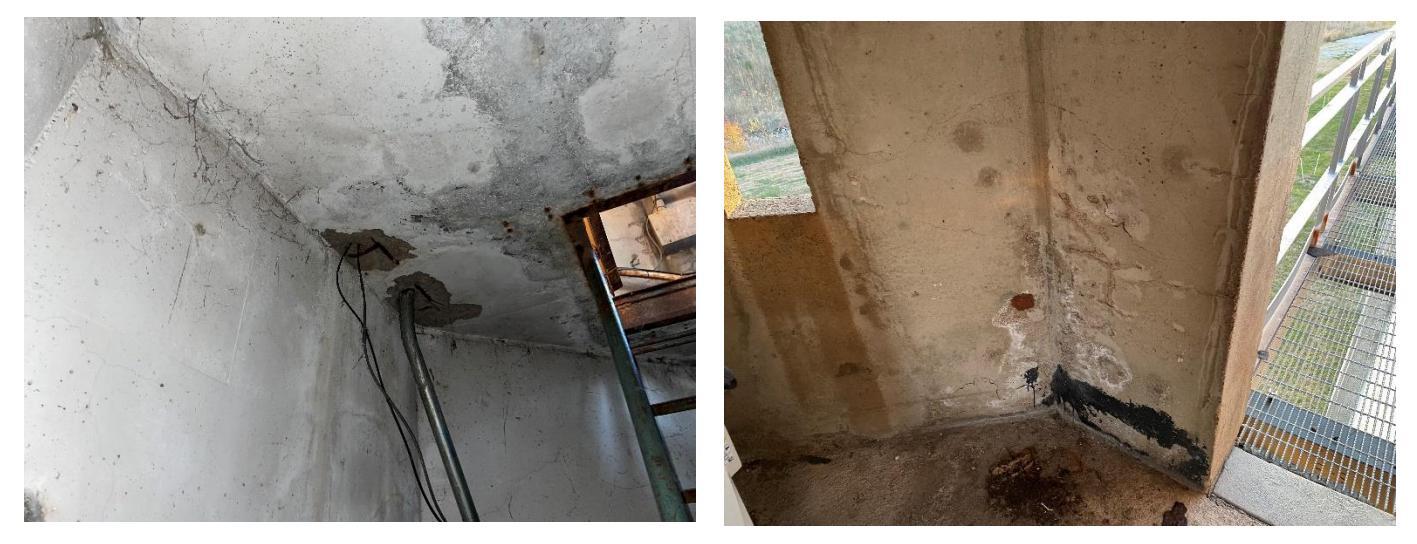
GT5 is a concrete structure. Spalling is present in small areas on the bottom of the observation level floor where utilities were run through the floor. Random cracking is present at various locations on the tower walls and observation level. Additionally, concrete has spalled from the bottom of the beam located at the edge of the intermediate landing exposing the reinforcing.

Photo GT5-S1: Spalled Concrete

Photo GT5-S2: Random Cracking

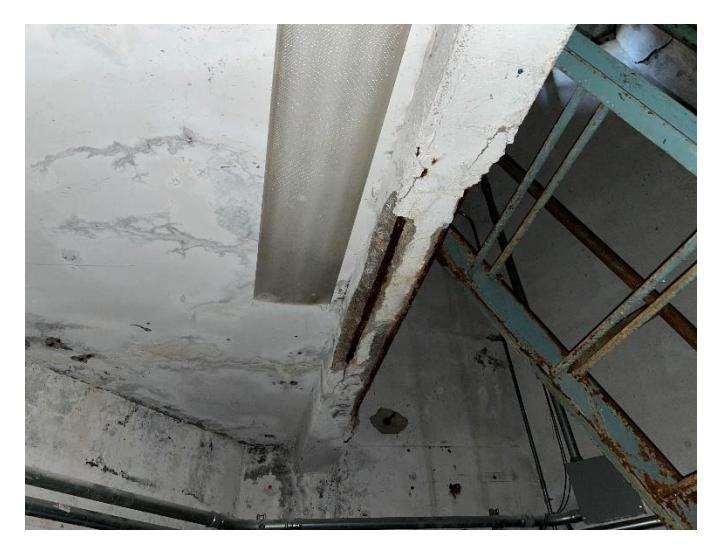
Photo GT5-S3: Spalled Concrete Beam

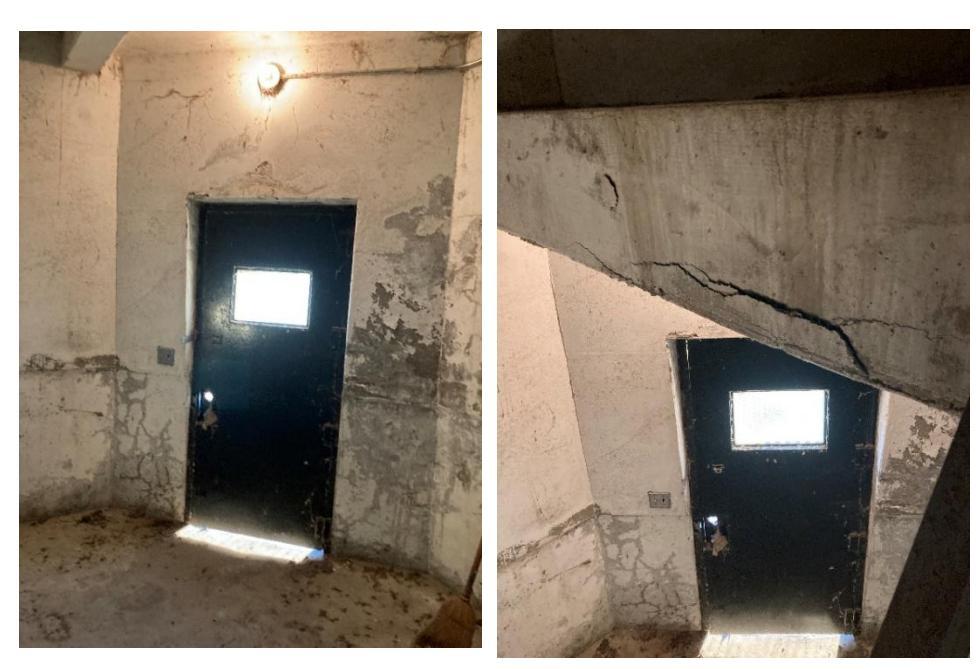
Photo GT6-S2: Map Cracking in Walls

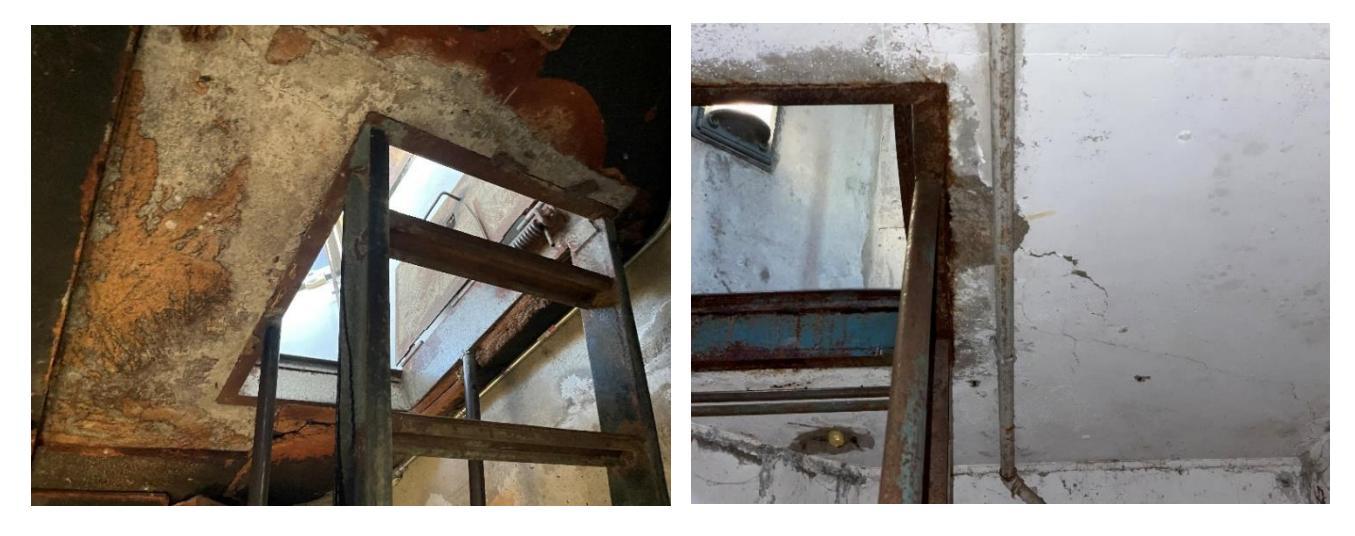
Concrete around the floor hatches is spalling and deteriorated. See Photo GT6-S4.

Photo GT6-S4: Deteriorated Concrete at Floor Hatches

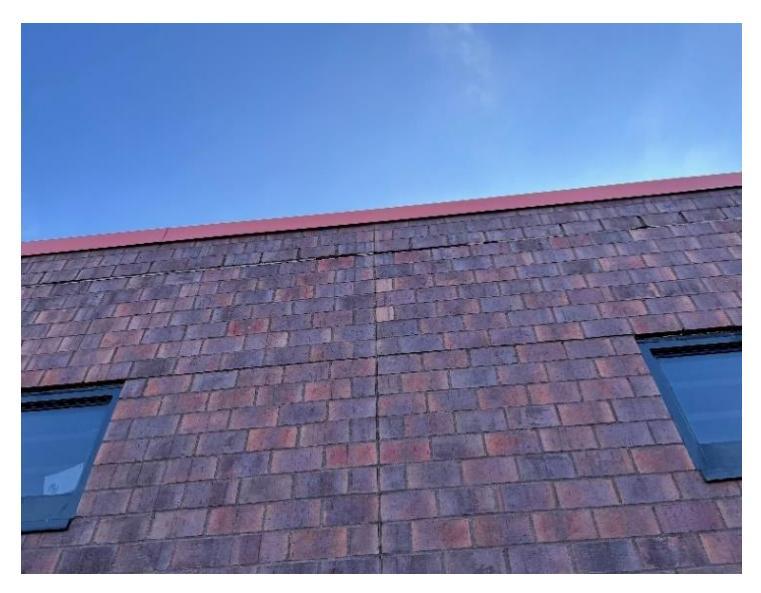
A horizontal crack near the top of the north wall of the northeast wing is nearly continuous. It appears previous repairs were attempted and those have also failed.

Photo HU1-5-S2: Cracked Brick at Parapet

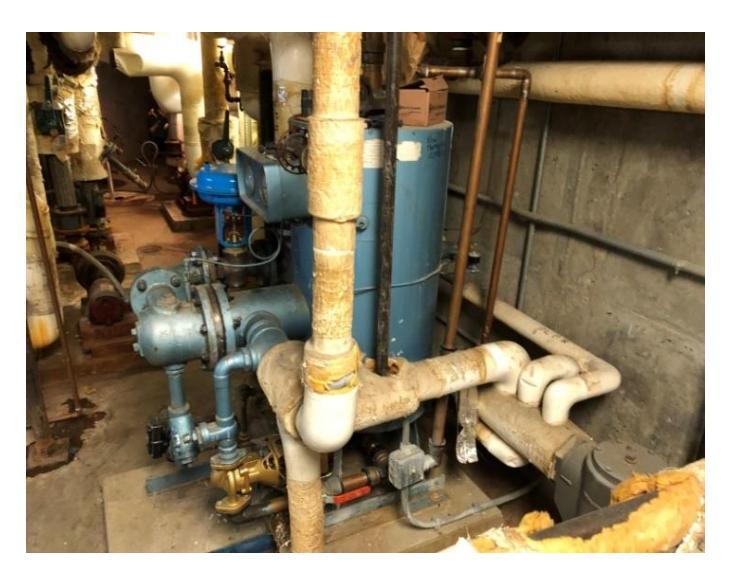
A steam water heater exists in the basement which is original from 1981. See Photo HU1-5-M1. The water heater has a pneumatic steam control valve which serves a steam tube bundle in this water tank. There is only one tube bundle in this water heater so, there is no redundancy in the case of equipment failure.

Photo HU1-5-M1: Existing Steam Water Heater

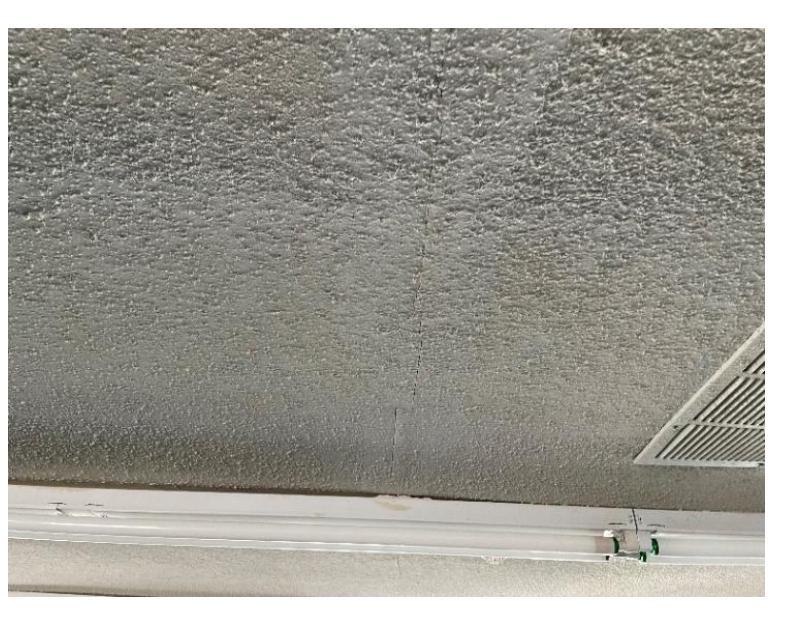
Photo LIB-S1: Cracked Gypsum Sheathing

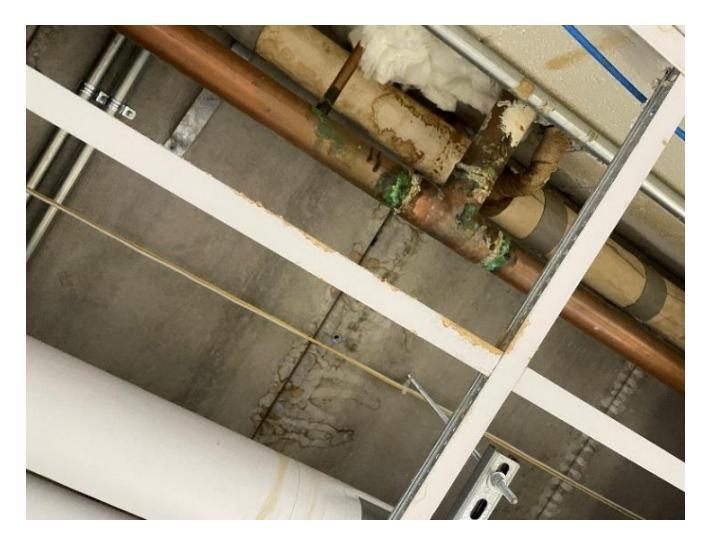
Photo MENT-S1: Water Staining at Roof

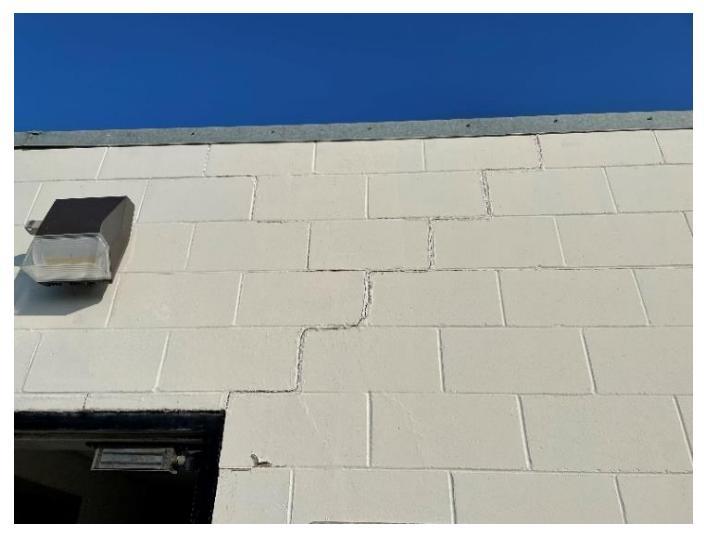
Random cracking in the exterior masonry walls is present, some of which have evidence of previous repairs.

Photo MENT-S2: Previously Repaired Masonry Cracks

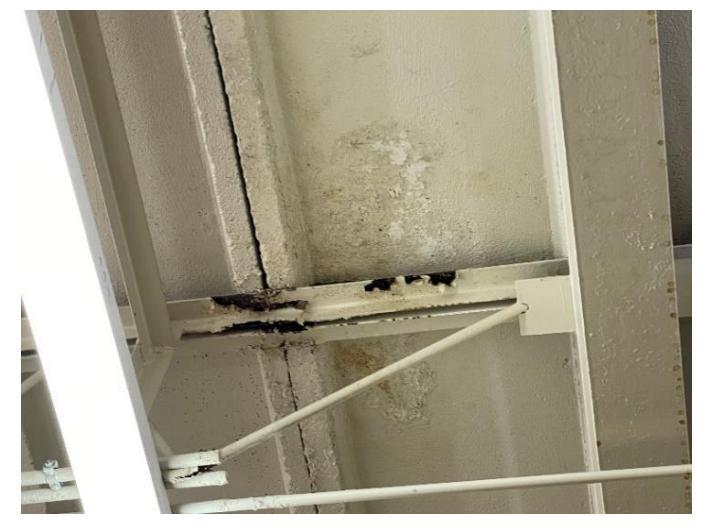
Photo PEB-S2: Rusted Roof Joist

Photo PEB-S1: Spalled Roof Panels and Cracked Masonry Walls

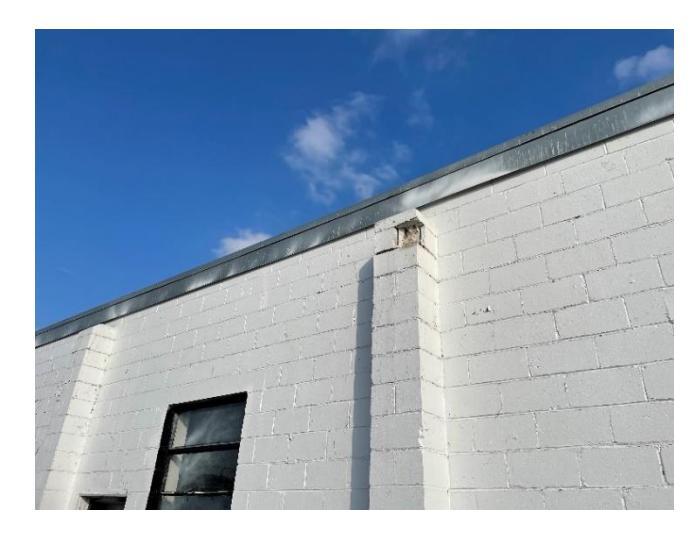
Photo PEB-S3: Spalled CMU at Pilasters

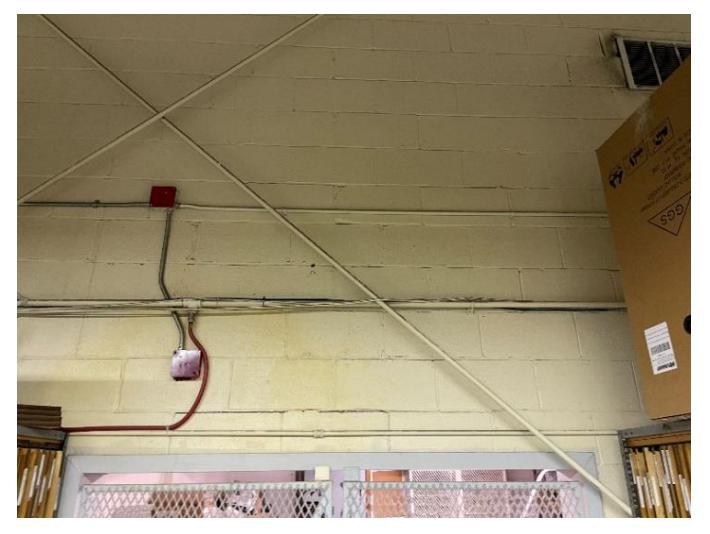
The PVB is a PEMB. CMU partition walls are present inside the building. There are offices at the west end of the building and their ceilings are being used as a storage mezzanine. No structural concerns were observed with the building. However, there is one opening in a CMU partition that appears to not have a lintel as there is cracking above it. See Photo PVB-S1.

Photo PVB-S1: Cracked CMU Partition

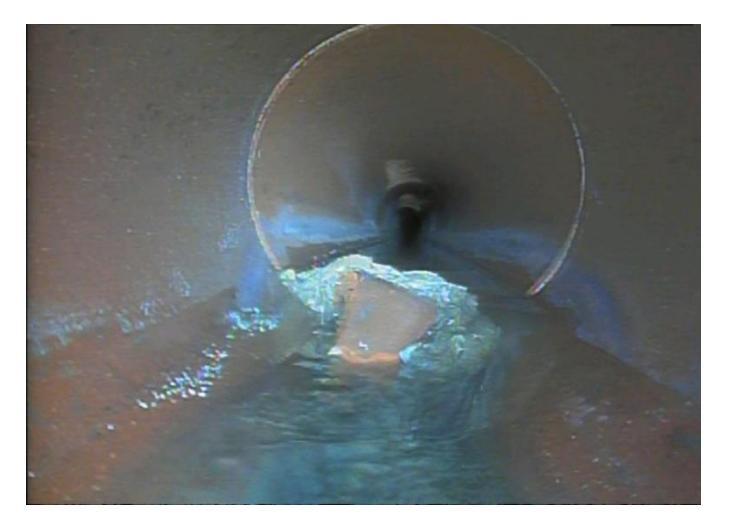
Photo SAN-2: Debris Found in SAN Piping

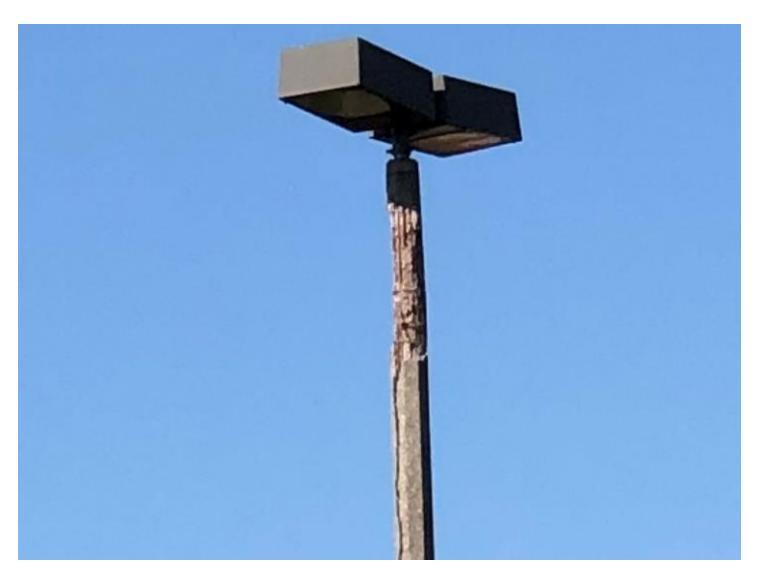
Photo LTG-2: Enlarged Image of Concrete Light Pole South of Housing Unit No. 5. (Note Severe Pole Deterioration with Reinforcing and Interior Conduit Visible)

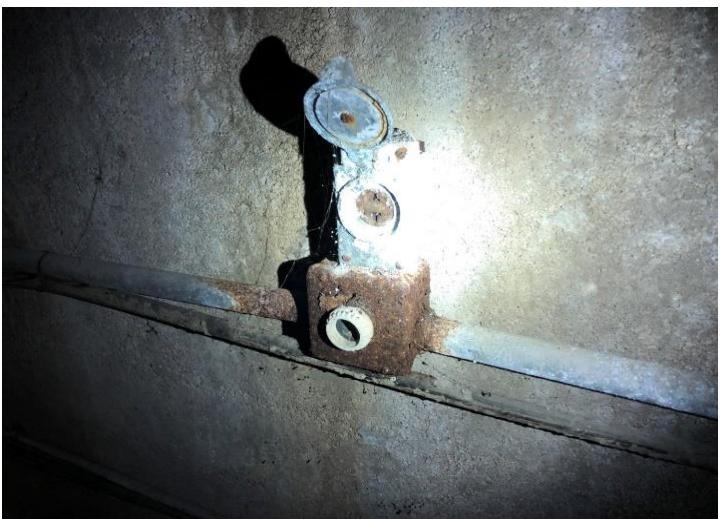
Photo UT-E1: Representative Photo of Rusted Tunnel Lighting and Receptacle Box, Lamp is Missing

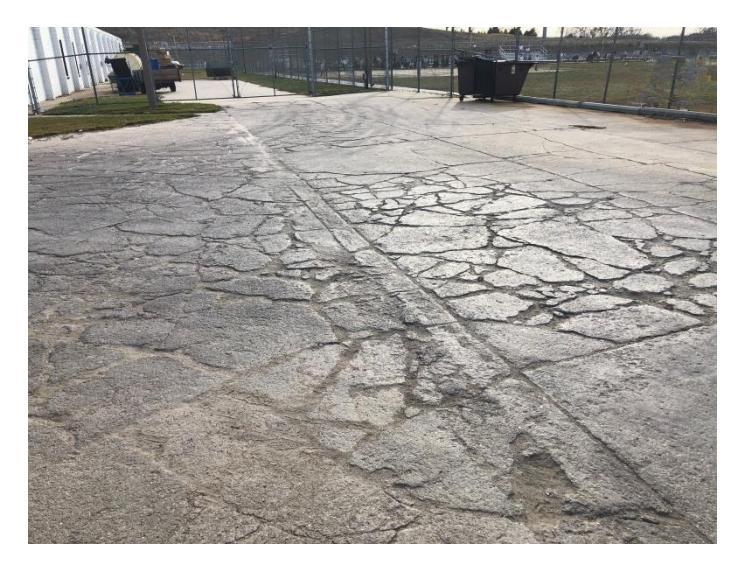
Photo PAVE-1: Poor Pavement Near HU6
