# Nebraska State Penitentiary Useful Life Engineering Study

Lincoln, Nebraska

Alvine No. 2021 8777 January 2022

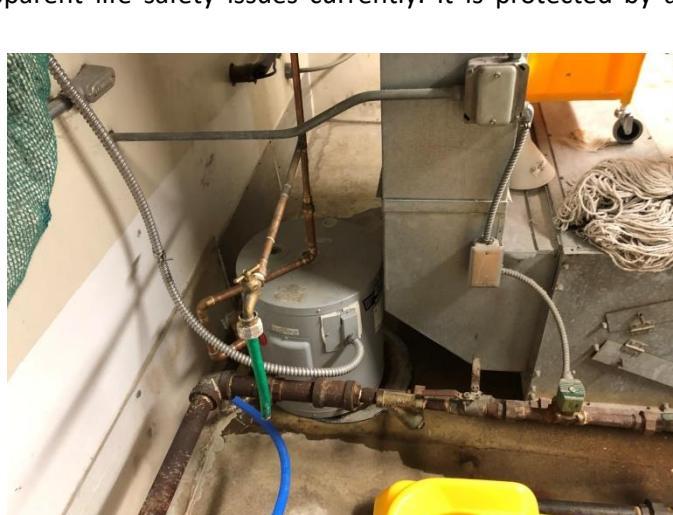
Photo ACT-M1: Existing Electric Water Heater

An electric water heater exists, which is about 10 years old. See Photo ACT-M1. The water heater was observed to be actively leaking water. The domestic hot water piping has no pipe insulation installed.

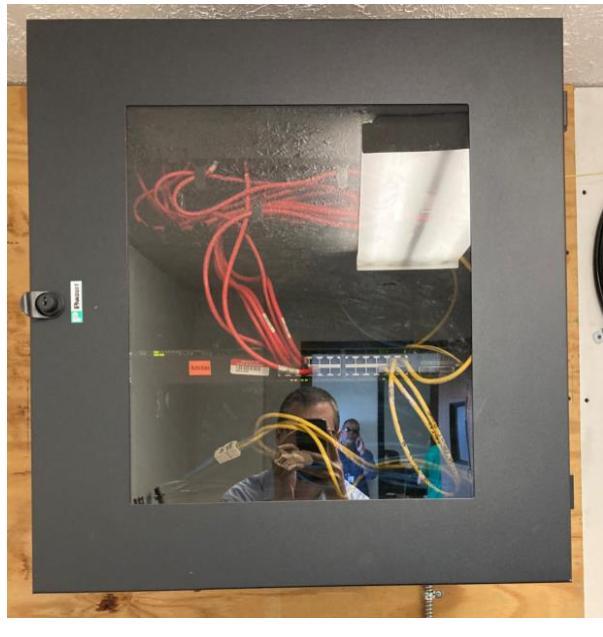
Photo ACT-T1: Existing Telecom Cabinet

There is an existing lockable wall-mount telecommunication cabinet located in Storage 112 that serves data for the entire building. The building is served by a 24-strand, single mode fiber optic cable that runs back to the telecommunications rack located in the basement telecommunications room of the Laundry Building (LAUN). The horizontal data cabling serving the building is all Category 6 copper cabling, which is in line with current industry standards for horizontal copper cabling. There is an uninterruptible power supply (UPS) within the telecommunications rack that supports the telecommunication network. The telecommunications cabinet is not properly grounded per BICSI standards.

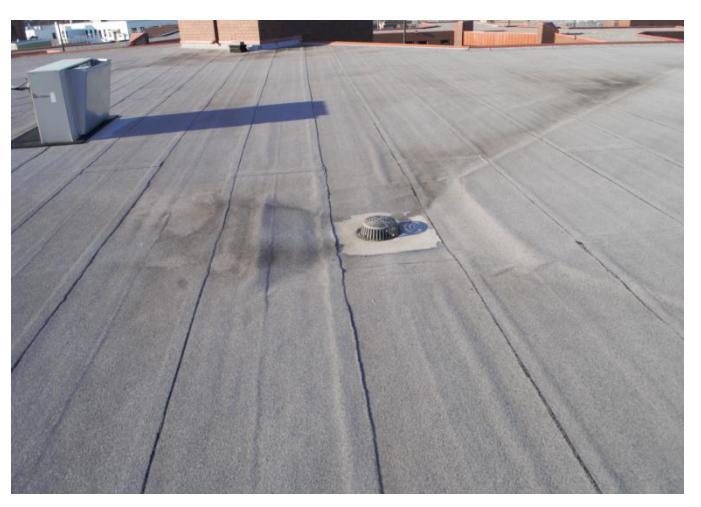
Photo ANC-A1: Existing Roof

The windows on the building are double-paned aluminum and in good condition. The roof appears to be a modified bitumen roof and is roughly 20-25 years old, an age when this type of roof typically reaches the end of its useful life. All exterior doors on the secure side are hollow metal (HM) with the main entry doors being aluminum storefront.

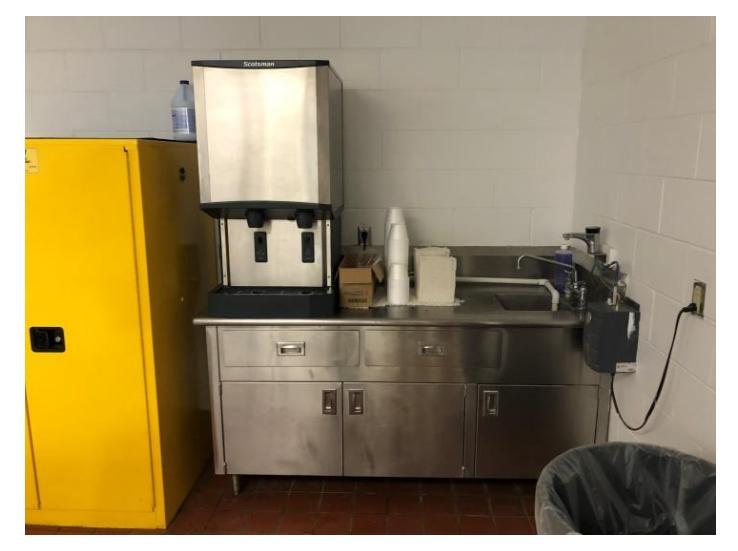
Photo ANC-FS1: Existing Hot Water Dispenser

The hot water dispenser in employee dining area is an older unit and shows signs of extensive use. See Photo ANC-FS1. Also, the existing ice/water dispenser appears to not have a water filter assembly.

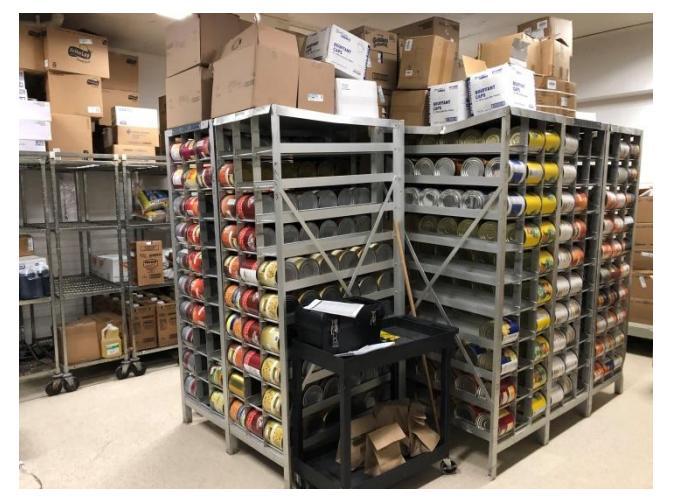
Photo ANC-FS2: Existing Can Racks

The can racks and track wire shelving in the dry storage room show signs of being heavily used, as they have bent tops and shelves, and some units are showing signs of rust. See Photos ANC-FS2 and ANC-FS3.

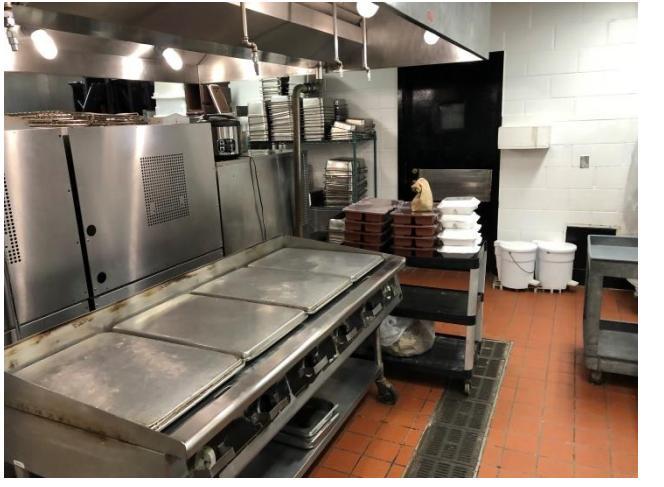
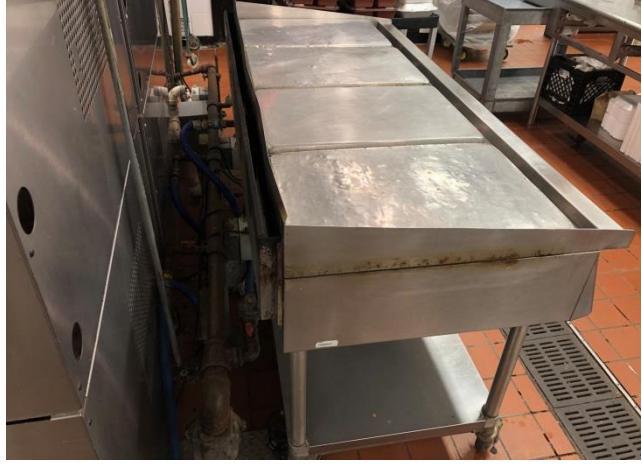
The griddle with stand appears to be heavily used (loss of control knobs, shows signs of high heat and unit has numerous dents) and shows signs of end of serviceable life. See Photos ANC-FS4 and ANC-FS5. The mixer is an older discontinued model, and appears to be extensively used and shows signs of end of serviceable life. See Photo ANC-FS6. The conveyor toasters appear to be heavily used. See Photo ANC-FS7.

Photo ANC-FS4: Existing Griddle

Photo ANC-FS5: Existing Griddle with Stand

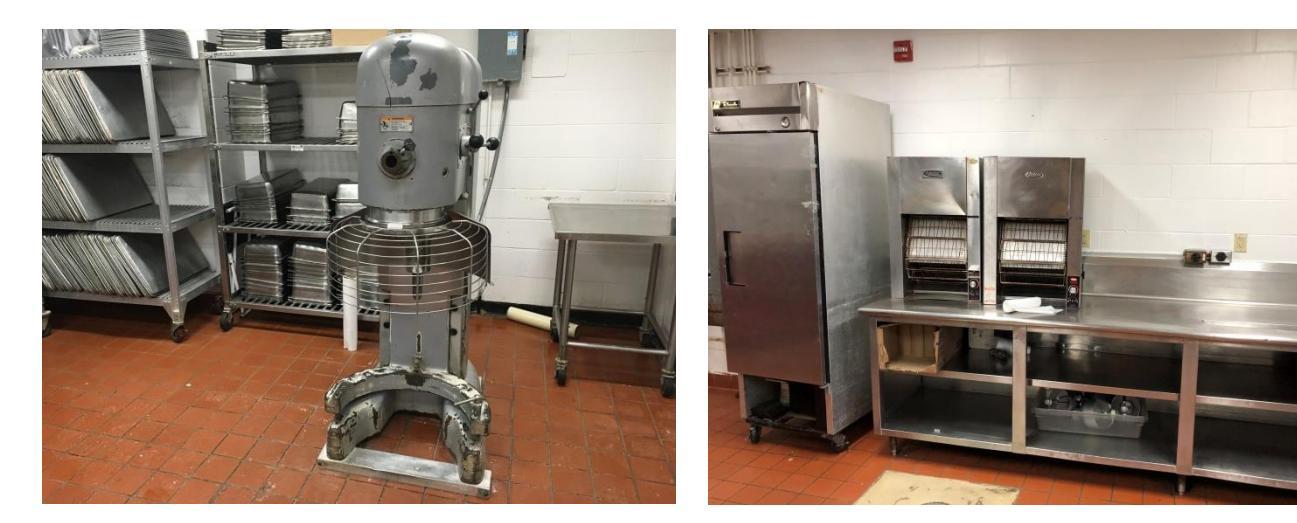
Photo ANC-FS6: Existing Mixer

Photo ANC-FS7: Existing Conveyor Toasters

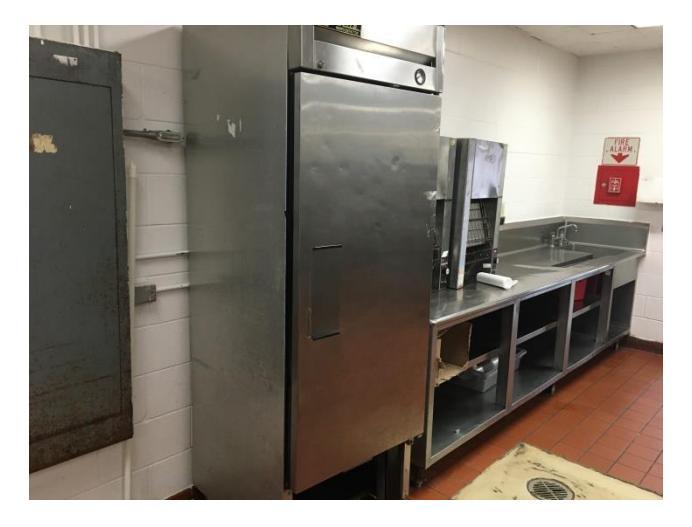
Photo ANC-FS8: Existing Reach-in Refrigerator

The reach-in refrigerators are older units and appear to be extensively used (both units are missing bottom front panels and have numerous dents on exterior), and show signs of end of serviceable life. See Photos ANC-FS8 and ANC-FS9.

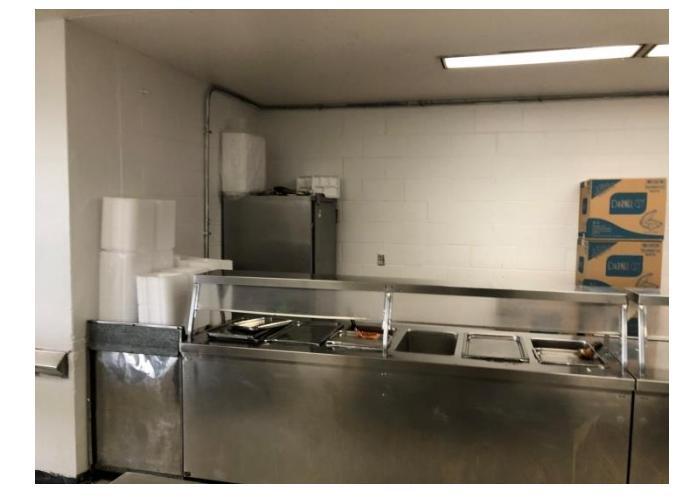
Photo ANC-FS10: Existing Utility & Hot Counter

All serving counters (utility counter, hot serving counter, refrigerated/cold serving counter) appear to be extensively used (loss of control knobs and scratched sneeze guards), and show signs of end of serviceable life. See Photos ANC-FS10, ANC-FS11, ANC-FS12, and ANC-FS13.

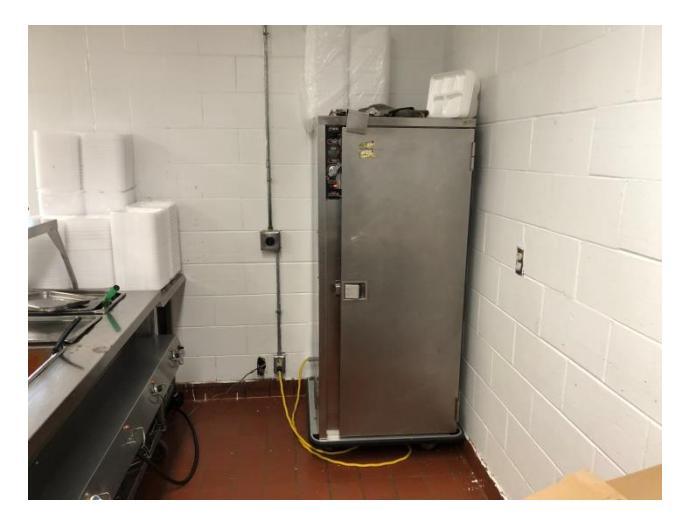
Mobile hot cabinet in serving area appears to be an older unit and shows signs of extensive use. See Photo ANC-FS14.

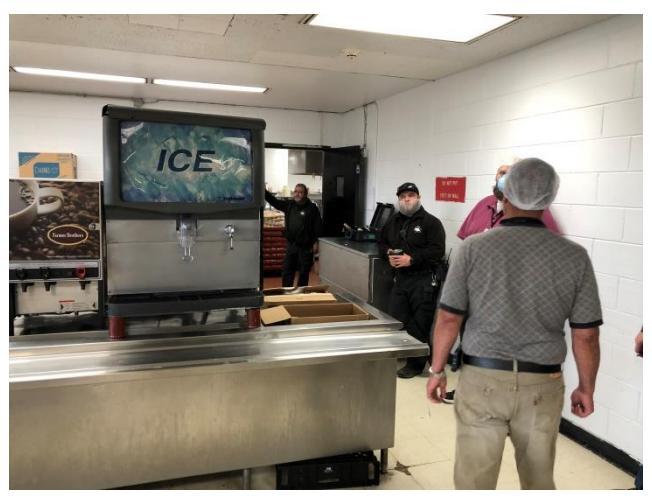
Ice/water dispenser in serving area shows signs of extensive use. See Photo ANC-FS15.

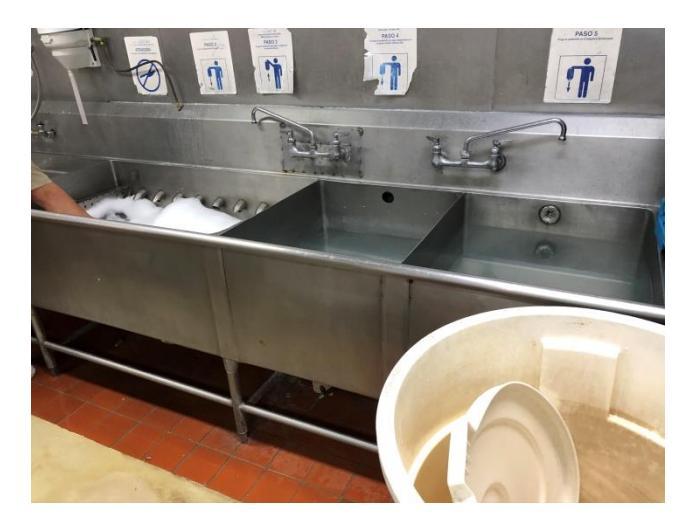
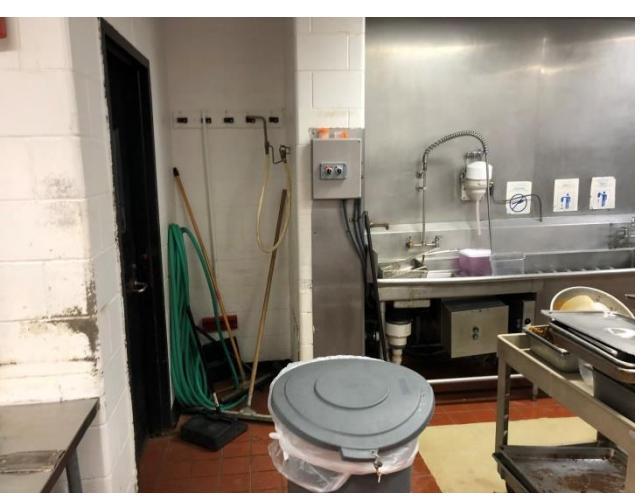
The scullery sink and pre-rinse assembly appear to be original and shows signs of being heavily used (missing parts). See Photos ANC-FS16 and ANC-FS17.

Photo ANC-FS16: Existing Scullery Sink

Photo ANC-FS17: Existing Pre-Rinse Assembly

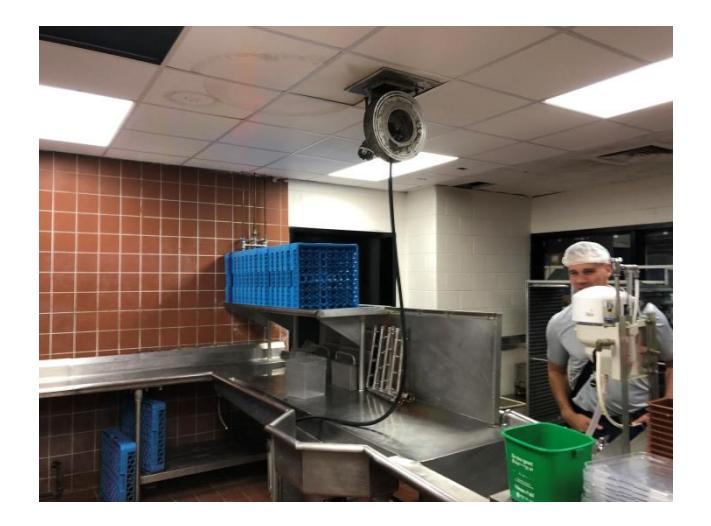
Photo ANC-FS18: Existing Hose Reel Spray Assembly

The hose reel spray assembly (at ceiling) and mixing valve (at wall) in the dish wash room appear to be original. They show signs of being heavily used and are at end of serviceable life. See Photos ANC-FS18 and ANC-FS19.

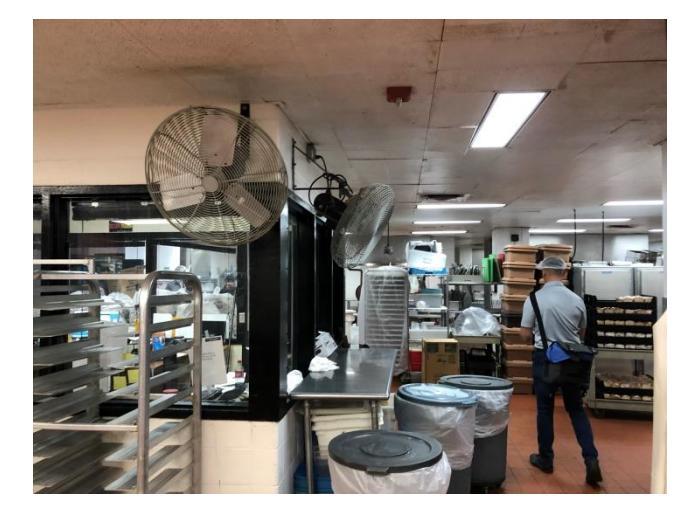
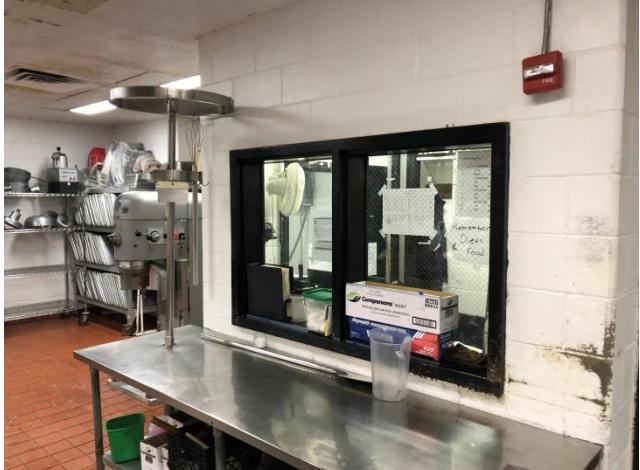
The work tables appear to be original units and show signs of heavy use. Some of the units are in worse condition than others (dented countertops and bent/damaged legs). See Photos ANC-FS20 and ANC-FS21.

Photo ANC-FS20: Existing Work Table

Photo ANC-FS21: Existing Work Table with Utensil Rack

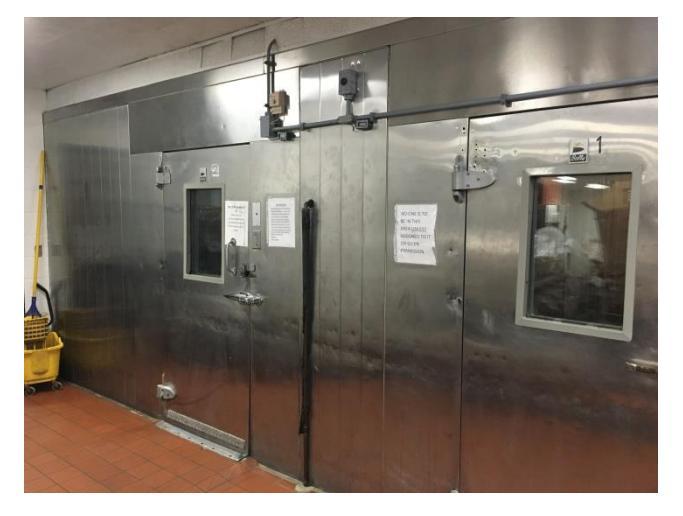
Photo ANC-FS22: Existing Walk-in Coolers/Freezer

Walk-in coolers/freezer appear to be original box assemblies and show signs of end of serviceable life. Walk-in door hinges have been pulled off of wall panels and doors numerous times, as there are multiple holes from hinges being relocated (vertically). See Photos ANC-FS22 and ANC-FS23.

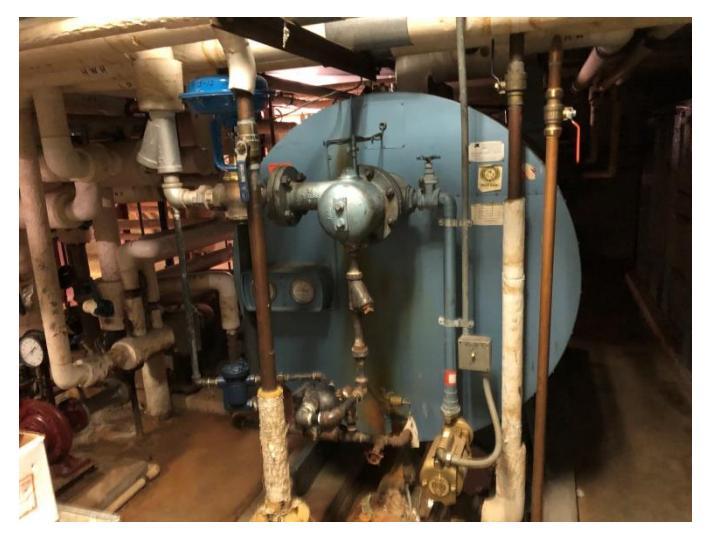
Photo ANC-M1: Existing Steam Water Heater

A steam water heater exists in the second floor Mechanical Room 2B68 which is original from 1981. See Photo ANC-M1. The water heater has a pneumatic steam control valve which serves a steam tube bundle in this 680-gallon water tank. There is only one tube bundle in this water heater.

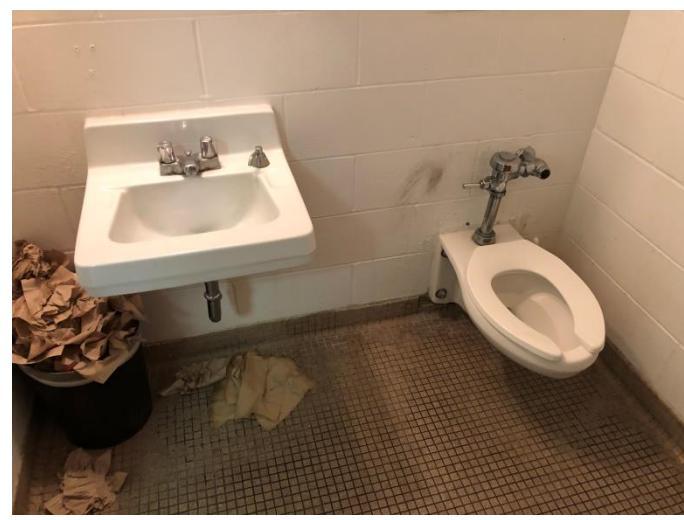
Photo ANC-M2: Typical Existing Plumbing Fixtures

With exception of the electric water coolers, the plumbing fixtures are operating beyond their useful life and not conforming to modern water flow rates or ADA requirements. It is recommended to replace the plumbing fixtures with modern water conserving fixtures which also meet ADA requirements. The probable project cost for this scope of work is \$772,000.

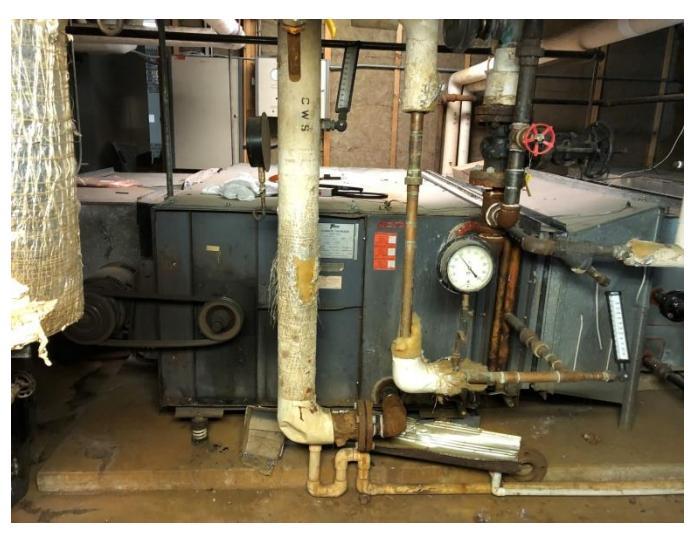
Photo ANC-M3: Typical Existing AHU

a steam heat exchanger; perimeter finned-tube heating; hydronic four-pipe fan coils; and base-mounted, endsuction pumps with most equipment still original from 1981. Humidifiers do not exist for this building.

It is recommended to replace the existing HVAC equipment, clean, and reuse duct mains where they are not accessible, install modern supply air diffusers and ducted return air grilles, and to upgrade the building to a fully integrated digital BAS. The new AHUs will be provided with fan arrays which are composed of multiple direct drive fans which can automatically speed up to provide redundancy in the event that one fan should fail. The AHUs will also include MERV 13 filters, ultraviolet (UV) lights at the cooling coils, and humidifiers to provide improved indoor air quality for the occupants. This work will require the acoustical lay-in ceilings and the hard ceilings to be removed and replaced, and those costs are included. The light fixtures would also need to be

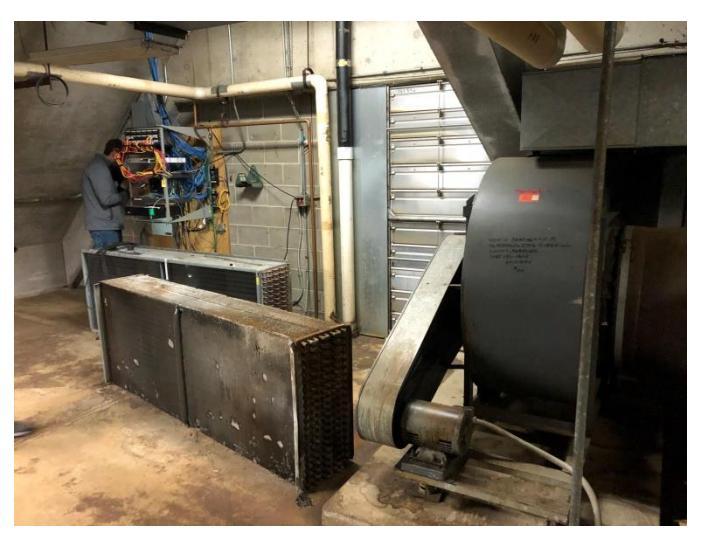
In the second floor Mechanical Room 2B68, two AHU chilled water coils have been changed out and left on the floor of the mechanical room, which provides evidence of previous equipment failure. See Photo ANC-M4.

Photo ANC-M4: Changed Out Chilled Water Coils

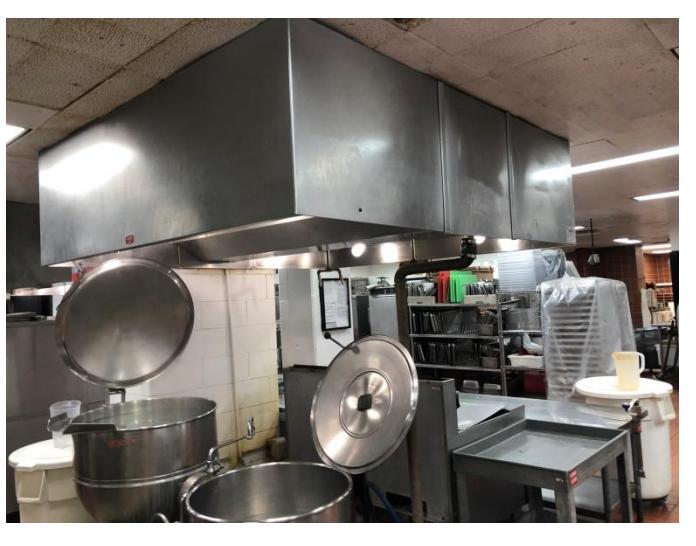
Photo ANC-M5: Existing Kitchen Exhaust Hood

away from the two kitchen exhaust hoods. One of the kitchen exhaust hoods is shown in Photo ANC-M5. The kitchen exhaust hood ductwork is welded black steel, but it is not insulated with any type of duct insulation. There is a single centrifugal exhaust fan serving these hoods which appears to be from 1981.

The kitchen exhaust hoods are original from 1981 which makes them about 40 years old and due for replacement. The kitchen exhaust ductwork is welded black steel, but fire-rated duct insulation is not installed, which is required by the International Mechanical Code (IMC) and by National Fire Protection Association (NFPA).

It is recommended to replace both of the kitchen exhaust hoods with two similar-sized, modern, Type I exhaust hoods which are rated for grease exhaust air. The welded black steel exhaust ductwork will be cleaned and reused, but a new grease rated exhaust fan will be provided. The hoods will be provided with 100% outdoor air make-up air at the perimeter of the hoods to help with the capture of moist grease laden air from the cooking equipment below. A make-up air unit (MAU) will be installed on the roof and ducted down to the kitchen exhaust hoods in the first floor kitchen. The MAU and the exhaust fan will be controlled in steps to correspond to having one or both kitchen exhaust hoods on at a time. The probable project cost for this scope of work is \$452,000.

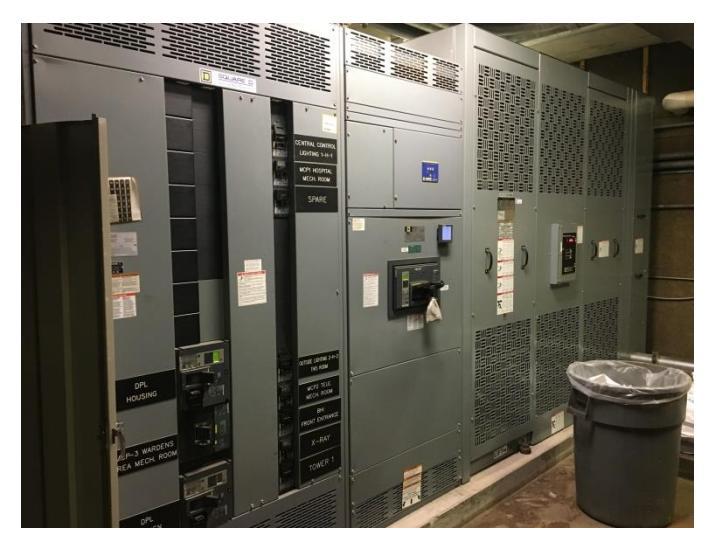
The electrical power distribution system includes a newer main service switchboard. See Photo ANC-E1. The remaining system components are a majority of equipment that is original to the building and some equipment that appears to be approximately 20 years old. The equipment original to the building is serving beyond its useful service life and needs to be replaced. It is also by a manufacturer that has been well documented for unreliable equipment. Replacement parts are only available on the secondary market, if they are available at all. It was noted in some locations that proper National Electrical Code (NEC) working clearances are not

Photo ANC-E1: Main Electrical Service

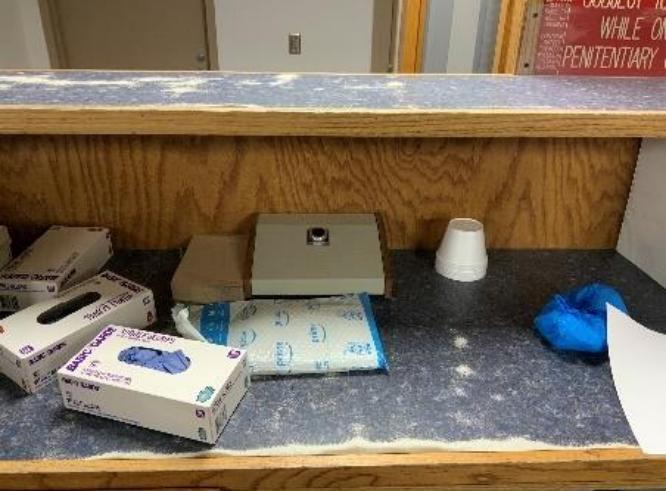
All control locations use obsolete control panels to control and monitor their areas. Control panels consist of rotary switches and old-type LED indicators installed on composite board (plastic/steel) with text engraved on their surface. Some panels are installed into desk mounted turrets, and some are wall-mounted. The

Photo ANC-SEC1: Existing Door Control Panel -Basement Level - Public Entrance

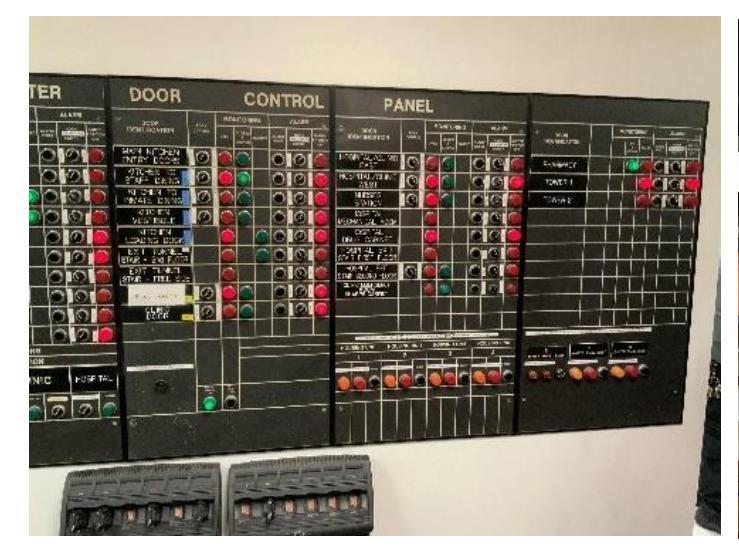
Photo ANC-SEC2: Existing Door Control Panel -Master Control Room

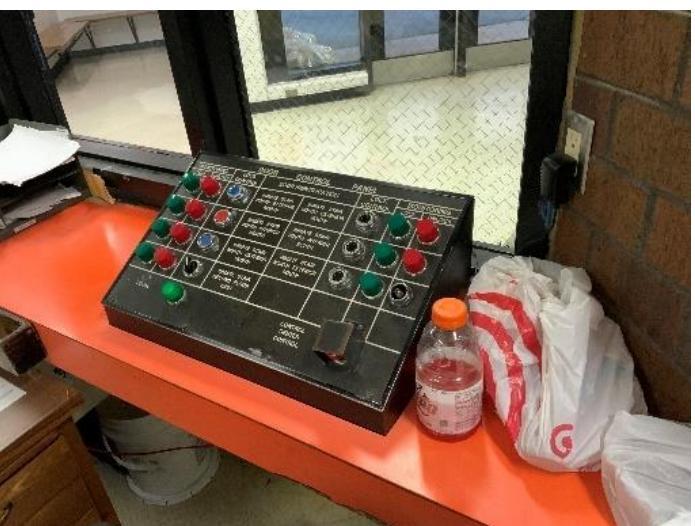
Photo ANC-SEC3: Existing Door Control Panel – Turnkey Entrance

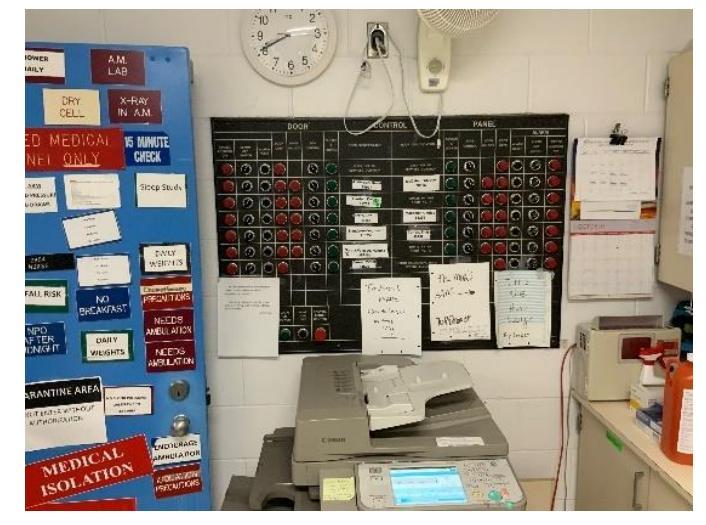
Photo ANC-SEC4: Existing Door Control Panel – Nurses Office

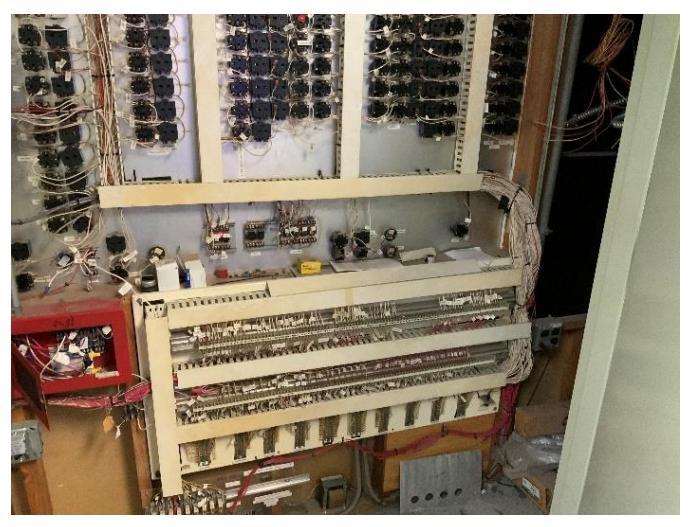
Photo ANC-SEC5: Existing Door Control Panel – Medical Area Entrance

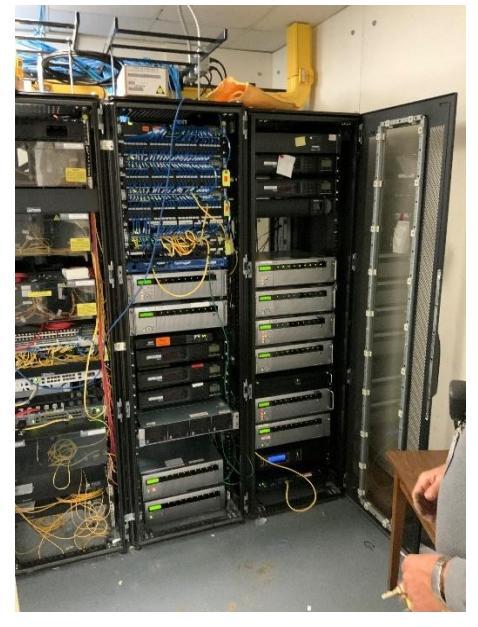
The existing video surveillance has existing IP cameras managed by an obsolete Panasonic PMPU server with Panasonic ND400 storage arrays. Most cameras are low resolution Panasonic internet protocol (IP) fixed and

Photo ANC-SEC8: Video Surveillance System Servers and Recorders

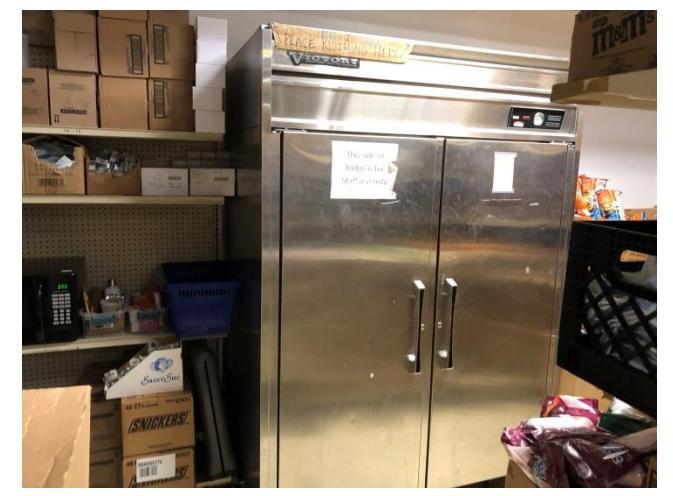
The reach-in refrigerator appears to be an older unit and nearing the end of its serviceable life. The interior cavity of the unit is showing signs of rust/corrosion along the panel joints. See Photos CAN-FS1 and CAN-FS2.

Photo CAN-FS1: Existing Reach-in Refrigerator

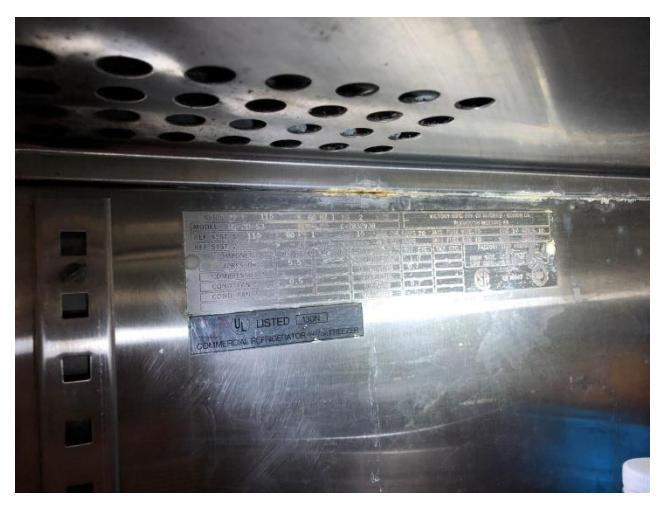
Photo CAN-FS2: Existing Reach-in Refrigerator Interior

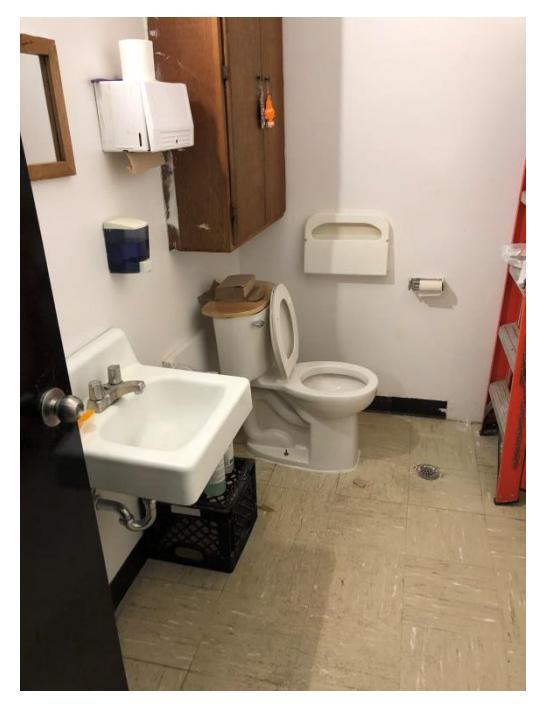
The domestic hot water is provided to this building from a water heater in the Soap Factory (SOAP). The plumbing fixtures are a mixture of ages. The flush tank water closet is about five years old, but the lavatory appears to be original from 1981. See Photo CAN-M1. This building was built before the EPAct of 1992 and before ADA, so the lavatory and faucet are operating beyond their useful life and not conforming to modern water flow rates or ADA requirements. For a discussion on ADA issues, see architectural.

Photo CAN-M1: Existing Plumbing

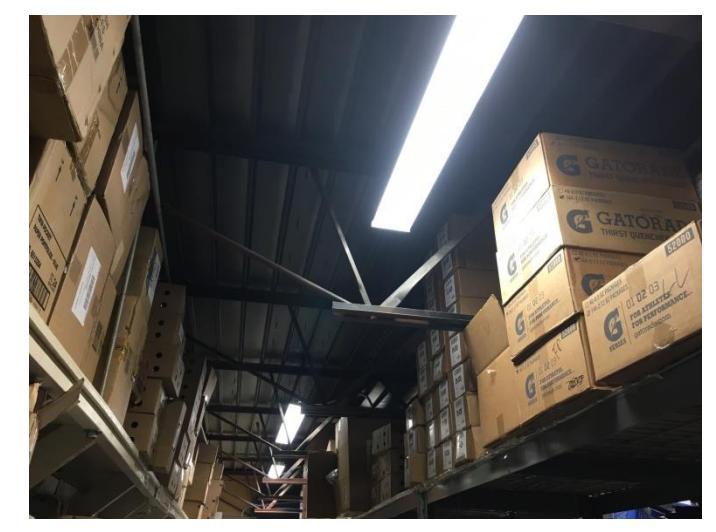
This building does not have a fire sprinkler system. Boxes of items are stacked up to the bottom of the roof deck. See Photo CAN-M2, which would need to be reduced if a fire sprinkler system was added.

Photo CAN-M2: Stacked Boxes up to Roof

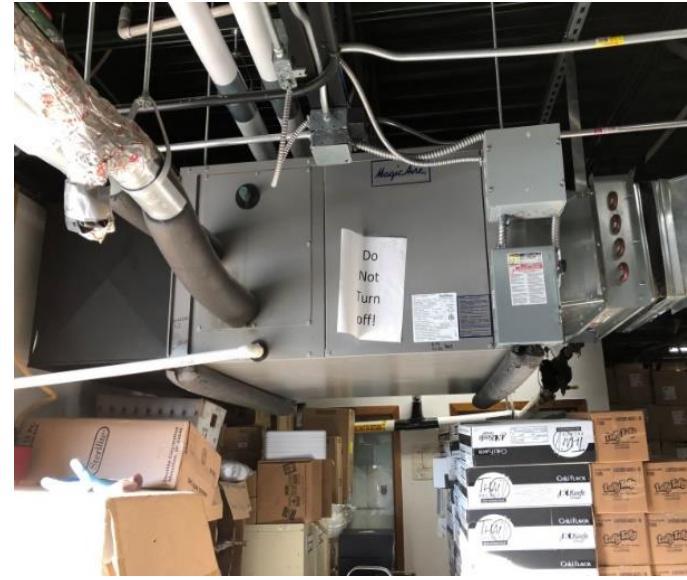
The HVAC system is composed of two AHUs one ACCU thermostats, and one restroom exhaust fan. The west AHU is from 2012 and has a steam heating coil and a chilled water cooling coil. See Photo ACT-M3. The steam piping, chilled water piping, and cooling coil condensate are all routed over food items which need to be avoided. There is not any mechanically introduced ventilation air provided for this building.

The east AHU, ductwork, and exhaust fan are original from 1981, which makes them about 40 years old; while the west AHU is from 2012, which makes it about 9 years old. According to ASHRAE, most fans and coils have a median service life of about 20 years. As a result, the existing east AHU and the exhaust fan are operating beyond its expected useful life.

Photo ACT-M3: Existing AHU

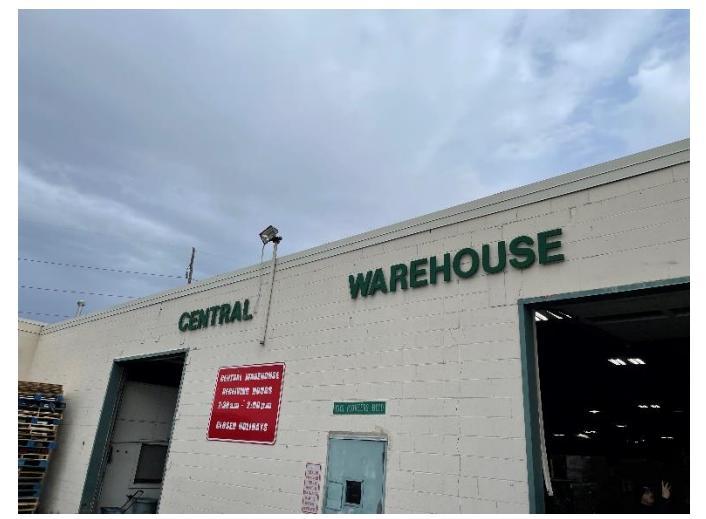
Cracks are present in the south-central CMU wall. No control joints were observed in this wall.

Photo CW-S1: Cracked CMU

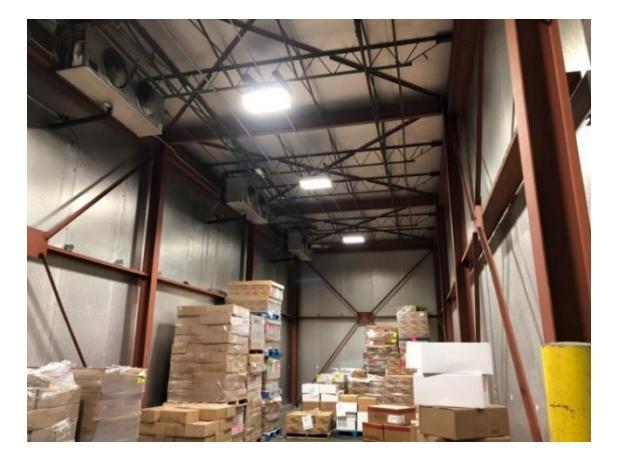
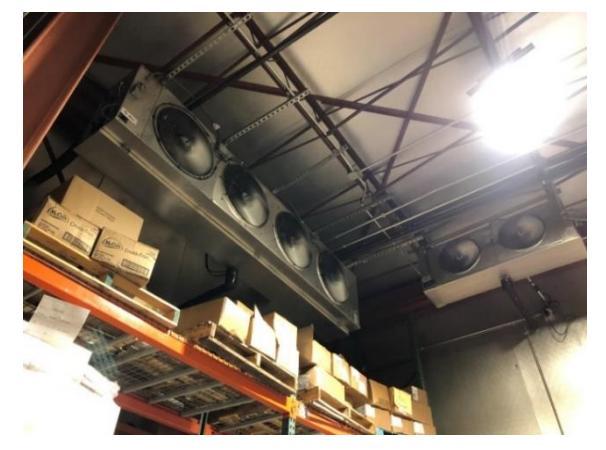
The existing walk-in freezer contains a total of five evaporator coils, of which four appear to be original equipment from 1999. The larger (fifth) evaporator coil was added to aid in holding the proper temperature inside of the freezer compartment. See Photos CW-FS1&CW-FS2.

Photo CW-FS1: Existing Freezer Evaporator Coils

Photo CW-FS2: Existing Freezer Evaporator Coils

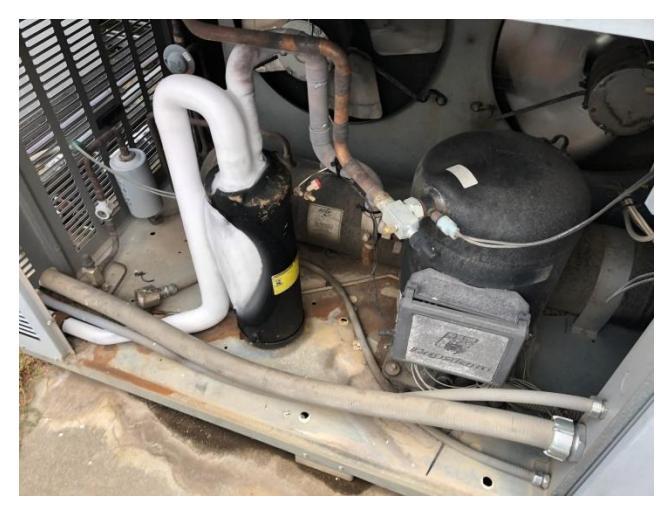
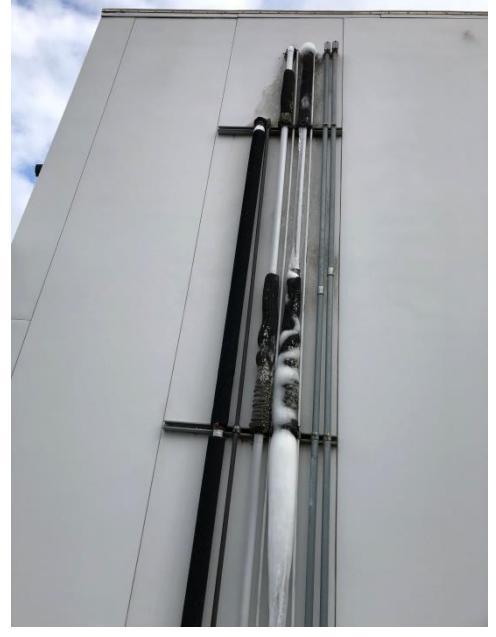
The existing insulation on the refrigeration piping (between the condensing units outside and the evaporator coils) is in poor condition, as it is missing in areas and deteriorating in other areas. See Photos CW-FS3&CW-FS4. This results in cold dissipating in the pipe and allowing ice to build-up around the refrigeration piping (especially

at the exterior of the compartment). This reduces the efficiency of the refrigeration system by not providing the proper operating temperature at the evaporator coils.

Photo CW-FS3: Existing Older Condensing Units

Photo CW-FS4: Existing Refrigeration Piping

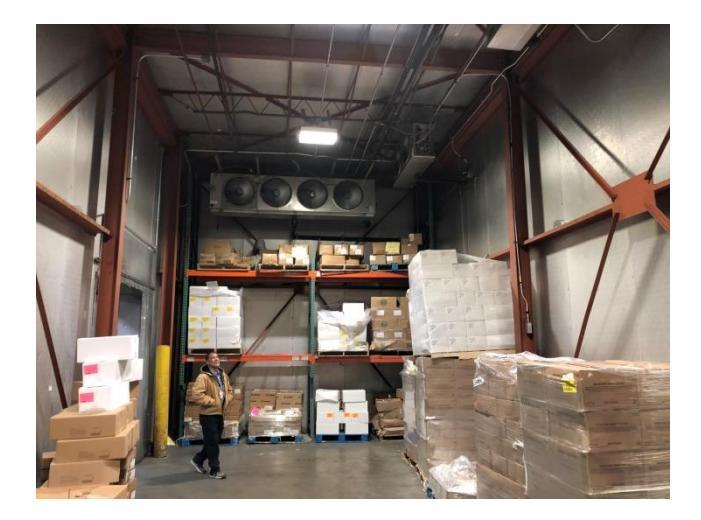
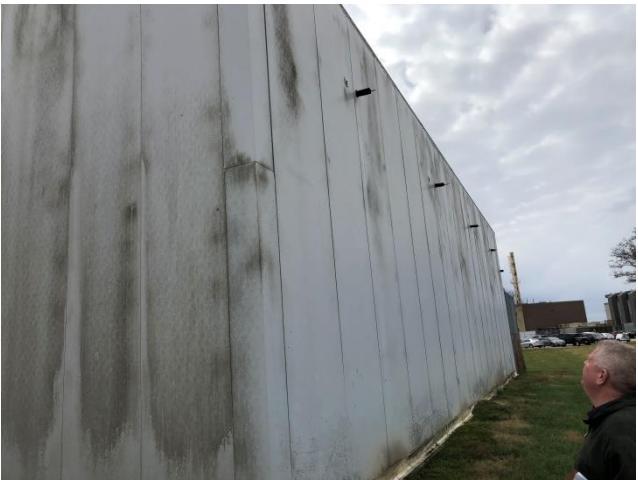
The condensate drain lines from all five evaporator coils appear to be routed straight through the wall panel of the walk-in freezer compartment to the exterior of the building without any traps. See Photos CW-FS5&CW-FS6. This results in warm/humid air infiltrating into the walk-in freezer compartment through the condensate drain piping and being dispersed throughout the interior of the box by the evaporator fans.

Photo CW-FS5: Existing Freezer Evaporator Coils

Photo CW-FS6: Existing Evaporator Coil Drains

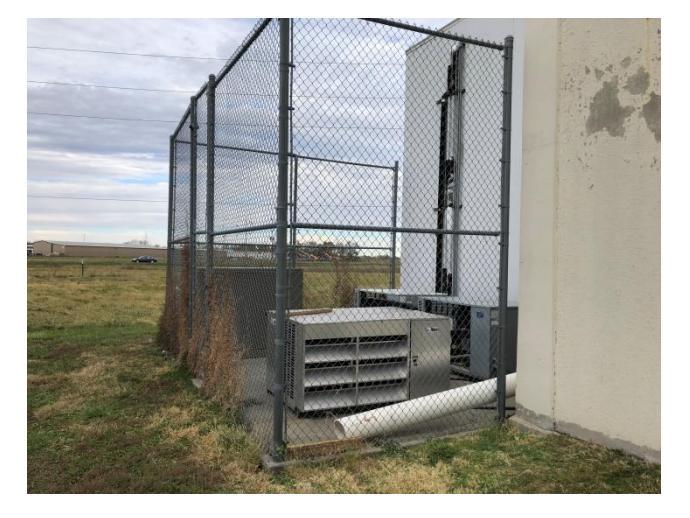
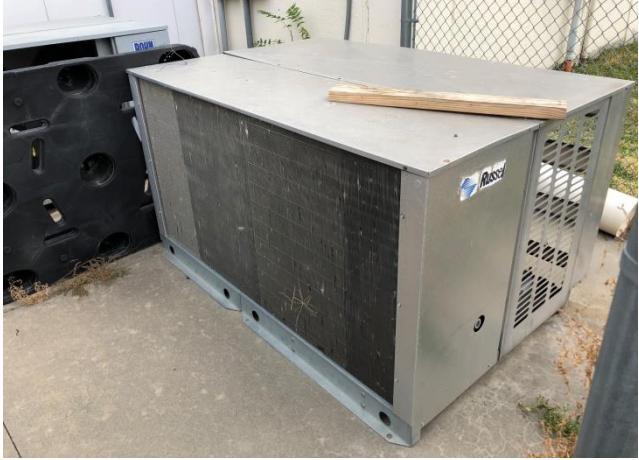
Regarding the location of the newer/larger Russell condensing unit, it has been located directly in front of the hot air discharge (exit) side of the two older condensing units. See Photos CW-FS7&CW-FS8. This results in the newer condensing unit bringing in warmer air into the air in-take side, making it less efficient for cooling the unit. Photo CW-FS8 shows that a plastic pallet has been attached to the end of the newer condensing unit to help prevent the hot air from blowing into the newer condensing unit.

Photo CW-FS7: Existing Freezer Condensing Units

Photo CW-FS8: Existing Large Condensing Unit

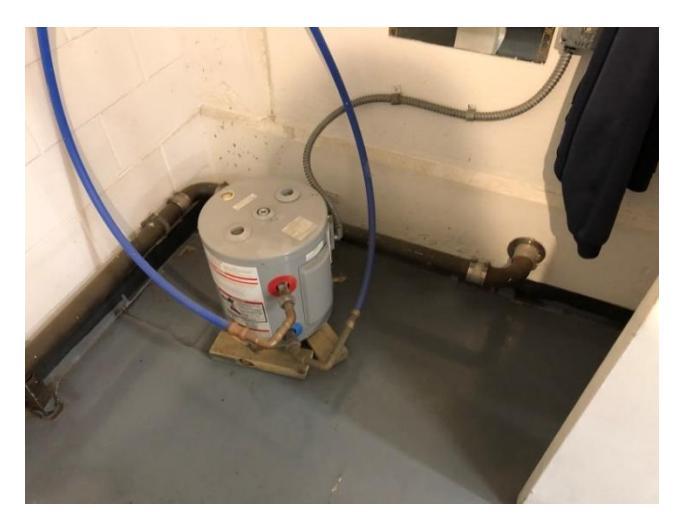
Two electric water heater exists which are both about five years old. See Photo CW-M1. The domestic hot water piping has no pipe insulation installed.

Photo CW-M1: Typical Existing Electric Water Heater

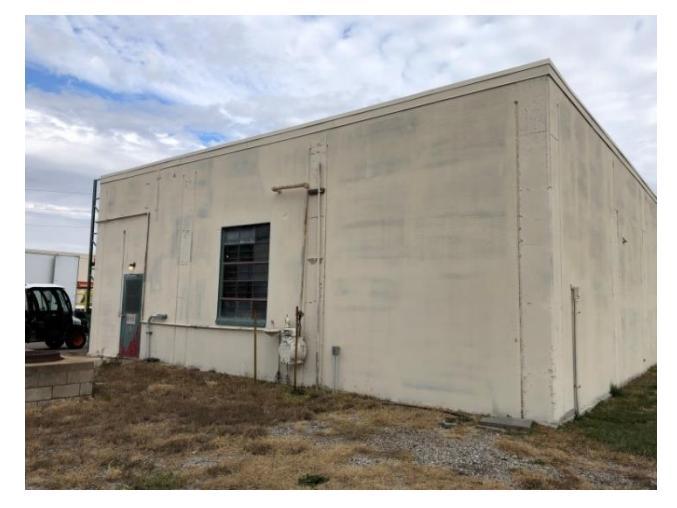
The building is served by two natural gas meters with one on each end of the U-shaped building. The southwest gas meter and piping appears to be at least 40 years old and is shown in Photo CW-M2.

Photo CW-M2: Existing Natural Gas Meter at SW Wall

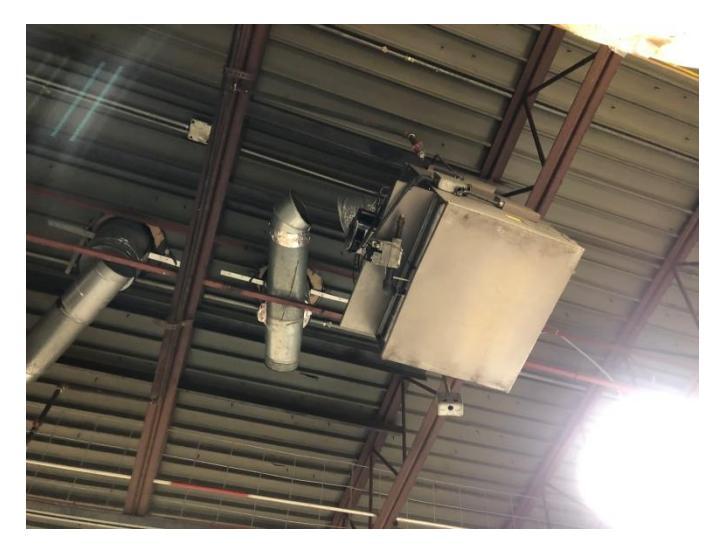
The HVAC system is composed of eight natural, gasfired unit heaters of which, three do not work. See Photo CW-M4. There are two rows of natural gas infrared radiant heaters in the middle warehouse area.

Photo CW-M4: Existing Abandoned Gas Unit Heater

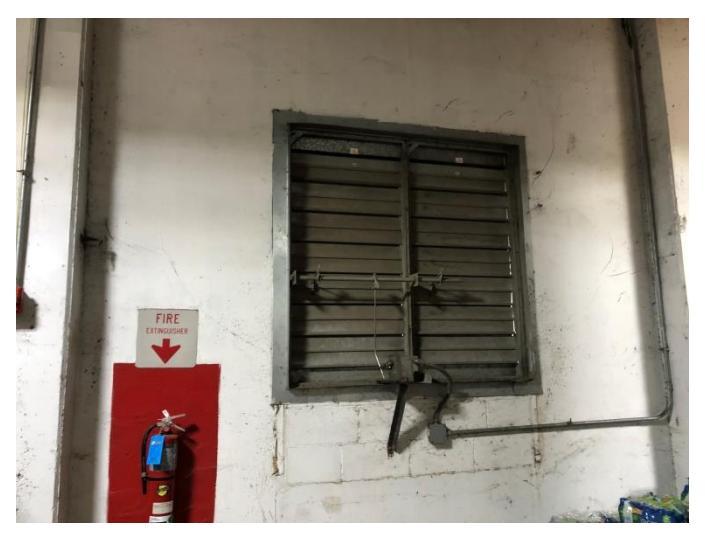
Photo CW-M5: Existing Ventilation Control Damper

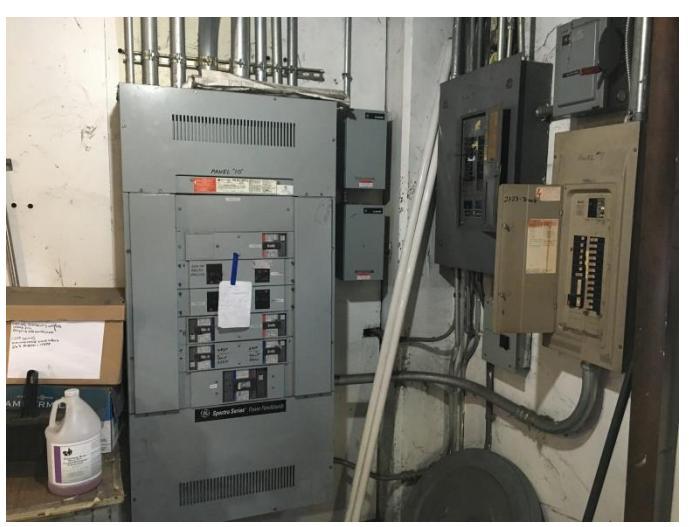
The power distribution system is comprised of several different vintages of electrical gear. See Photo CW-E1. Most all of the equipment is serving beyond its useful service life and needs to be replaced. Convenience receptacles are of varied vintages as well. Convenience receptacle mounting heights are not compliant with modern ADA standards.

Photo CW-E1: Main Electrical Service

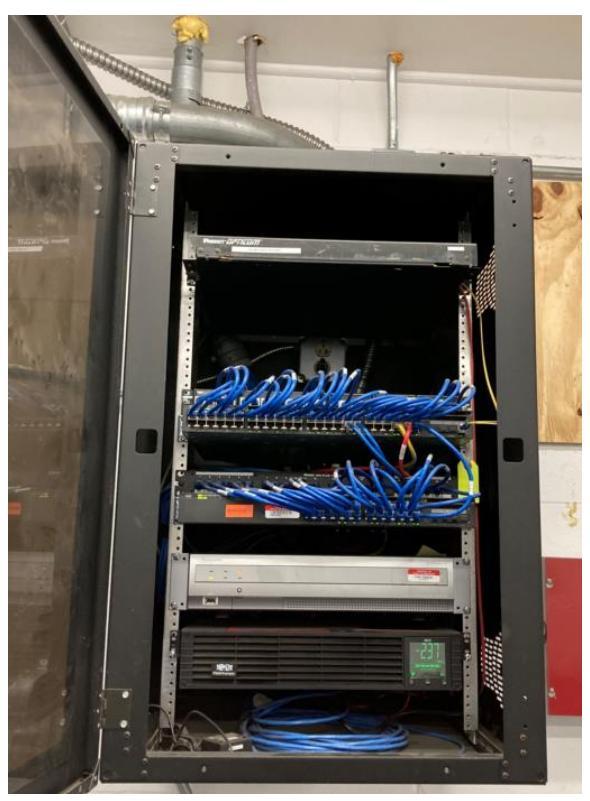
Photo CW-T1: Existing Telecom Cabinet

building is served by a 24-strand, single mode fiber optic cable that runs back to the telecommunication rack located in Mechanical 102 of the CERT building. The horizontal data cabling serving the building is all Category 6 copper cabling, which is in line with current industry standards for horizontal data cabling. There is a UPS within the telecommunications rack that supports the telecommunication network. The telecommunications cabinet is not properly grounded per BICSI standards.
