# Nebraska State Penitentiary Useful Life Engineering Study

Lincoln, Nebraska

Alvine No. 2021 8777 January 2022

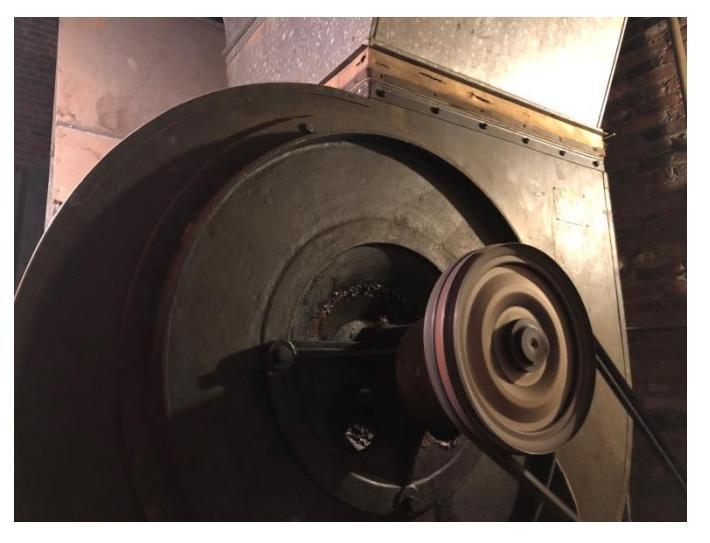
The HVAC system is composed of two original 1930s AHUs and perimeter steam finned tube with no controls. Since there is no control over the heating systems when the steam is on, it is hot in the CHAP; and the windows need to be opened on mild days to keep from overheating the CHAP. Chilled water was extended to the CHAP's basement in 2003, but has never been put to use. The AHUs are original from 1931, except for the fan motors, and each AHU has a steam-heating coil with no control either. See Photo CHAP-M1. The building's only source of ventilation air is from operable windows which are primarily used during mild weather conditions.

Photo CHAP-M1: Existing South AHU

It is recommended to replace the existing HVAC equipment, clean and reuse ductwork where possible, and to upgrade the building to an electronic centralized BAS. The new AHUs will be provided with fan arrays which are composed of multiple direct drive fans which can automatically speed up to provide redundancy in the event that one fan should fail. The AHUs will also include MERV 13 filters and UV lights at the cooling coils to provide improved indoor air quality for the occupants. Working in a historic building also brings more challenges than normal so, extra time and coordination is anticipated. The number one request from the chaplain is to provide cooling to the chapel. This HVAC project would also fix the deficiencies for the hot floor issue in the sanctuary, the unsafe AHU access pathway issues at the stage, and the hot basement issue. The probable project cost for this scope of work is \$1,510,000.

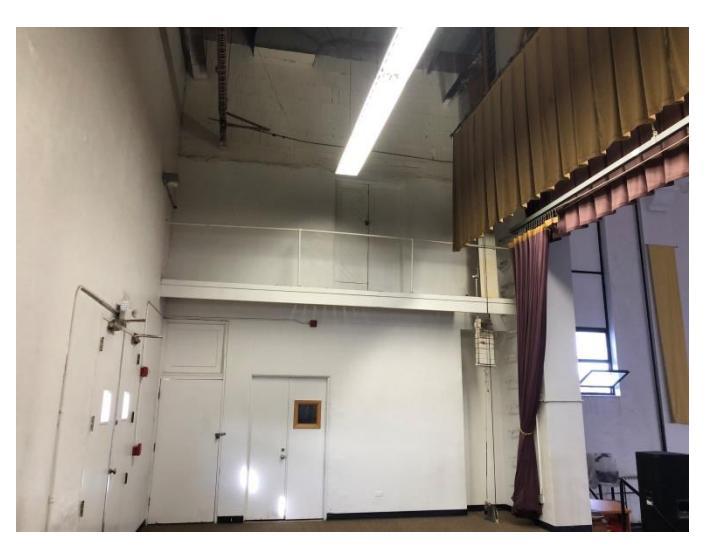
The AHUs exist on a mezzanine level which is about 12 feet above the stage and is accessed via an old ladder and wood catwalk system which do not meet current codes for safe access to mechanical equipment. See Photo CHAP-M2.

Photo CHAP-M2: Existing Access to AHUs

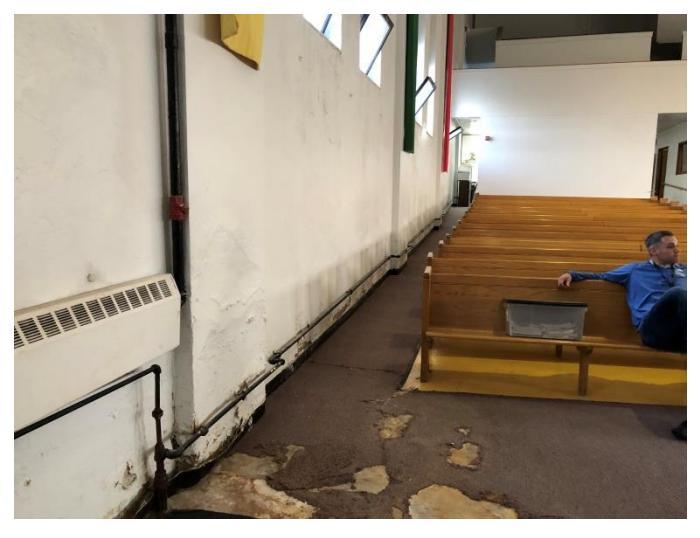
There is a leaking steam condensate pipe in the floor of the sanctuary near the north wall, which is causing the floor to be excessively hot. It is so hot that it has melted/vaporized the carpet, plus a rug that was then placed over the melted carpet. See Photo CHAP-M4.

Photo CHAP-M4: Melted/Vaporized Carpet and Rug

The carpet in the entire chapel needs to be replaced. It is either bunching up or heavily damaged in just about every area of the building. The probable project cost for this scope of work is \$50,000.

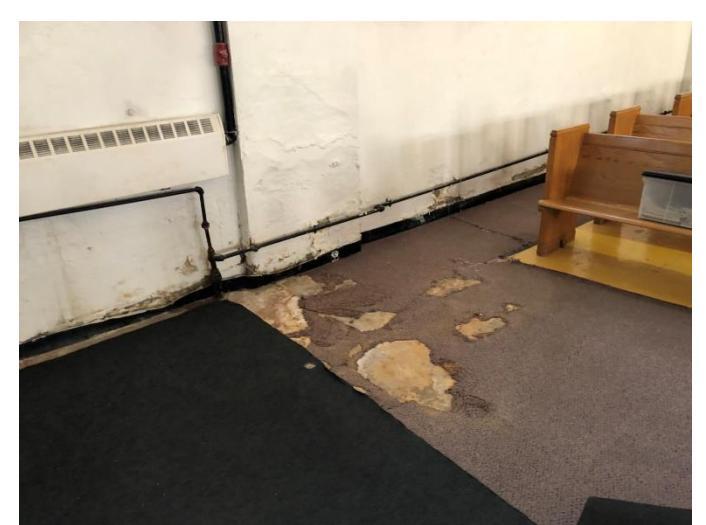
The steam finned tube is estimated to be about 40 years old and has exposed uninsulated steam piping serving it. See Photo CHAP-M3. The steam piping is a scald hazard for people who walk near it.

Photo CHAP-M3: Exposed Steam Condensate Piping

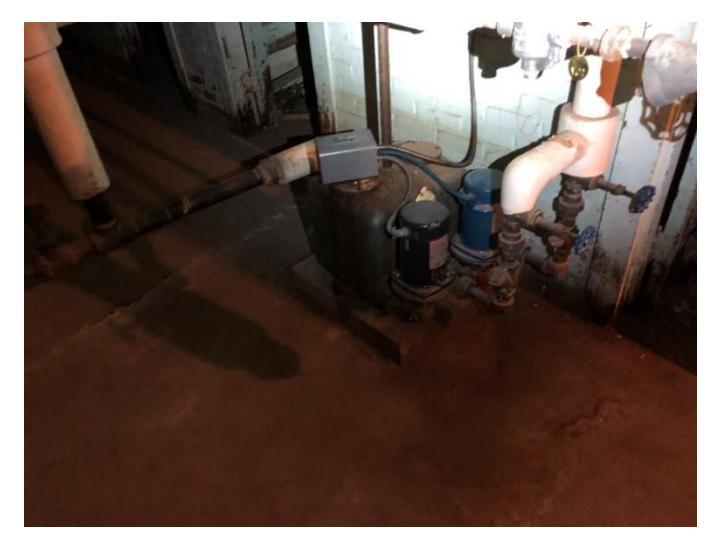
The basement is hot enough that you do not want to spend more than a couple of minutes down there, so those spaces are not usable when the steam system is on. It is hot because the steam service entrance is located there, and it has a steam condensate return pump. The condensate return pump has a receiver from

1981, but the pumps have been replaced over the years. The pumps cannot be insulated, but there is a lot of steam condensate piping that needs to be insulated. See Photo CHAP-M5.

Photo CHAP-M5: Existing Steam Condensate Return Pump

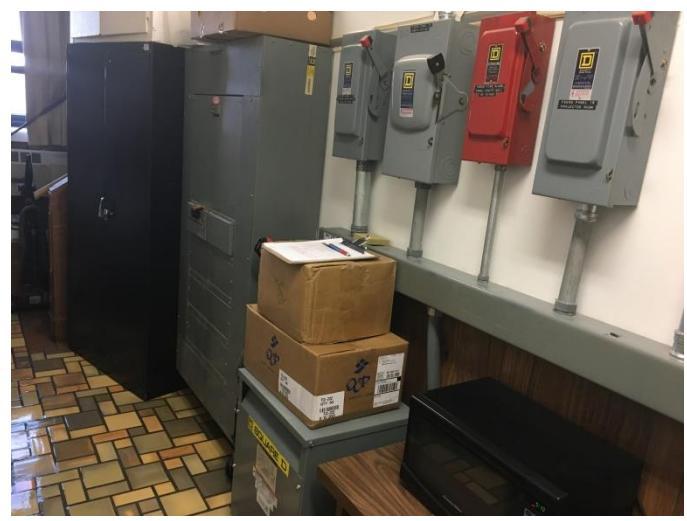
The main electrical panel is an older vintage-fused distribution panel. See Photo CHAP-E1. The branch circuit panels are older vintage as well and are serving beyond their useful service life and need to be replaced. Convenience receptacle mounting heights are not compliant with modern ADA standards.

Photo CHAP-E1: CHAP Electrical Service

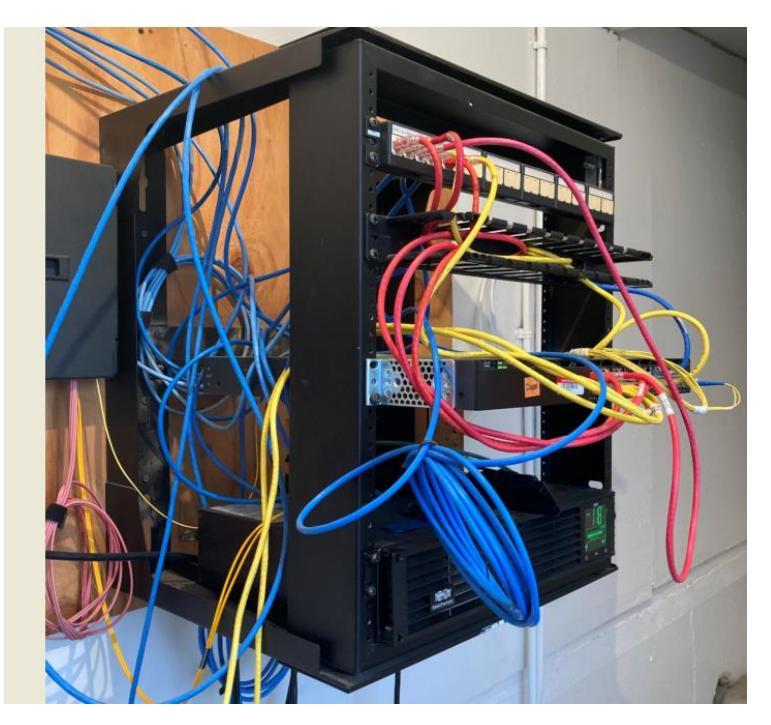
There is an existing wall-mount telecommunication rack located in Stairway 014 that serves data for the entire building. The building is served by a 24-strand, single mode fiber optic cable that runs back to the telecommunication rack located in the basement telecommunication room of the LAUN. The horizontal data cabling serving the building is all Category 6 copper cabling, which is in line with current industry standards for horizontal copper cabling. There is a UPS within the telecommunications rack that supports the telecommunication network. The telecommunications rack is not properly grounded per BICSI standards and is located in a stairwell that is open to the tunnels below.

Photo CHAP-T1: Existing Telecom Cabinet

The existing telecommunications rack in located in Stairway that is shared space to the tunnels below. BICSI standards recommend that telecommunications equipment cabinets should control against unauthorized access and in a controlled environment. It is recommended that the existing telecommunications wall mounted rack be relocated to a location where access to the rack can be secured and controlled. This will require the existing data cabling within the building to be re-done. Recommend building out a dedicated telecommunications room with proper security, cooling and grounding per BISCI standards. The probable project cost for this scope of work is \$110,000.

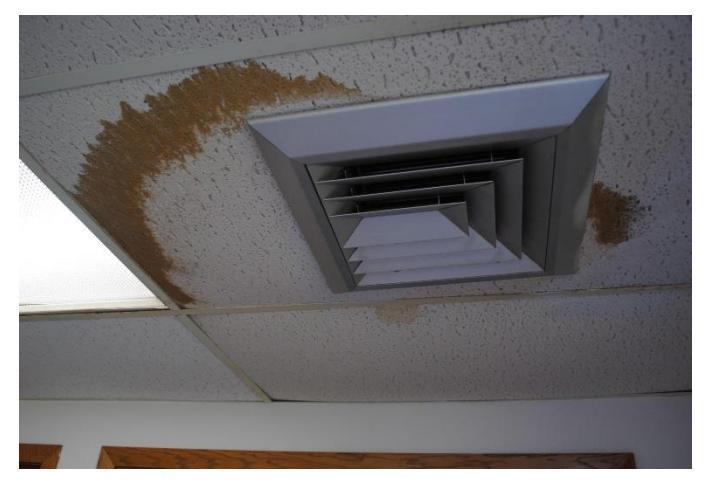
Photo EDU-A1: Typical Ceiling Stain in classroom

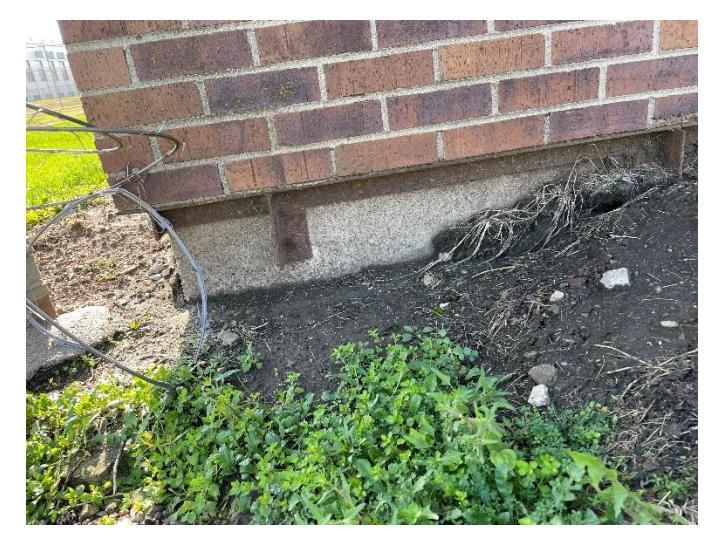
This building is a PEMB manufactured by Star. The exterior finish is metal wall panels with a brick wainscot. The brick appears to have been added to the exterior and is supported by a steel angle bolted to the foundation wall. See Photo EDU-S1.

Photo EDU-S1: Brick Wainscot Supported by Steel Angle

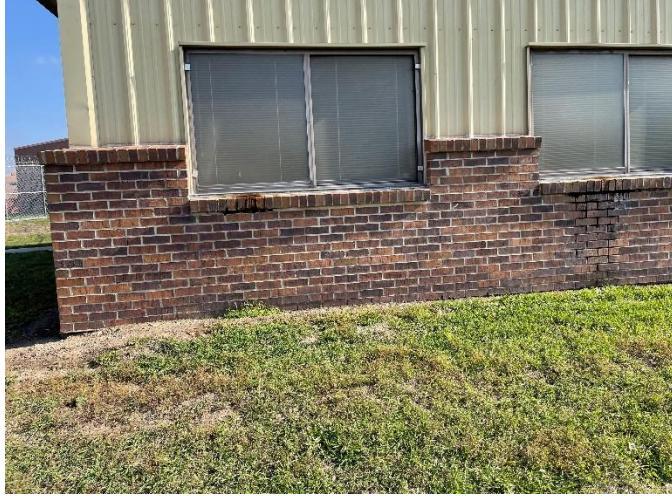
Sealant at the top of the brick has failed and moisture is able to get between the brick and metal wall panels. There is also moisture infiltration in the brick sills at some windows. See Photo EDU-S2.

Photo EDU-S2: Sealant and Moisture Issues

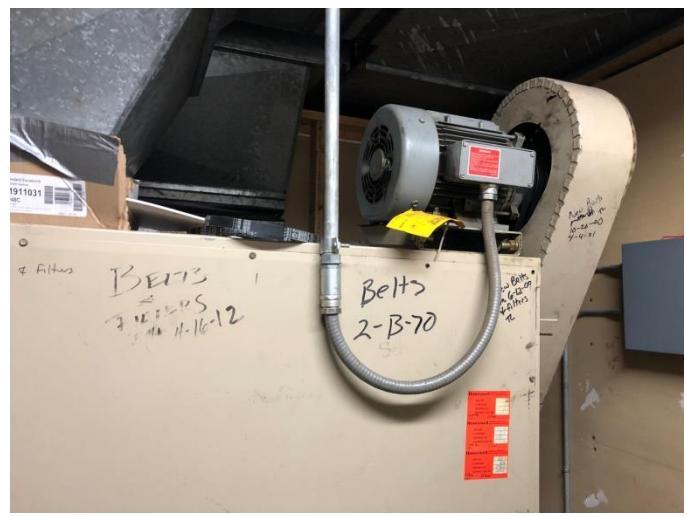
The HVAC system is composed of one AHU, a thermostat, above ceiling supply air ductwork serving ceiling diffusers, and one restroom exhaust fan. The AHU is original from 1981 and has a steam heating coil, as

Photo EDU-M1: Existing AHU

well as a chilled water cooling coil. See Photo EDU-M1. The cooling coil is noted as being replaced in 2012.

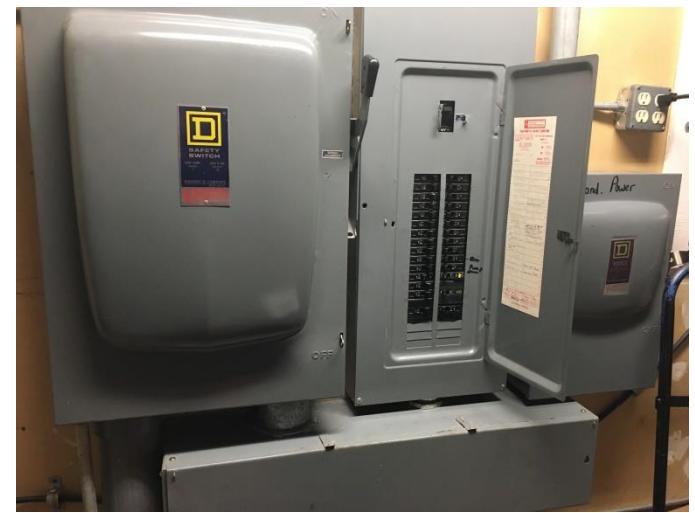
The main electrical panel is in good condition but it is serving beyond its useful service life and needs to be replaced. Convenience receptacle mounting heights are not compliant with modern ADA standards.

Photo EDU-E1: Main Electrical Panel

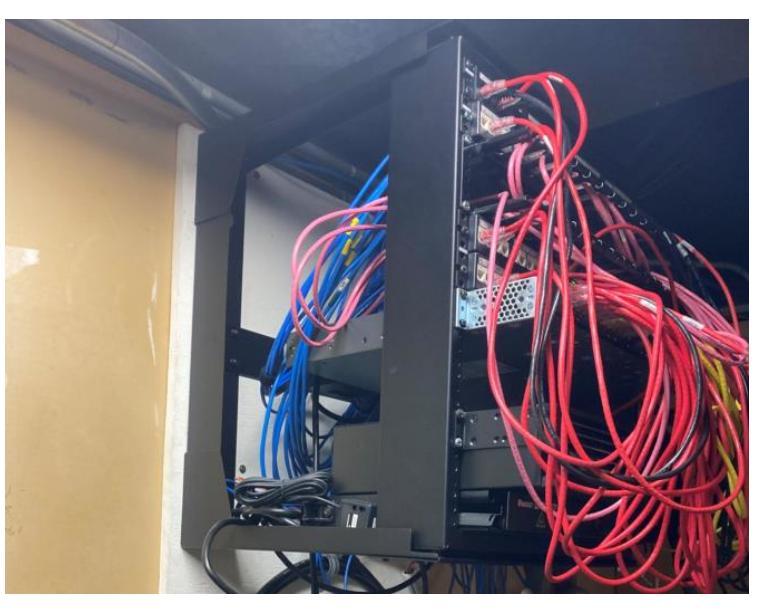
There is an existing wall mount telecommunication rack located in Mechanical 114 that serves data for the entire building. The building is served by a 24-strand, single mode fiber optic cable that runs back to the telecommunications rack located in the basement telecommunications room of the Laundry building. The horizontal data cabling serving the building is all Category 6 copper cabling, which is in line with current industry standards for horizontal copper cabling. There is a UPS within the telecommunications rack that supports the telecommunication network. The telecommunications rack is not properly grounded per BICSI standards.

Photo EDU-T1: Existing Telecom Cabinet

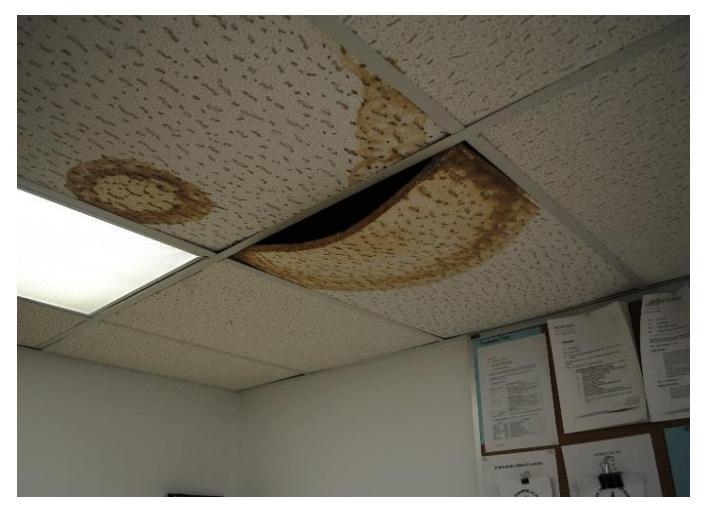
Photo FTO-A1: Typical Ceiling Stain

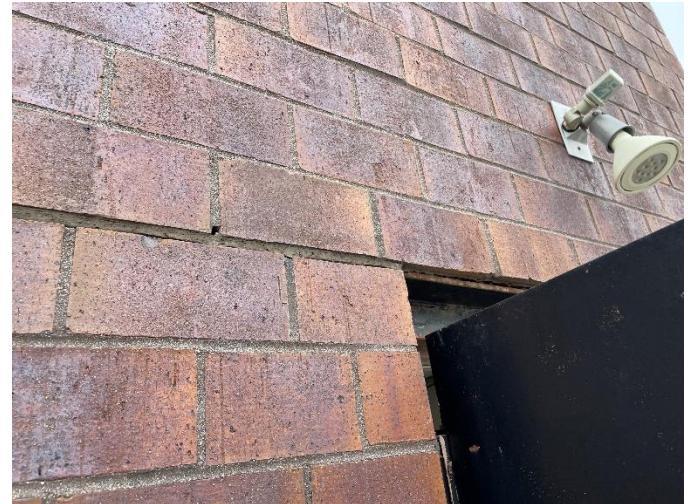
GT1 is a CMU and brick structure with cast-in-place concrete floors and intermediate landings. There were no noted structural items of concern; however, there are locations where sealant needs to be replaced.

Photo GT1-S1: Failed Sealant

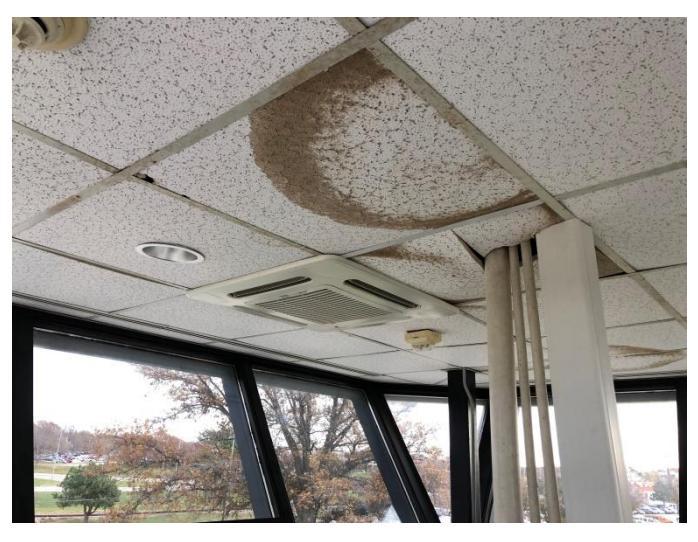
Photo GT1-M2: Existing Ceiling Mounted Fan Coil

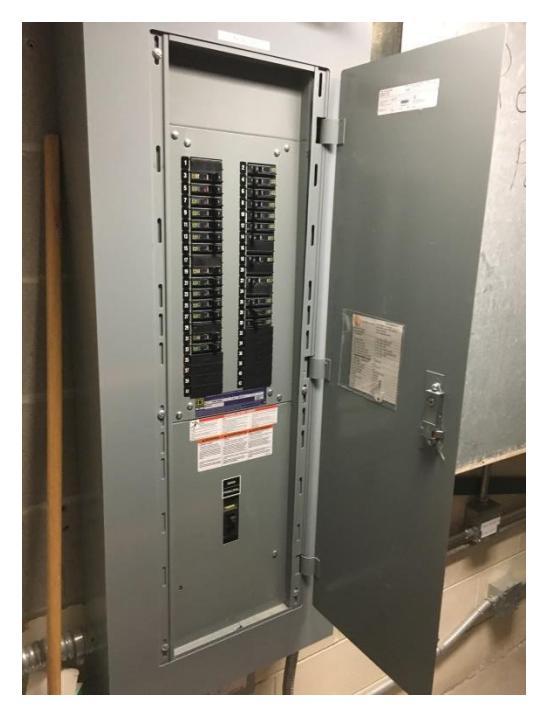
Power distribution equipment within this tower is relatively new and in good working condition. See Photo GT1-E1. Convenience receptacle quantities are fewer than what should be available for the occupancy and use of the tower. Convenience receptacle mounting heights are not compliant with modern ADA standards.

Photo GT1-E1: Existing Electrical Panel

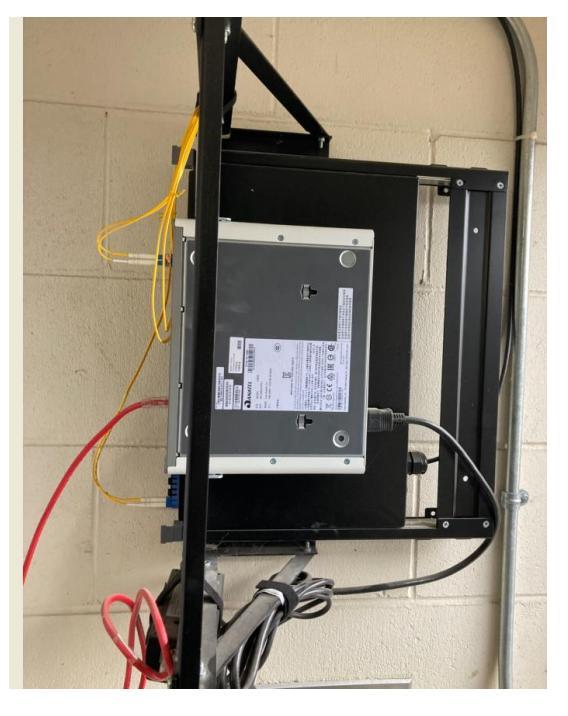
There is an existing wall mount telecommunication rack located on the lower at the front entry way that serves data for the entire guard tower. There is an existing fiber optic cable that serves the guard tower; however, it is unknown what building this fiber optic cabling runs back to. The telephone in the guard tower control room is served from existing copper backbone lines running to the guard tower. The existing copper lines do not have protectors on them when entering the building. This guard tower has not been updated like GT4, 5, 6, and 8 were with new fiber optic cabling, telecom rack, and new horizontal data cabling.

Photo GT1-T1: Existing Telecom Cabinet

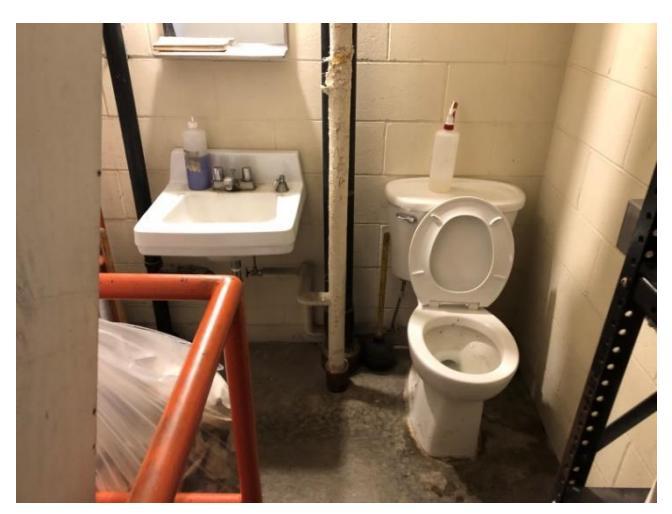
Photo GT2-M1: Existing Plumbing Fixtures

The vanity and plumbing fixtures are damaged and should be replaced. The probable project cost for this scope of work is \$5,000.

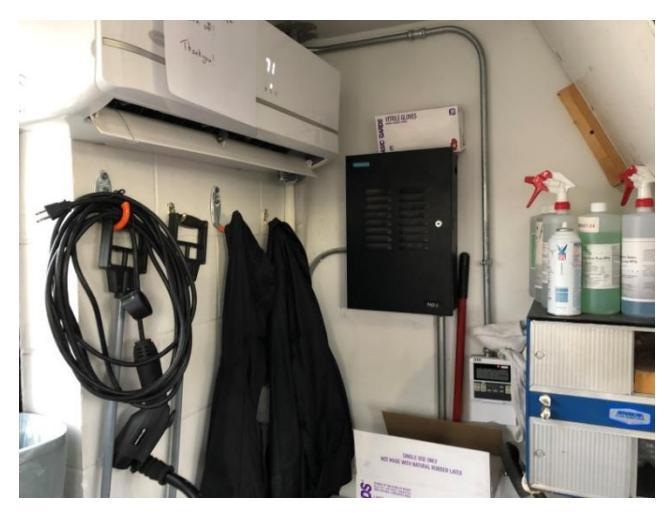
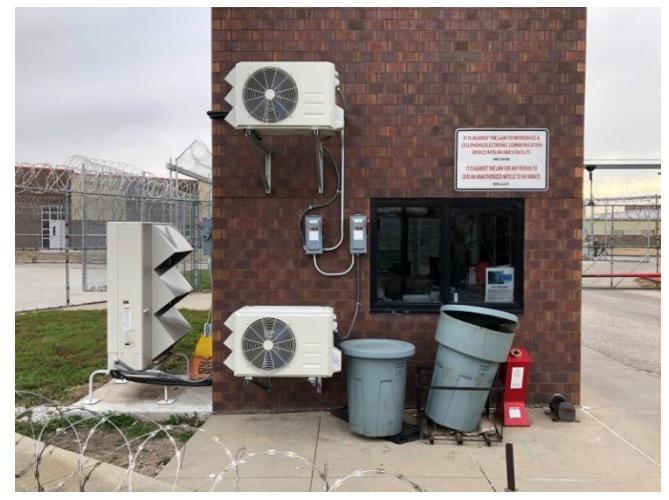
The HVAC system is composed of three ductless split systems. Each ductless split system has an indoor fan coil, an outdoor air-source heat pump, and one stand-alone thermostat. See Photos GT2-M2 and GT2-M3. The first fan coil is located in the ceiling of the tower, the second one is on the middle level, and the third one is located down at the entry level. The thermostat for the entry level fan coil is installed too close to the fan coil and the guards say it cycles off too quickly. Ventilation air is provided via operable windows. The ductless split systems are all brand new this year.

Photo GT2-M2: Existing Wall Mounted Fan Coil

Photo GT2-M3: Existing Air-Source Heat Pump

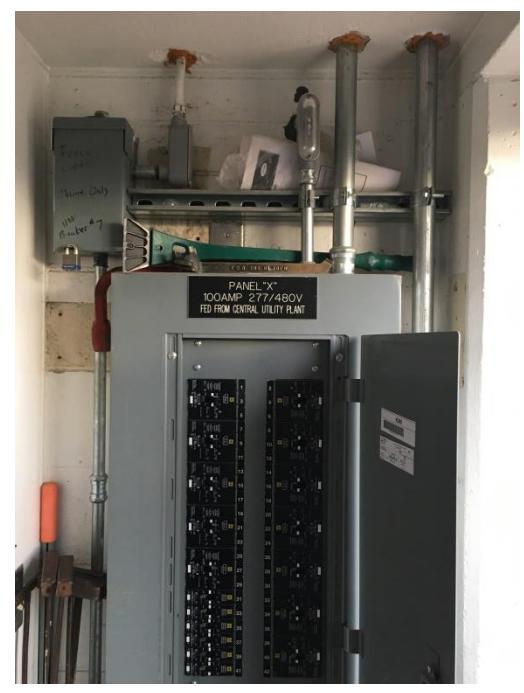
Power distribution equipment within this tower is relatively new and in good working condition. See Photo GT2-E1. Convenience receptacle quantities are fewer than what should be available for the occupancy and use of the tower. Convenience receptacle mounting heights are not compliant with modern ADA standards.

Photo GT2-E1: Existing Electrical Panel

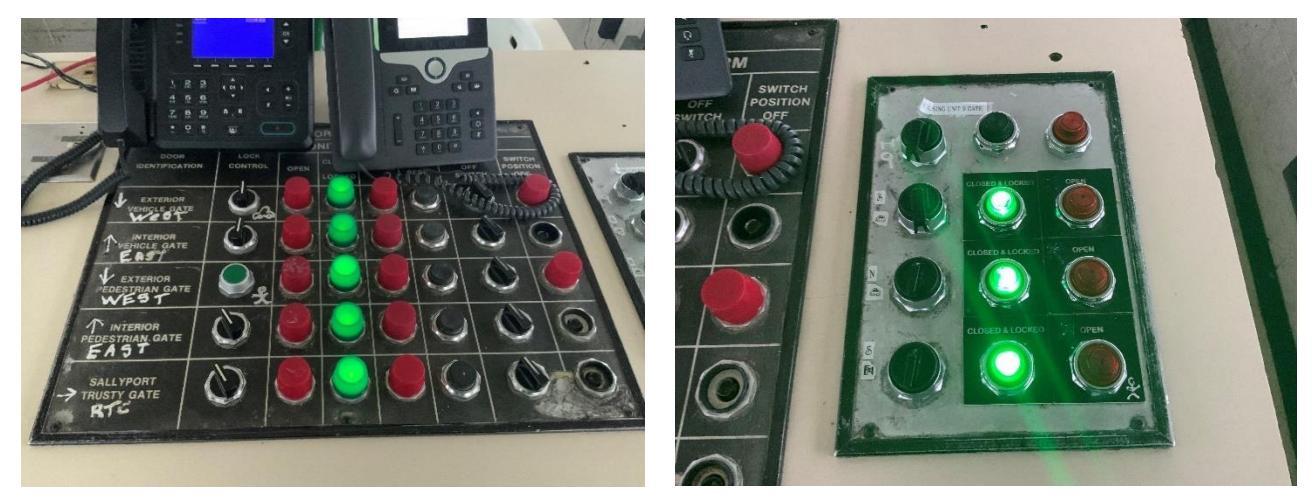
GT2 control room is responsible to observe and control movement through the West vehicle sallyport. There are two control panels that are remotely controlling, and monitoring vehicle and pedestrian gates located beneath the GT2. The smaller of the two panels controls four vehicle gates associated with entrance to HU9. Control panels consist of rotary switches and old type LED indicators installed on composite board (plastic/steel) with text engraved on their surface. Both panels are desk mounted. The existing gates are hard wired into door control relays and switches that are installed in the wall mounted enclosure. The enclosure is installed on the wall one level below the tower control room. All door control panel components are using very old technology.

Photo GT2-SEC1: GT2 Control Panels

The existing control panels are in very bad shape. There are some missing/broken rotary switches. The door control technology used to control and monitor existing field devices is obsolete and does not provide any flexibility necessary to provide more secure and efficient system.

The replacement of the existing control panels and the existing relays should be considered as a high priority considering the age and present condition of the existing door control equipment. The new door control system shall consist of a single PLC and touch screen control station. New PLC based head-end equipment (included but not limited to CPU, Ethernet communication modules, I/O modules, power supplies, relays, etc.) shall be provided in place of the existing relay-based equipment (existing wall mounted enclosure may remain in use). All new electronic security system head-end equipment and TS shall communicate over the new security system network.

New touch screen (TS) control station is recommended for the GT2 Control Room. New intercom stations and camera coverage of the gates currently controlled by the local panels is recommended. New TS control station should be provided with the capability to transfer control to the Master Control Room. The probable project cost for this scope of work is \$21,000.

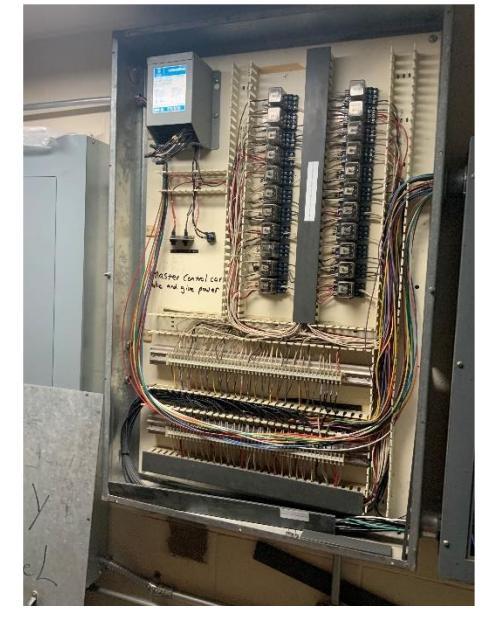
Photo GT2-SEC2: GT2 Gate Control Relays, Wire Termination Blocks, and Power Supply

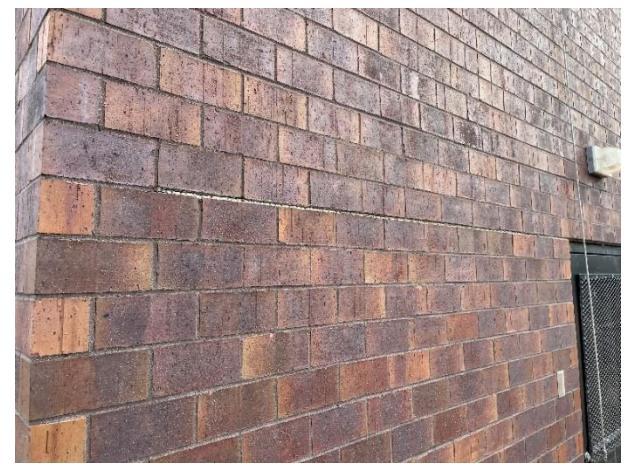
GT3 is a CMU and brick structure with cast-in-place concrete floors and intermediate landings. There were no noted structural items of concern; however, there are locations where sealant needs replaced.

Photo GT3-S1: Failed Sealant

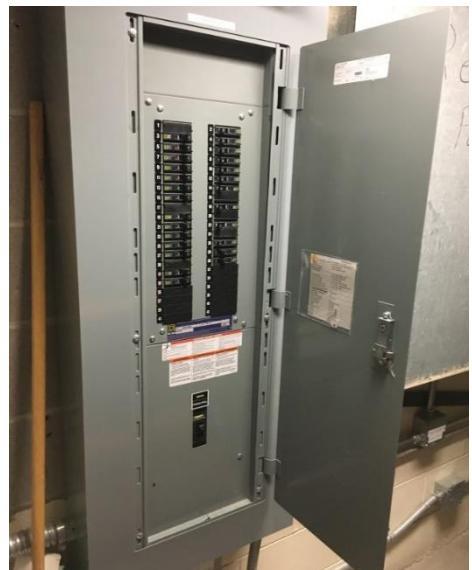
Power distribution equipment within this tower is relatively new and in good working condition. See Photo GT3-E1. Convenience receptacle quantities are fewer than what should be available for the occupancy and use of the tower. Convenience receptacle mounting heights are not compliant with modern ADA standards.

Photo GT3-E1: Existing Electrical Panel

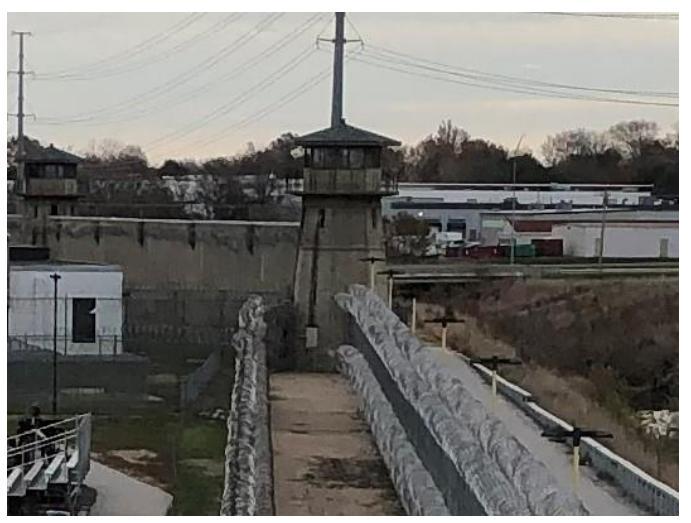
Photo GT4-1: Guard Tower No. 4

of the tower is open air with no windows or doors. The roof is asphalt shingles and has been recently replaced. It was noted that there are several cracks in the wall that have been filled with caulk. One of the doors at the guard station appeared to be a replacement and is painted wood. There is a wood soffit and trim under the overhang of the roof over the windows. The tower ties into the concrete wall that forms a portion of the secure perimeter.

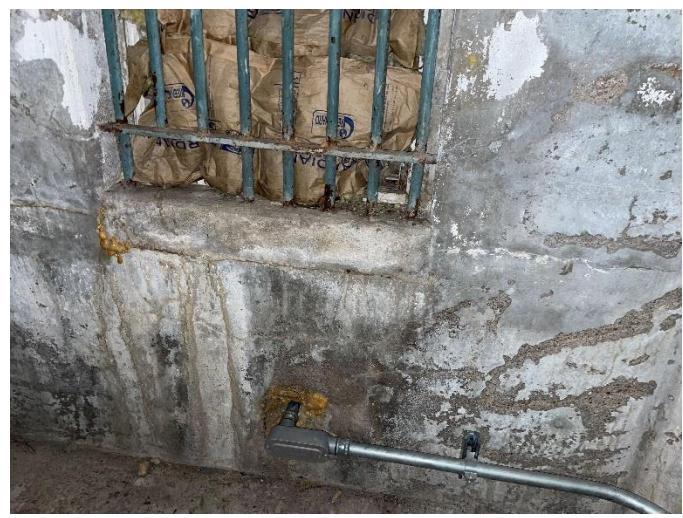
Photo GT4-S3: Concrete Deterioration at Window

Areas of map cracking were present in several locations on the tower.

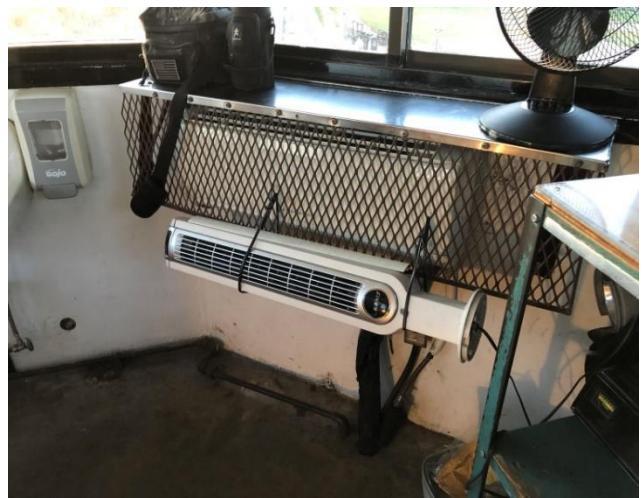
The HVAC system is composed of one ductless split system and a natural gas unit heater. The ductless split system has an indoor fan coil, an outdoor air-source heat pump, and one stand-alone thermostat. The fan coil is installed low on a sidewall of the tower as shown in Photo GT4-M1. This system had problems working this summer until it stopped working all together in June of this year. Before it stopped working the guards tied up a fan to help distribute the air from the fan coil as can be seen in the photo. Ventilation air is provided via operable windows.

Photo GT4-M1: Existing Wall Mounted Fan Coil

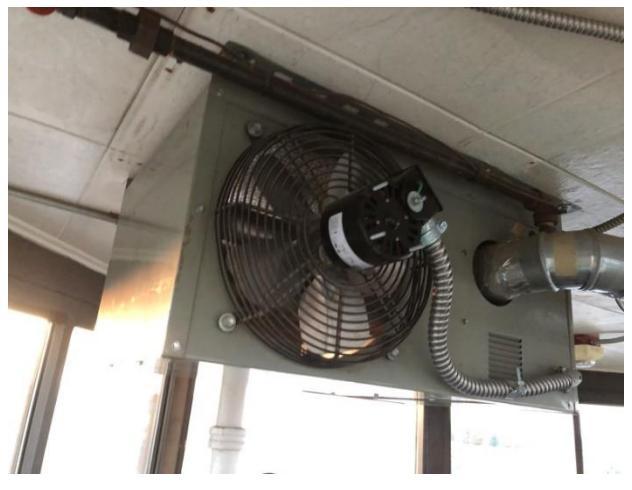
The gas unit heater was installed in the last ten years or so, but it produces too much heat. The gas unit heater as shown in Photo GT4-M2 delivers hot air in a very directional pattern so, it can overheat one side of GT4 and under heat the other side. As a result, the guards only use this on either very cold days or when the fan coil fails.

Photo GT4-M2: Existing Gas Unit Heater

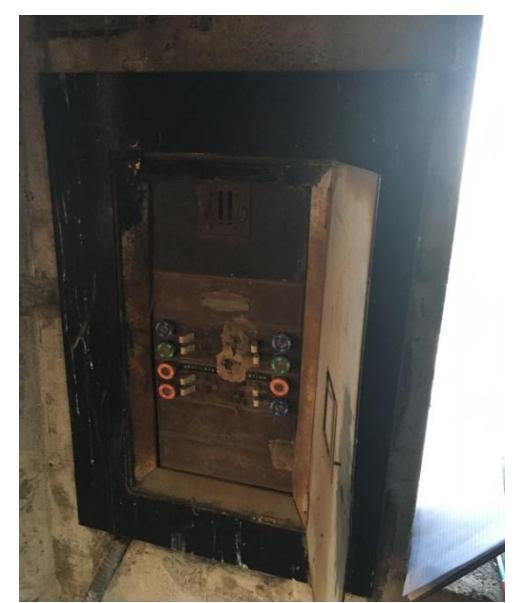
Power distribution equipment within this tower is in very poor condition and is serving well beyond its useful service life and needs to be replaced. The electrical panel was observed to have a wasp nest inside the front cover. See Photo GT4-E1. The equipment manufacturer, Frank Adam, has long since ceased to be in business. Any failure of equipment would require replacement parts that, if available, are only found on the secondary market. This particular equipment is well-known for developing dangerous electrical problems throughout its lifetime. Convenience receptacles are fewer quantities than what should be available for the occupancy and use of the tower. Convenience receptacle mounting heights are not compliant with modern ADA standards.

Photo GT4-E1: Existing Electrical Panel

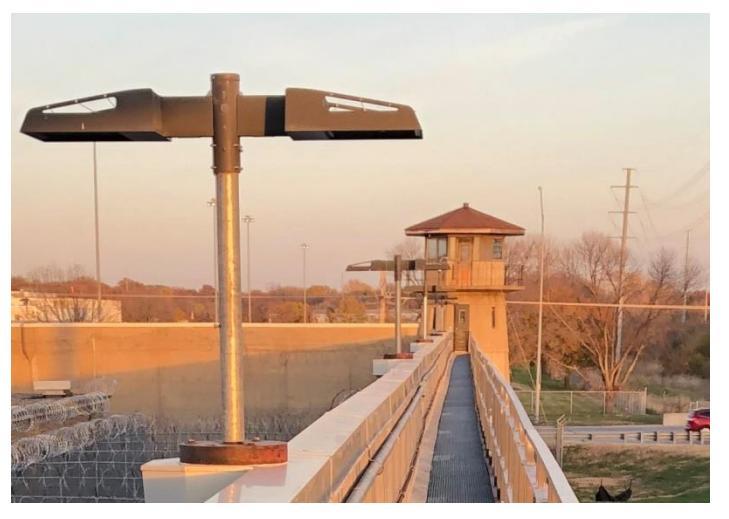
Photo GT6-1: Guard Tower No. 6

lower portion of the tower is open air with no windows or doors. The roof is asphalt shingles and needs to be replaced. It was noted that there are several cracks in the wall that have been filled with caulk. One of the doors at the guard station appeared to be a replacement and is painted wood. There is a wood soffit and trim under the overhang of the roof over the windows. The tower ties into the concrete wall that forms a portion of the secure perimeter.

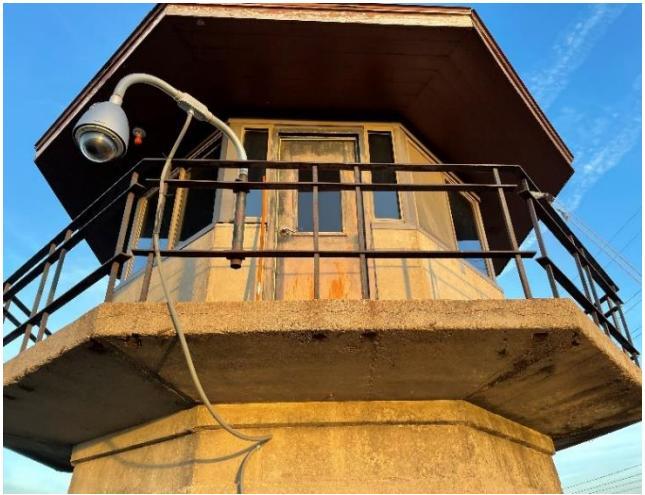
GT6 is a concrete structure. Spalling is present in random areas on tower walls.

Photo GT6-S1: Cracked/Spalled Concrete at Slab Edge

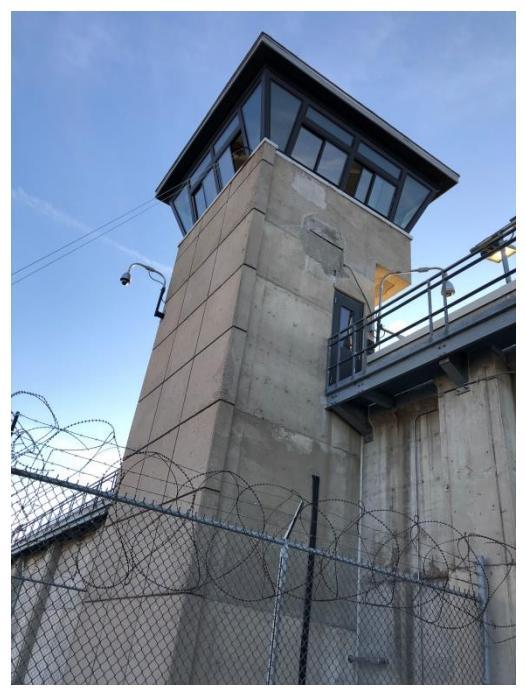
Photo GT8-1: Guard Tower No. 8

GT8 is a concrete structure. A previous opening had been infilled, as seen above the door in photo GT8-1 above. The landing at the walkway level is deteriorated.

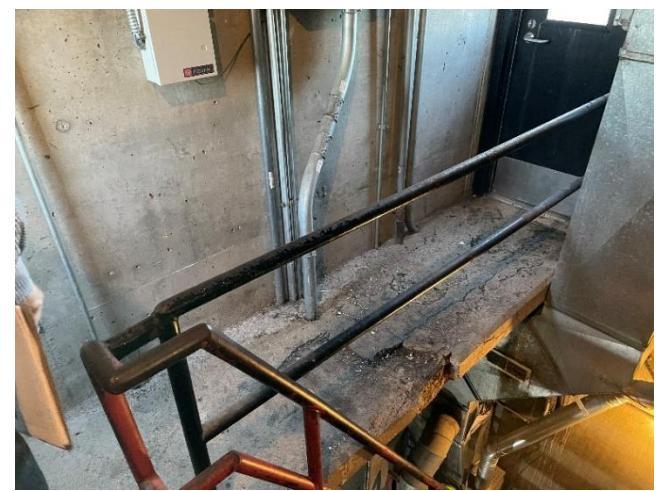
Photo GT8-S1: Deteriorated Walkway Landing

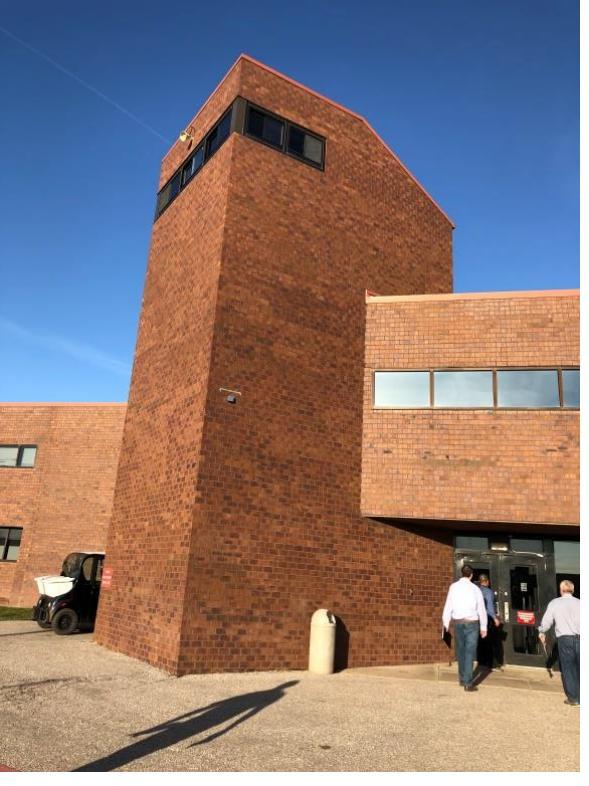
The envelope of the building is brick veneer with CMU backup. Most of the brick appears to be in good condition. The windows on the building are double paned aluminum frame and in good condition. The roof appears to be a modified bitumen roof and is roughly 20-25 years old, an age when this type of roof typically reaches the end of its useful life.

Photo GT10-1: Guard Tower No. 10

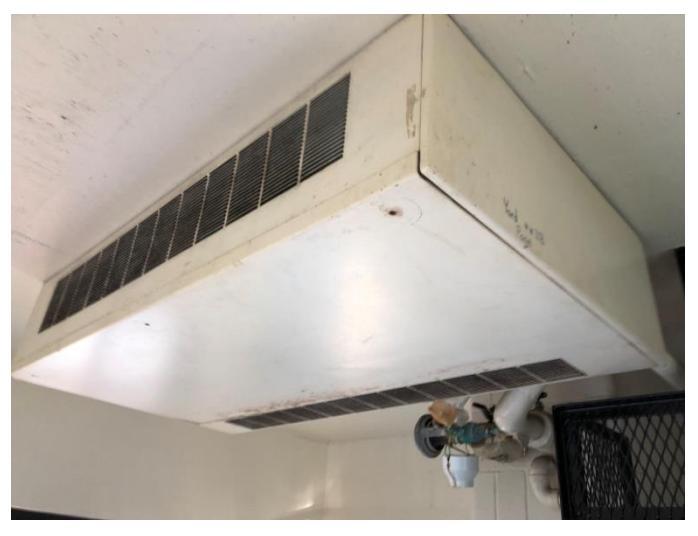
Photo GT10-M1: Existing Ceiling Mounted Fan Coil

The hydronic fan coil unit and finned tube system is about 40 years old. According to ASHRAE, most fans and coils have a median service life of about 20 years. As a result, the existing equipment is operating beyond its expected useful life. It is recommended to replace the existing equipment with a new ductless air-source heat pump split system. The probable project cost for this scope of work is \$11,600.

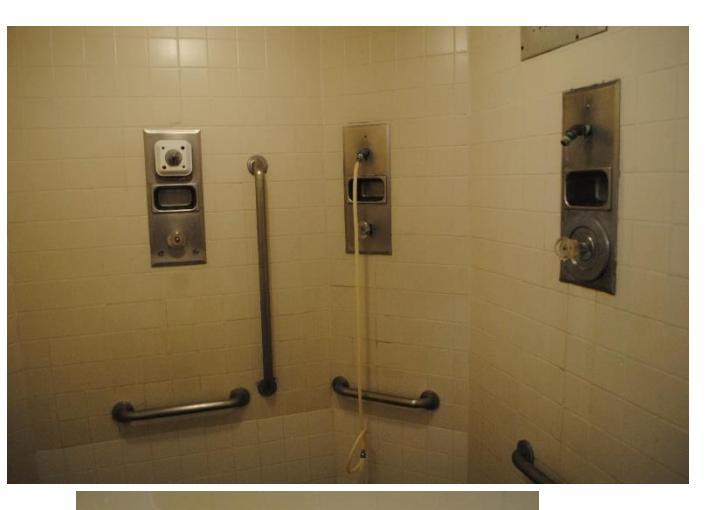
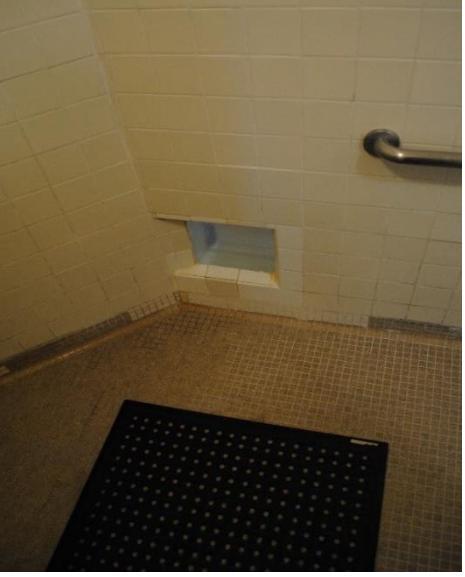
Photos HU1-5-A2-A3: Typical Shower

The interior of these units is all hard surfaces with CMU walls, VCT floors, and hard lid gypsum board ceilings. There are several areas with exposed sprinkler piping which is deteriorating and needs to be replaced. The showers are 1x1 tile on the floors with 4x4 subway tile on the walls and show significant amounts of damage. All the interior doors are painted security hollow metal doors. The control stations have millwork that needs to be replaced.

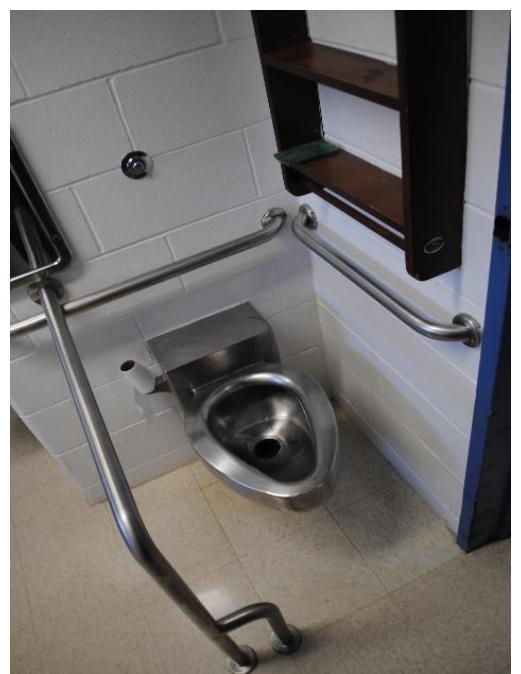
HU1 through HU4 were built pre-ADA. However, HU5 was built in 1993 just after the ADA was signed into law. None of these units meet ADA. The typical main entry is at a landing at the midpoint between the lower and upper galleries necessitating stairs to any housing level. At HU1, a ramp was cut into the grade that accesses the end of the lower gallery on the southeast wing of the unit. While this does provide ADA access to the building, there are no ADA compliant cells or showers. The facility has added grab bars and accommodations as best they can within the spaces that they have, but they still do not meet current standards. HU5 has similar issues.

Photo HU1-5-A4: Typical non-compliant ADA Modifications for Inmate Cell

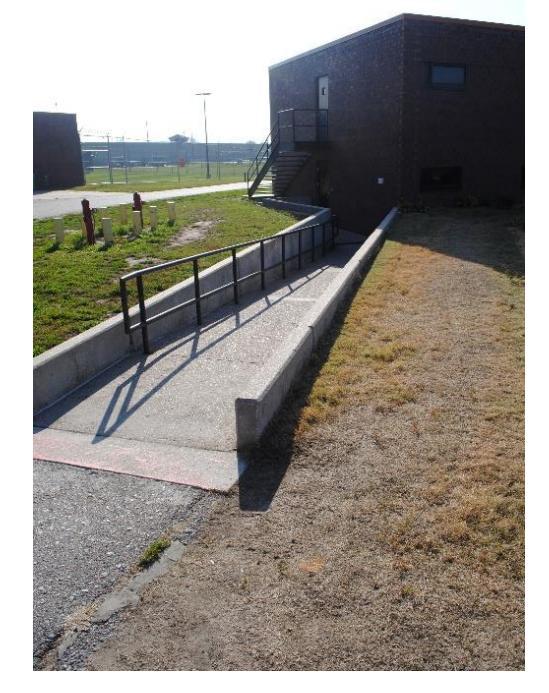
Photo HU1-5-A1: ADA Ramp to HU-1

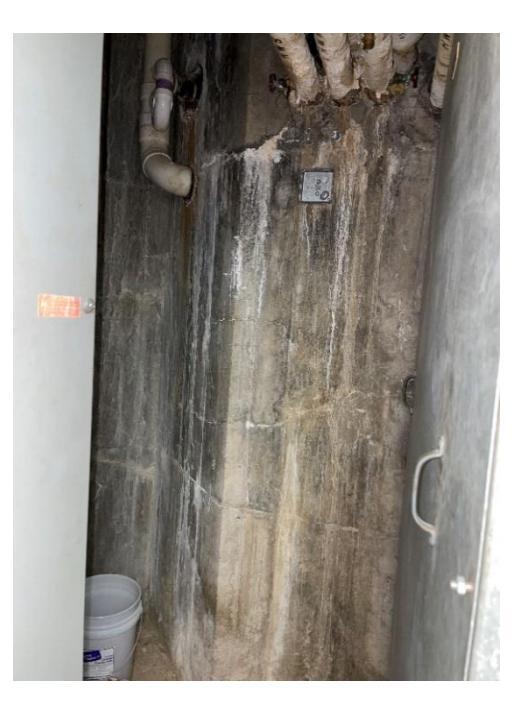
HU1 is concrete slab structure supported by concrete masonry (CMU) bearing walls above grade and concrete walls below grade. Narrow cracks were present in a small area of the lower-level mechanical room basement walls. There is staining indicating moisture has passed through these joints.

Photo HU1-5-S1: Cracks in Mechanical Room Wall

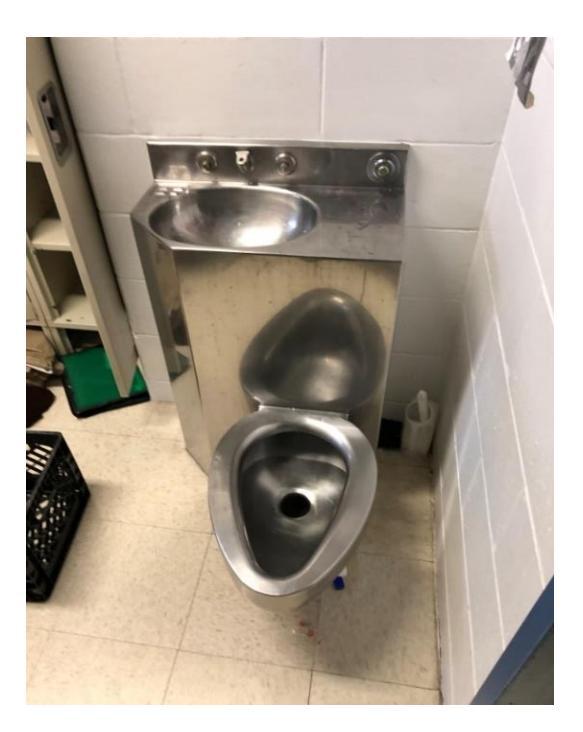
The plumbing fixtures are original from 1981. See Photo HU1-5-M2 for typical plumbing fixtures. This building was built before the EPAct of 1992 and before ADA so, the plumbing fixtures, flush valves, and shower heads are operating beyond their useful life and not conforming to modern water flow rates or ADA requirements. For a discussion on ADA issues, see architectural.

Photo HU1-5-M2: Existing Security Plumbing Fixtures

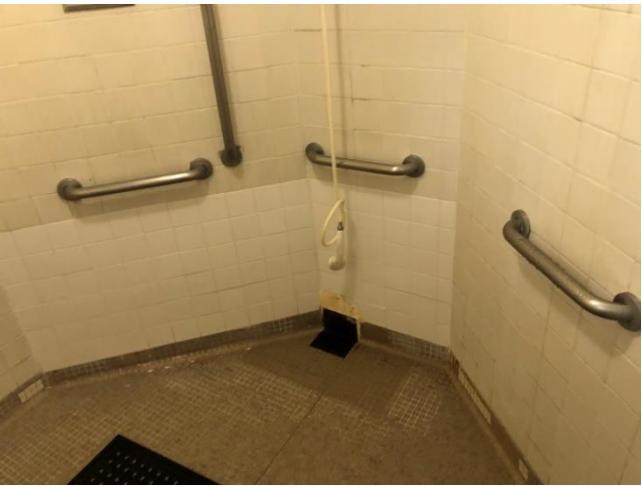
The inmate showers have problems with water drainage. See Photo HU1-5-M3. The water then leaks into the adjacent security guard office. The sanitary piping is likely corroding and getting plugged up.

Photo HU1-5-M3: Existing Shower Floor Drains

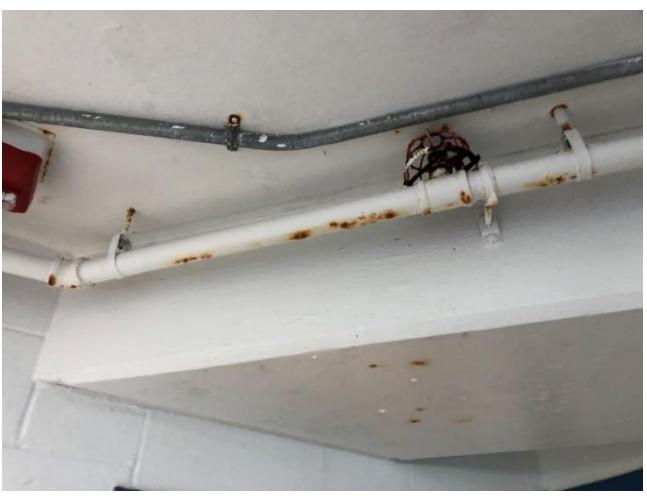
This building has a wet-pipe fire sprinkler system. The piping and heads are installed exposed and low in the corridors leading to the inmate rooms. The piping and sprinkler heads are low and not ligature resistant. The piping near the shower rooms has visible corrosion on it. See Photo HU1-5-M4.

Photo HU1-5-M4: Exposed and Rusting Fire Sprinkler Piping

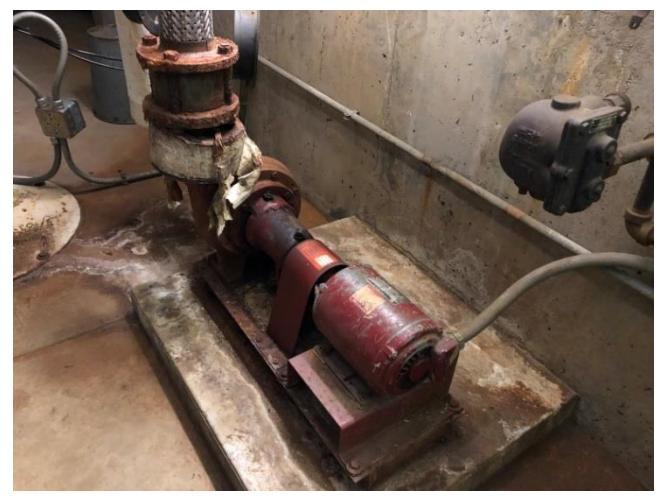
The HVAC systems are composed of one large multizone AHU system, a steam to heating hot water shell and tube heat exchanger, perimeter finned tube heating, hydronic cabinet unit heaters at the entries, and base-mounted end-suction pumps. See Photo HU1-5-M5, with most equipment still original from 1981.

Photo HU1-5-M5: Typical Existing Pump

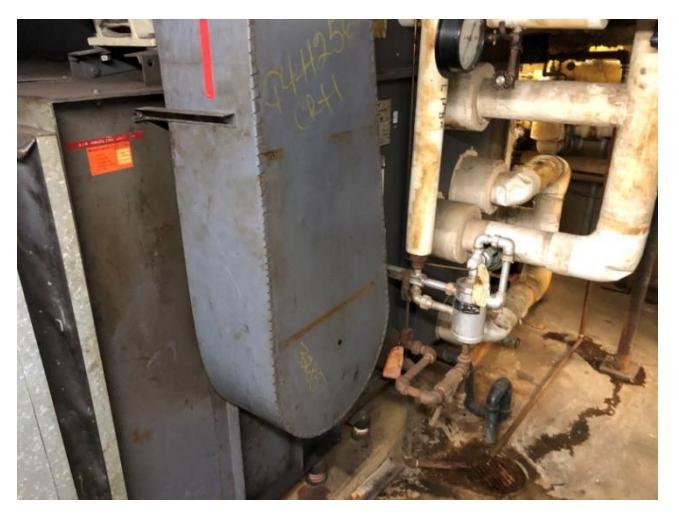
The AHU is constant volume with ducted supply and return air systems, a steam humidifier, heating hot water coil, and chilled water coil. See Photo HU1-5-M6 for a typical existing AHU. The AHU fans have a belt-driven fan motor. Ventilation air is provided via outdoor air louvers mounted in the exterior walls at the roof level.

Photo HU1-5-M6: Existing AHU
