# Nebraska State Penitentiary Useful Life Engineering Study

Lincoln, Nebraska

Alvine No. 2021 8777 January 2022

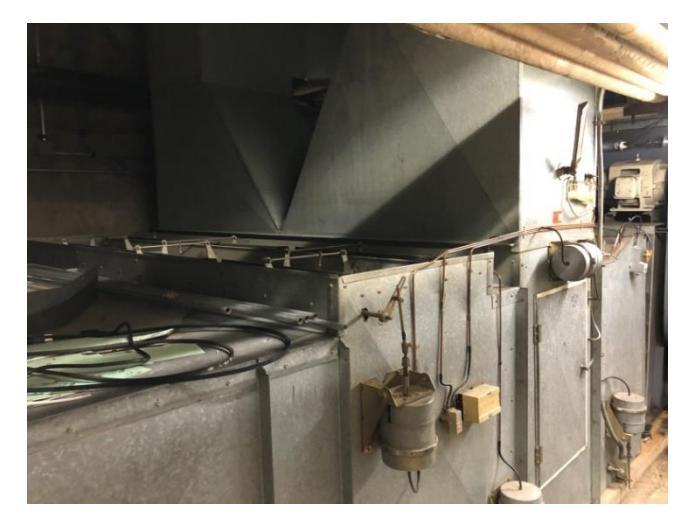
Photo HU1-5-M7: Existing Pneumatic Controls

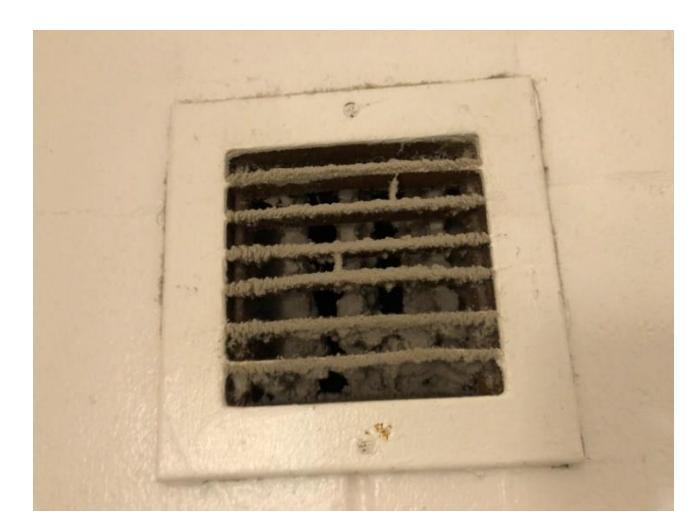
There is a lack of exhaust air noticed, particularly in the shower rooms. The moisture remains in the air and travels out of the shower rooms into the corridors and causes corrosion on steel items. The security type exhaust grilles are not easy to see through, but this exhaust grille in the security office is and the dirty exhaust air ductwork can be observed. See Photo HU1-5-M7. It is likely that the supply air and return air ducts are also dirty after 40 years of use.

Photo HU1-5-M8: Dirty Exhaust Air Ductwork

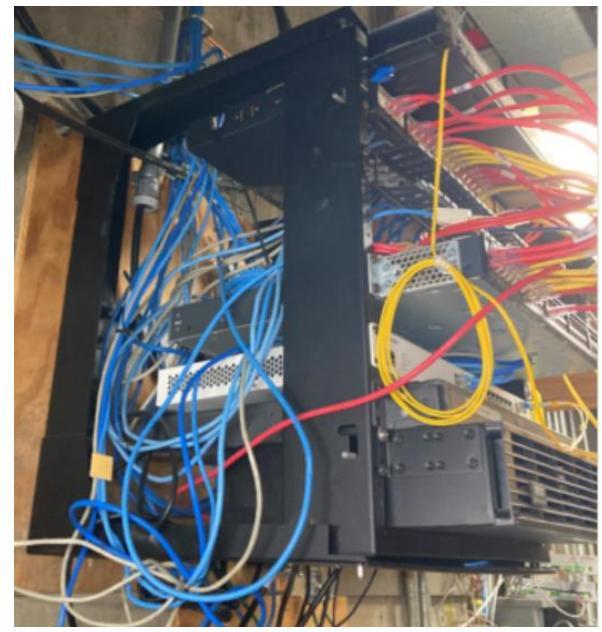
There is an existing wall mount telecommunication rack located in the lower level Mechanical Room 28 that serves data for the entire building. The building is served by a 24strand, single mode fiber optic cable that runs back to the telecommunications rack located on the second telecommunications room 2A18 of the Ancillary building. The horizontal data cabling serving the building is all Category 6 copper cabling, which is in line with current industry standards for horizontal copper cabling. There is a UPS within the telecommunications rack that supports the telecommunication network. There is a telecommunication bar that provides grounding the ground to telecommunications rack. There is existing coaxial cabling routed to televisions within the building from Mechanical Room 28. The paging amplifier for the building paging system is located in Mechanical Room 28. The JPAY network equipment and UPS are located in the telecommunication rack as well. The existing phone lines in the building are still on analog lines.

Photo HU1-5-T1: Existing Telecom Cabinet

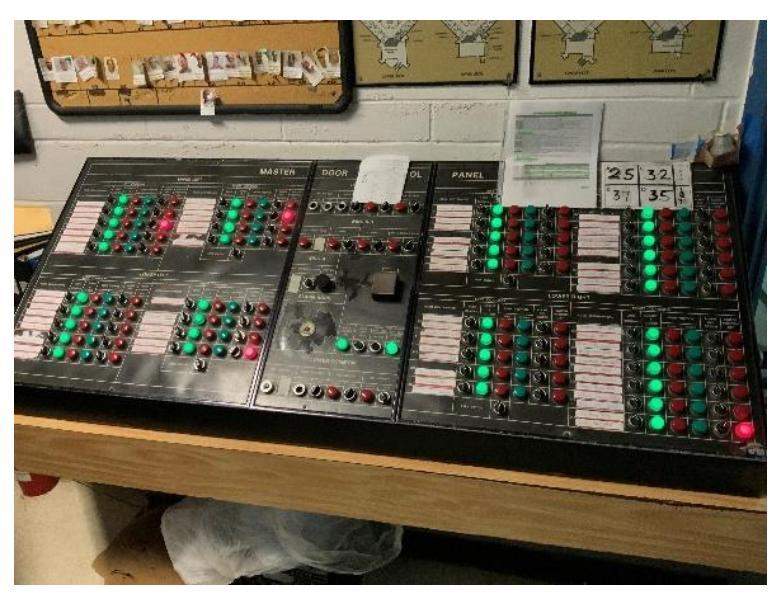
Both control locations use obsolete control panels to control and monitor their areas. Control panels consist of rotary switches and old type LED indicators installed on composite board (plastic/steel) with text engraved on their surface. Both panels are installed on desk mounted turrets. The system does have capability to transfer control to Central Control.

Photo HU1-SEC1: Control Panels in A Wing

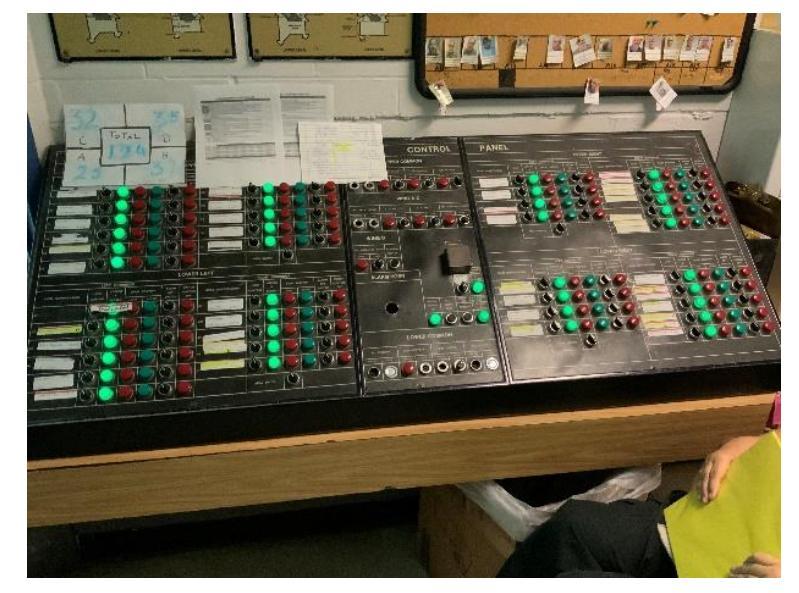
Photo HU1-SEC2: Control Panels in B Wing

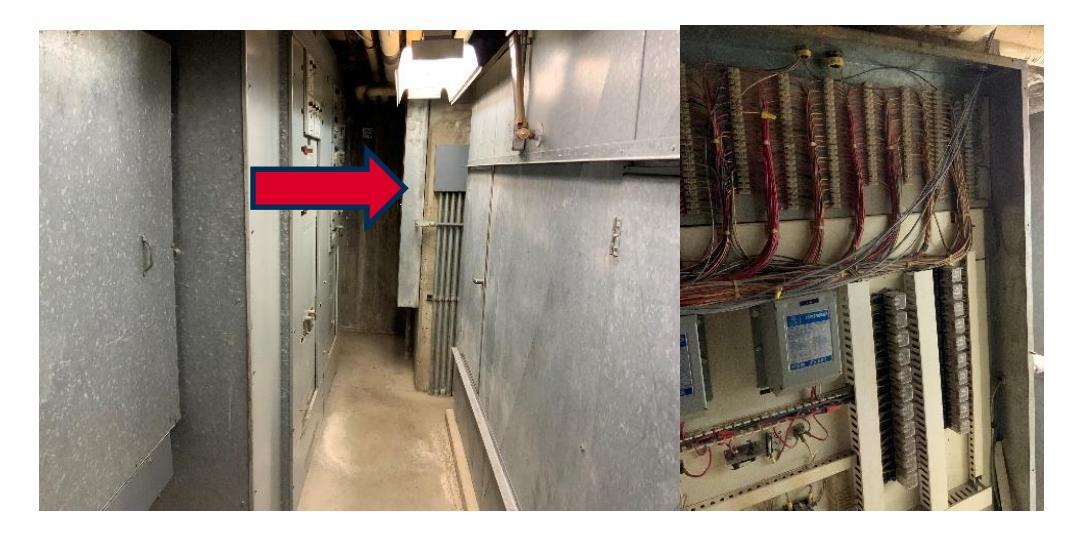
The existing doors are hard wired into door control relays and switches that are installed in the wall mounted enclosure. The enclosures are installed in the Mechanical space/chase below the control rooms. The room/chase is very difficult to access and does not meet National Electrical Code required work clearance space in front of the security enclosures.

Photo HU1-SEC3: Existing Door Control Enclosures-Typical for both A and B Wing

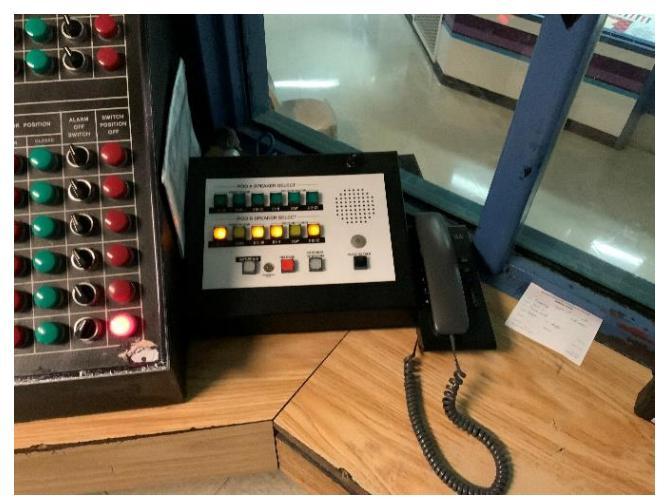
Photo HU1-SEC4: Existing Communication Console-Typical for both A and B Wing

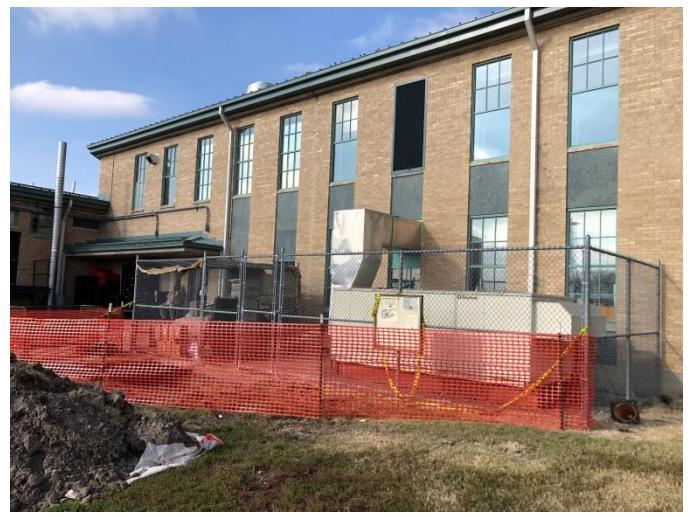
Photo HU6-1: Housing Unit No. 6

condition. The main entry was an addition to the building and consists of storefront framing and standing seam metal roof and is in poor condition with some significant damage.

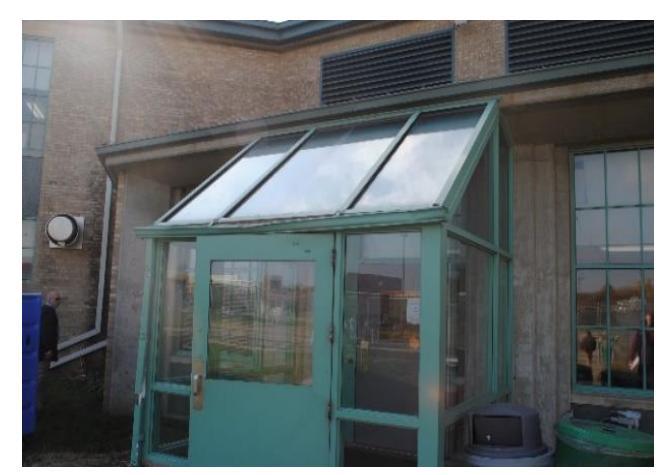
Photo HU6-A1: Weather Vestibule with Worn Door Hardware and Damaged Window Framing

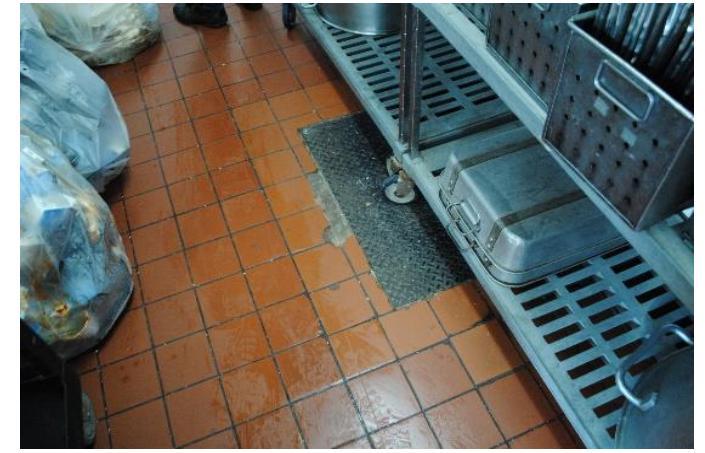
Photo HU6-A2: Floor Tile Damage and Missing in Kitchen

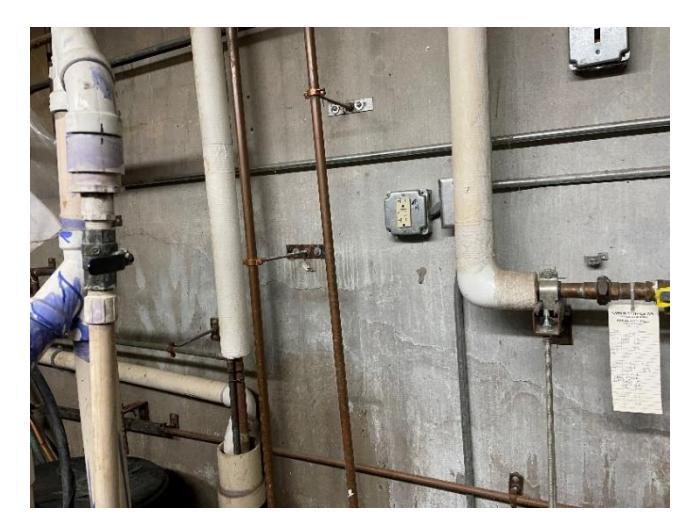
HU6 is a concrete slab and frame building with concrete masonry (CMU) infill. Cracks were present in the lowerlevel mechanical room walls. A portion of the steam tunnel lid was damaged from previous work and the historic metal lathe was unsupported.

Photo HU6-S1: Crack in Mechanical Room Wall

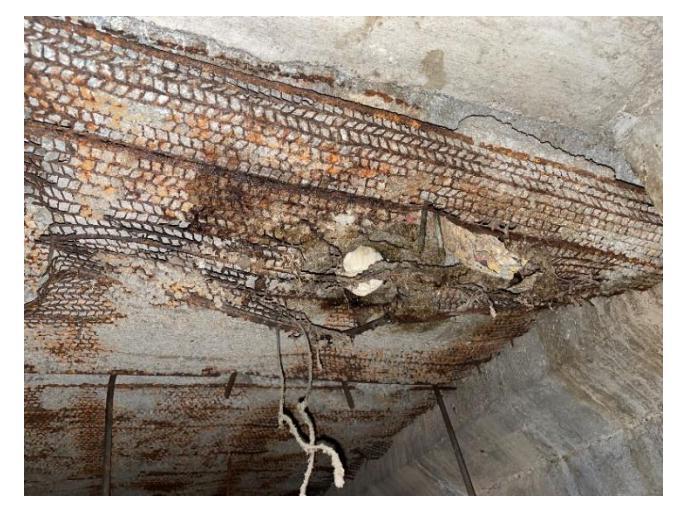
Photo HU6-S2: Damaged Lathe at Steam Tunnel Ceiling

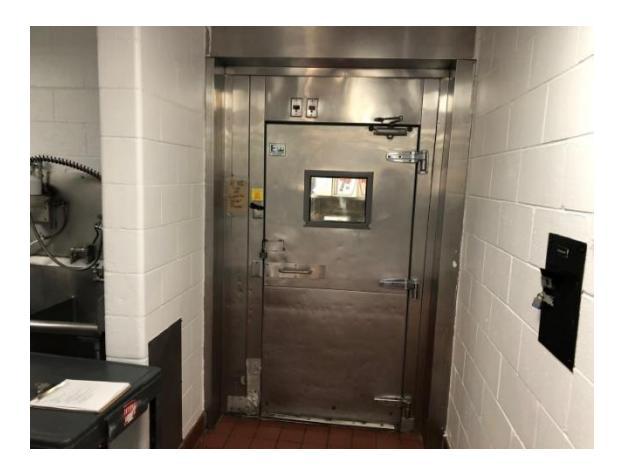
The walk-in cooler and freezer compartments appear to be original equipment from 1992. The freezer door has been previously replaced with a replacement door and frame, and the cooler door has numerous dents and damaged viewport frame. See Photos HU6-FS1 and HU6-FS2. The evaporator coils appear to be deteriorating from their age and humid operating conditions. See Photos HU6-FS3 and HU6-FS4. The food service manager noted that there is a gap in the cooler wall where it meets the floor, but the gap is located behind the storage racks and not easy to get to for repairs.

Photo HU6-FS1: Existing Walk-in Cooler Door

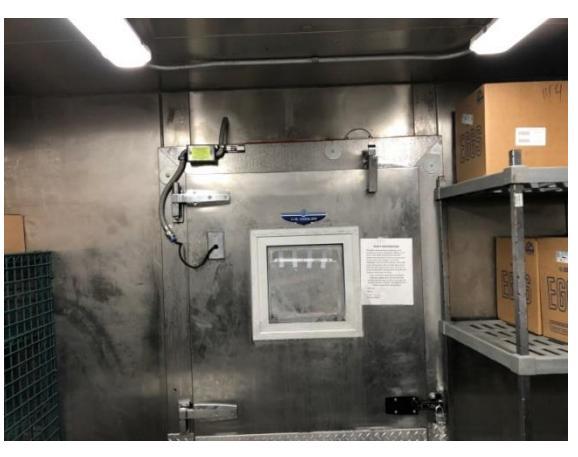
Photo HU6-FS2: Existing Walk-in Freezer Door

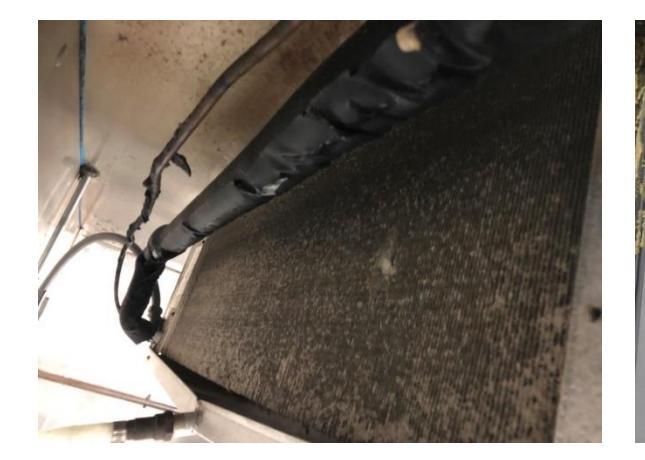
Photo HU6-FS3: Existing Cooler Evaporator Coil

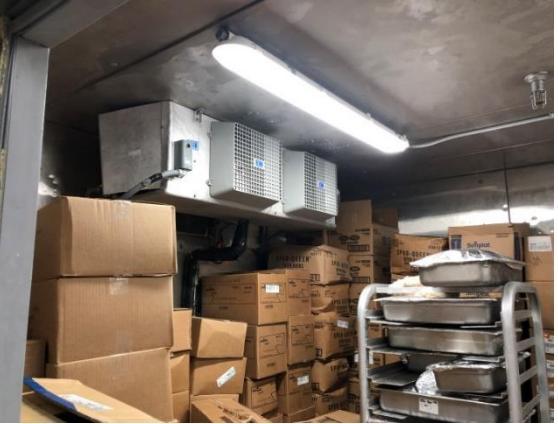
Photo HU6-FS4: Existing Freezer Evaporator Coil

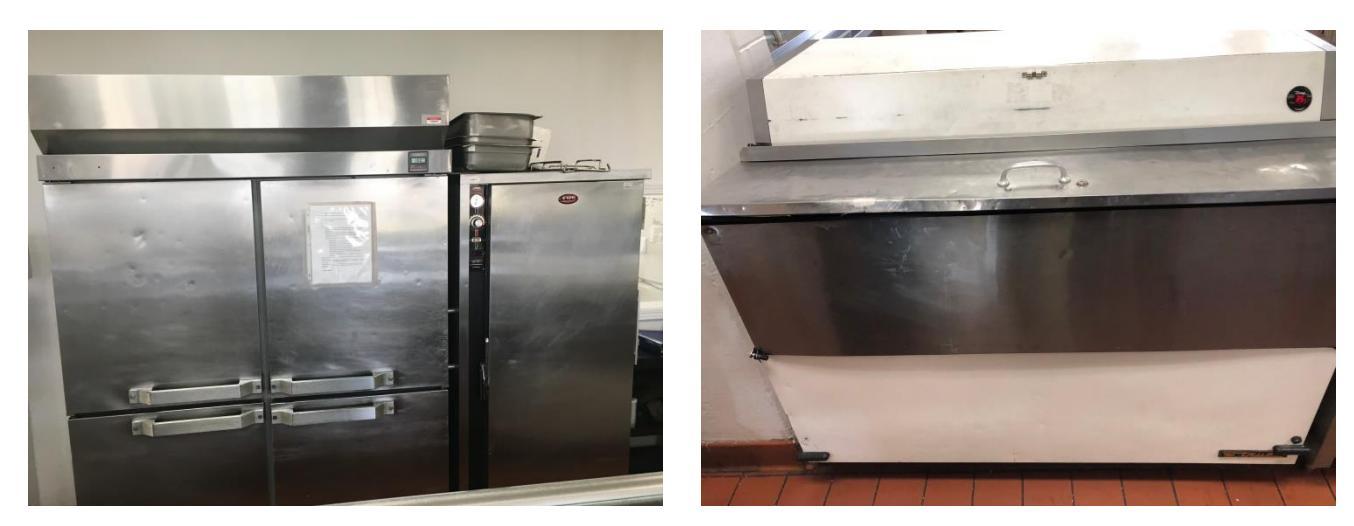
All reach-in refrigerator and milk coolers are older units and have sagging doors and numerous dents on exterior of units. See Photos HU6-FS5 and HU6-FS6. These units also require a discontinued refrigerant to operate.

Photo HU6-FS5: Existing Reach-in Refrigerator

Photo HU6-FS6: Existing Milk Cooler

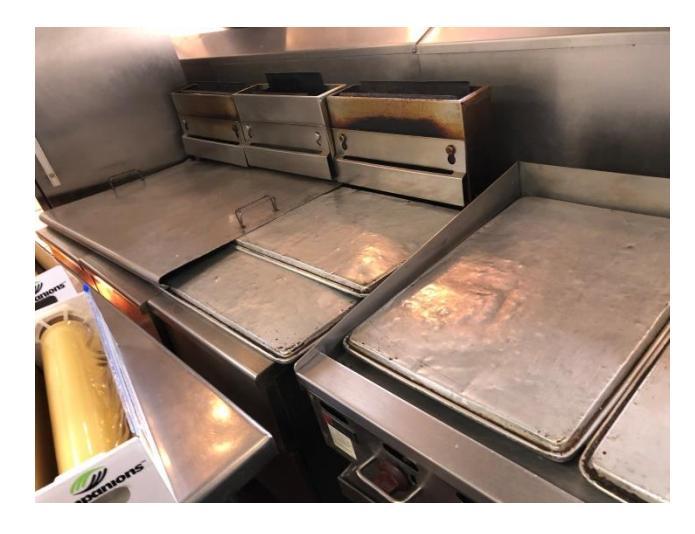
The fryers and tilt skillet are older units and show signs of extensive use with high heat. See Photos HU6-FS7 and HU6-FS8.

Photo HU6-FS7: Existing Fryers

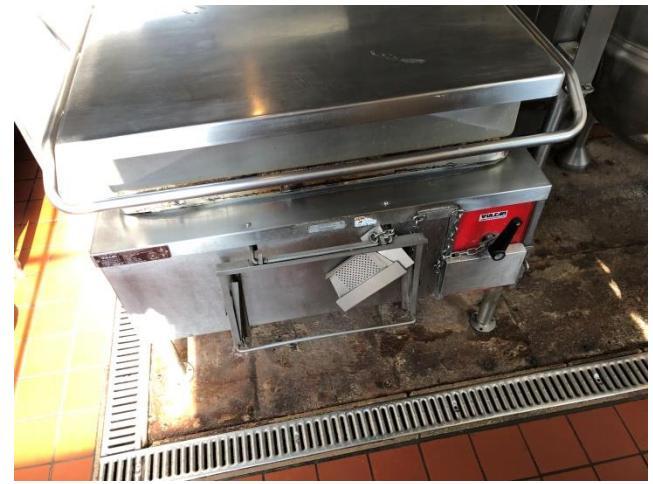
Photo HU6-FS8: Existing Tilt Skillet

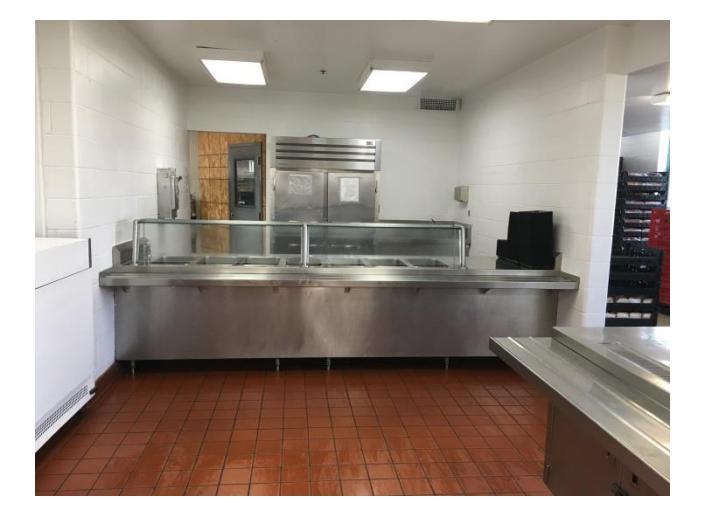
The hot and cold serving counters appear to be original equipment from 1992 and show signs of extensive use and nearing the end of its serviceable life. See Photos HU6-FS9 and HU6-FS10.

Photo HU6-FS9: Existing Hot Serving Counter

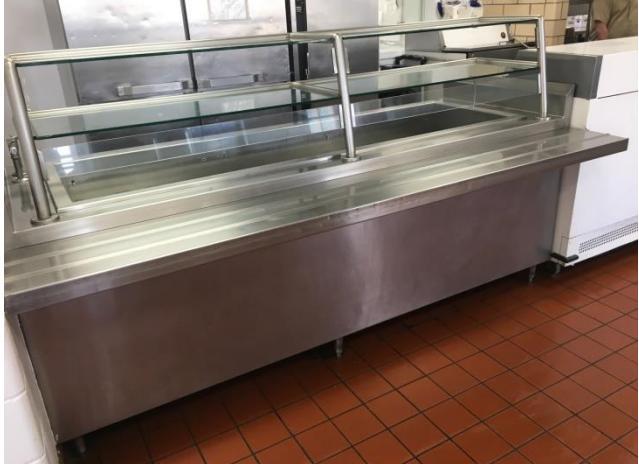
Photo HU6-FS10: Existing Cold Serving Counter

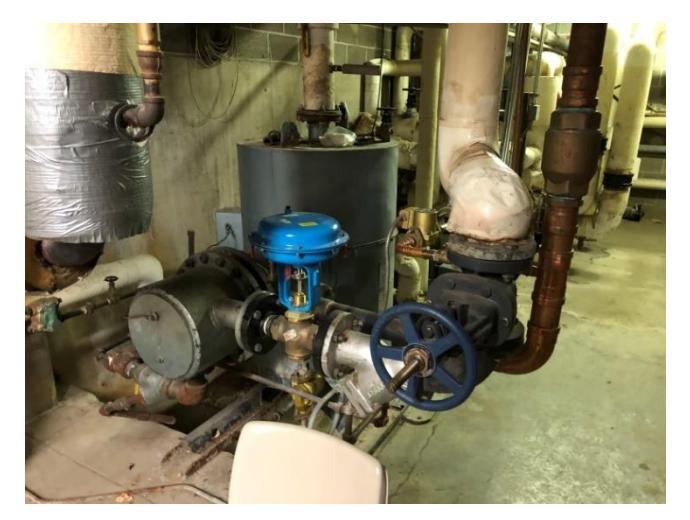
A steam water heater exists in the basement which is from 1995. See Photo HU6-M1. The water heater has a pneumatic steam control valve which serves a steam tube bundle in this water tank. There is only one tube bundle in this water heater so there is no redundancy in the case of equipment failure.

Photo HU6-M1: Existing Steam Water Heater

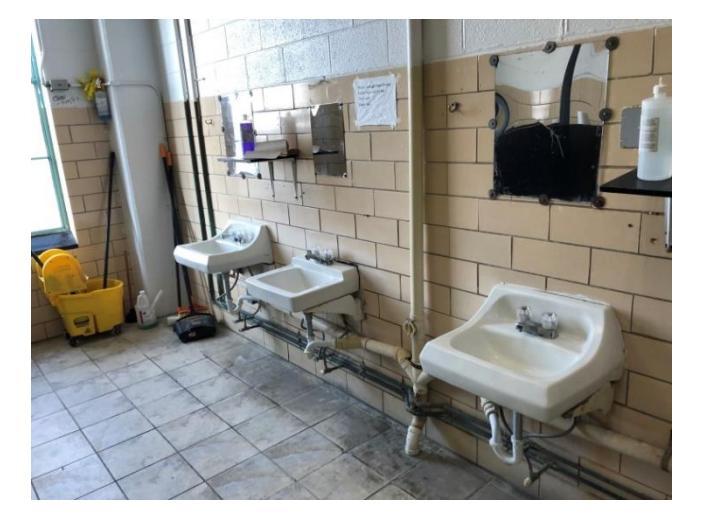
The inmate restrooms have exposed plumbing piping and vitreous china plumbing fixtures. See Photo HU6-M2. The inmates can easily damage the piping and it is not ligature resistant. The plumbing fixtures are easily broken for use as weapons.

Photo HU6-M2: Exposed Restroom Plumbing

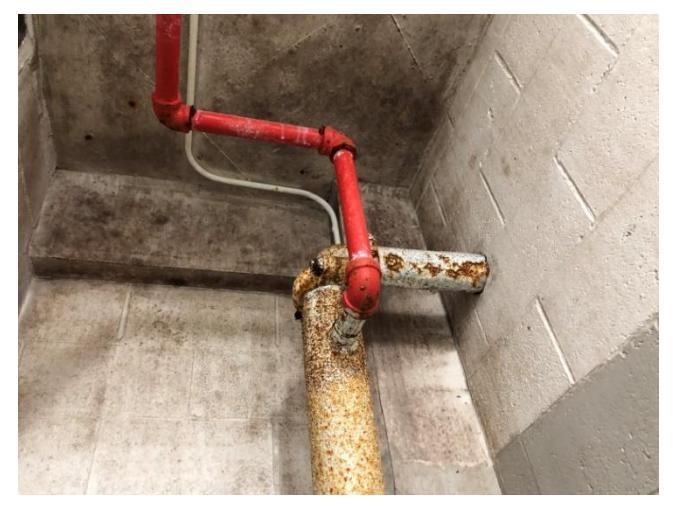
This building has a wet-pipe fire sprinkler system. The piping and heads are installed exposed in most spaces. The sprinkler main in a janitor's closet, next to a shower room on second floor, has excessive corrosion on it. See Photo HU6-M4. The janitor's closets are poorly ventilated and are humid thus leading to the growth seen on the walls and ceiling in Photo HU6-M4. The maintenance staff indicates that this has been occurring for so long that the they've tried to paint the vertical piping white several times, but it keeps rusting through. The white pipe is now actively leaking onto the floor and a constant puddle exists.

Photo HU6-M4: Rusting and Leaking Fire Sprinkler Piping on Second Floor

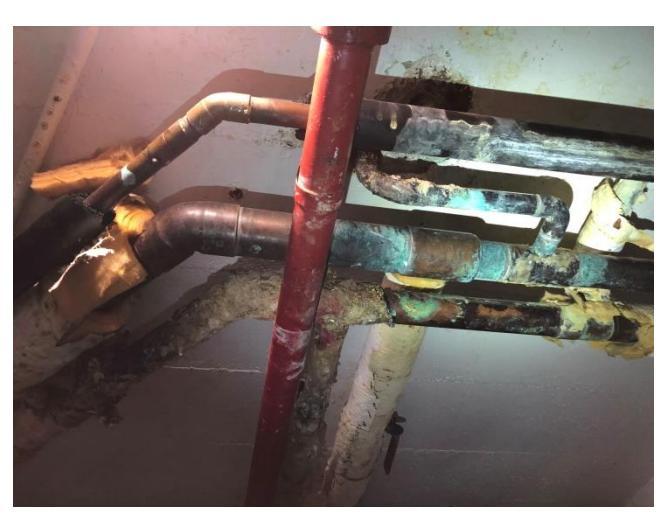
The same piping from Photo HU6-M4 continues down to first floor where the water follows it and continues to cause corrosion and humidity problems. This room is so damp and humid that the horizontal sprinkler piping in it rusted

through and started leaking so, that red section of piping in Photo HU6-M5 was replaced in the last two years. However, the newer red sprinkler piping already has rust forming on it again and there is extensive water damage to the other piping and pipe insulation in this room.

Photo HU6-M5: Rusting Fire Sprinkler Piping on First Floor

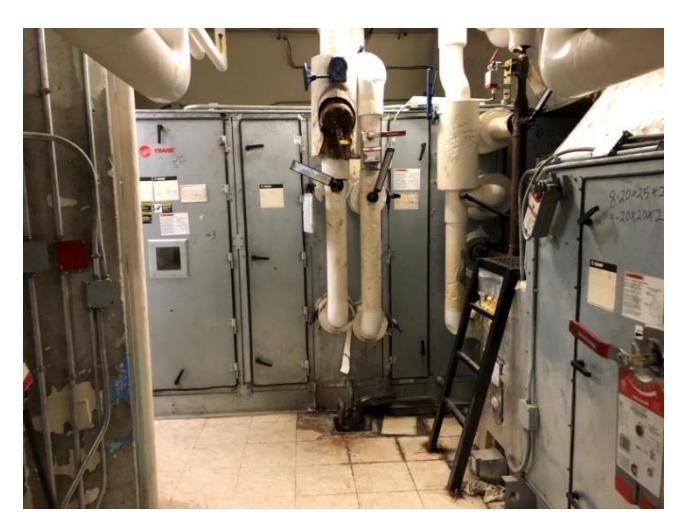
The AHUs are all constant volume with ducted supply and return air systems, heating hot water coils, and chilled water coils. See Photo HU6-M6 for a typical existing AHU. The AHUs have plenum fans. Ventilation air is provided via outdoor air louvers mounted in the exterior walls on second floor.

Photo HU6-M6: Typical Existing AHU

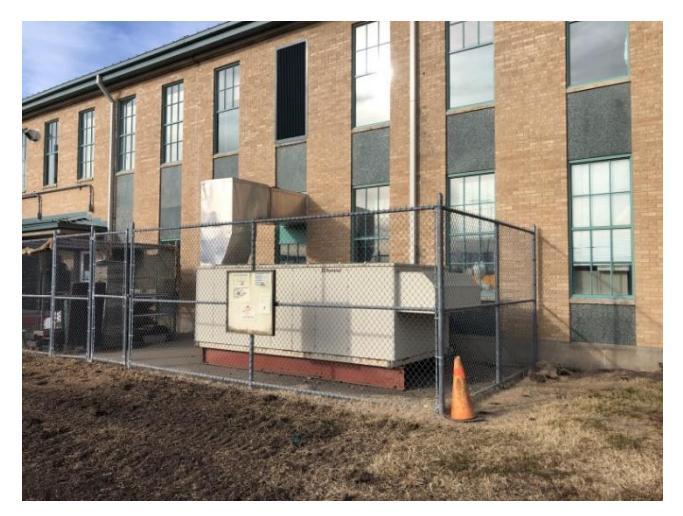
The kitchen make-up air unit does not work because it's heating coil froze a couple of years ago, so it no longer is interlocked to run with the kitchen exhaust hoods causing excessive negative air pressure inside the building during most of the day.

Photo HU6-M7: Existing Kitchen Make-Up Air Unit

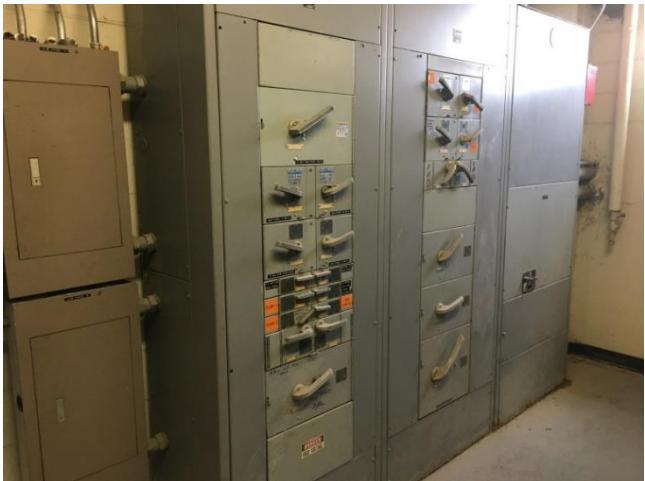
The majority of the electrical distribution system is original to the building construction. See Photo HU6-E1. This equipment is serving beyond its useful service life and needs to be replaced. Convenience receptacle mounting heights are not compliant with modern ADA standards.

Photo HU6-E1: Main Electrical Service

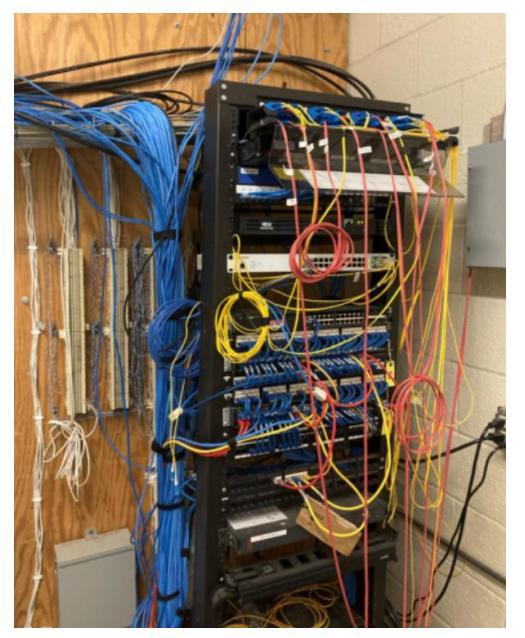
Photo HU6-T2: Existing Telecom Room 008

The main telecommunications room that services the building for data, wireless, and telephone is located in Telecom Room 008 located on the basement floor. There is a 2-post in the room that house fiber optic shelves, copper patch panels, networking

equipment, and a UPS. There appears to be fiber that routes to HU1,2,3,4,5,7,&8 plus

the Ancillary building and the control unit for distribution of the CATV systems. There is a 24-stand, single mode fiber optic cable that routes back to the Ancillary building. The horizontal data cabling to work area outlets is all Category 6 copper cabling, which is in line with current industry standards for horizontal copper cabling. The telecommunications rack is not grounded per BISCI standards.

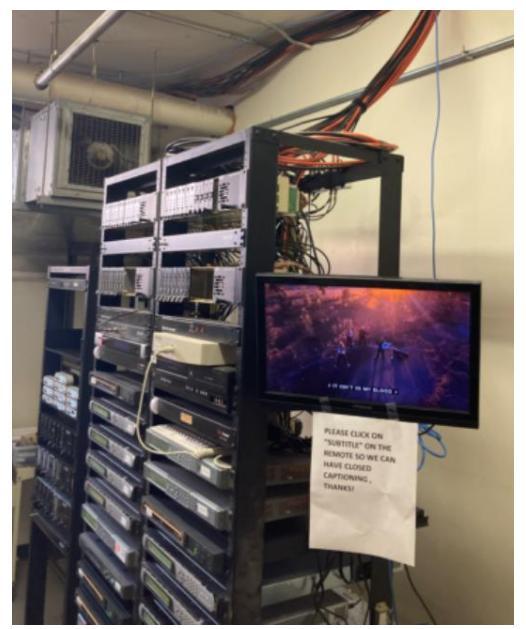
Photo HU6-T1: Existing Telecom Room 003

There are several telecommunication spaces throughout the building. Telecom Room 003 located in the basement houses the CATV services for the NSP site. There are 3 racks that contain multiple receivers, amplifiers, distribution equipment, power supplies, and other associated CATV equipment. If Housing Unit 6 will be demolished, all of this equipment would need to be relocated to another location on the premises. There appears to be fiber that routes to HU1,2,3,4,5,7,&8 plus the Ancillary building and the control unit for distribution of the CATV systems.

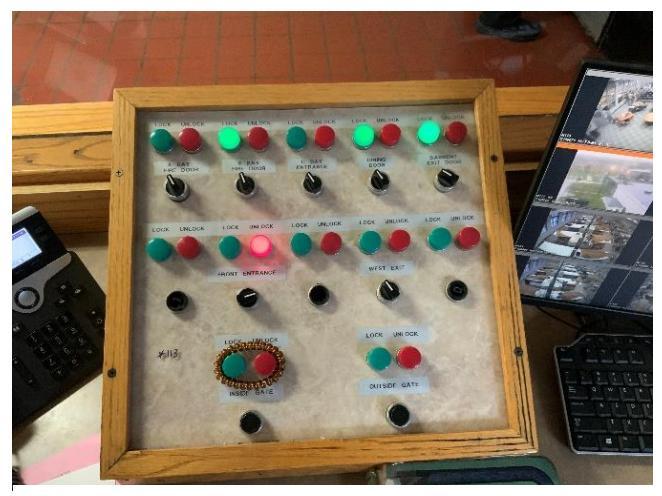
Photo HU6-SEC1: Existing Control Panel

The control location uses an obsolete control panel to control and monitor security devices. The control panel consists of rotary switches and old type LED indicators installed on composite board (plastic/steel) with text engraved on their surface. The panel is installed on a desk mounted turret. The system does not have capability to transfer control to any other control location. The existing doors are hard wired into door control relays and switches that are installed inside the control panel turret.

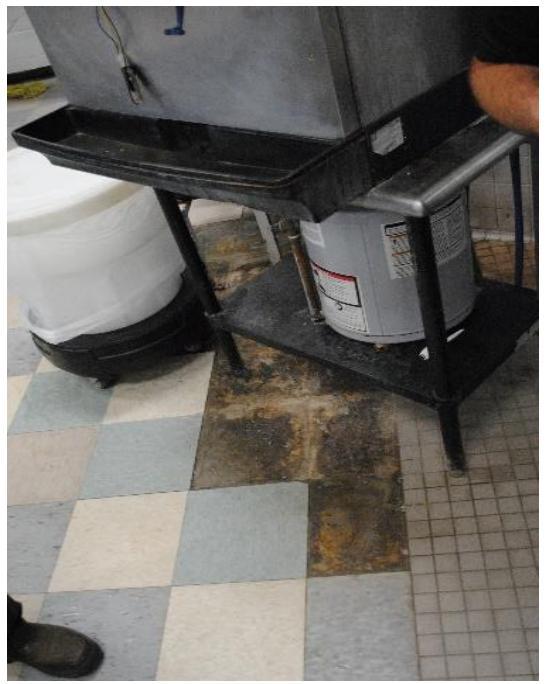
The interior of the building consists of 4 units. Each unit consists of a sleeping area and a dayroom. The sleeping area is a dorm with exposed concrete structure and painted walls and VCT flooring. There are several tiles missing in the dayrooms. The room is separated from the dayroom by a hollow metal window wall. These window walls appear to have a fair amount of damage due to heavy use. The dayroom opens to a toilet and shower area with 2x2 tile floors and 4x4 subway tile walls. The tile is missing in several areas and the hand lavatories have exposed piping. The toilet accessories have a fair amount of calcium build up and rust. Between the units is a control station with VCT floors and an ACT ceiling. The windows between the control station and the dayroom are hollow metal. The millwork at this control station should be considered for replacement.

Photo HU7&8-A1: Flooring in Dayroom of HU7&8

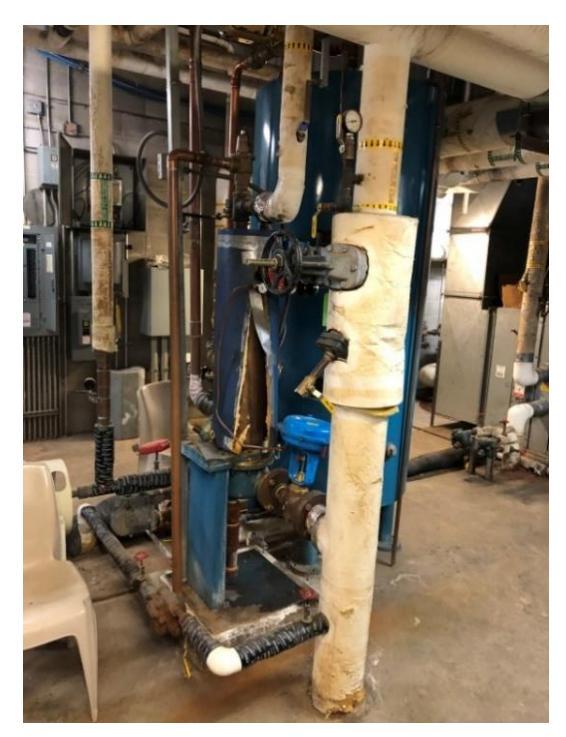
A steam water heater exists in the basement which is original from 1998. See Photo HU7&8-M1. The water heater has a pneumatic steam control valve which serves a steam tube bundle for this water tank. There is only one tube bundle serving this water heater. There is not an existing water softener serving this system.

Photo HU7&8-M1: Existing Steam Water Heater

The steam water heater is original from 1998 which makes it about 23 years old. According to ASHRAE, a steam tube bundle heat exchanger, which is part of this water heater, has a median service life of about 24 years. As a result, the existing water heater is at the end of its useful life and needs to be replaced. The water heater also has no redundancy so, if the steam tube bundle should fail, the building would be without domestic hot water until it can be repaired.

It is recommended to replace this water heater with two storage tank steam water heaters and two equally sized pumps which are piped in parallel. Each water heater would be capable of providing 100% of the heating load so, there is full domestic hot water heating redundancy. A water softener, digital mixing valve, and two inline hot water circulation pumps would also be provided. The probable project cost for this scope of work is \$349,000 per building or \$698,000 for both buildings.

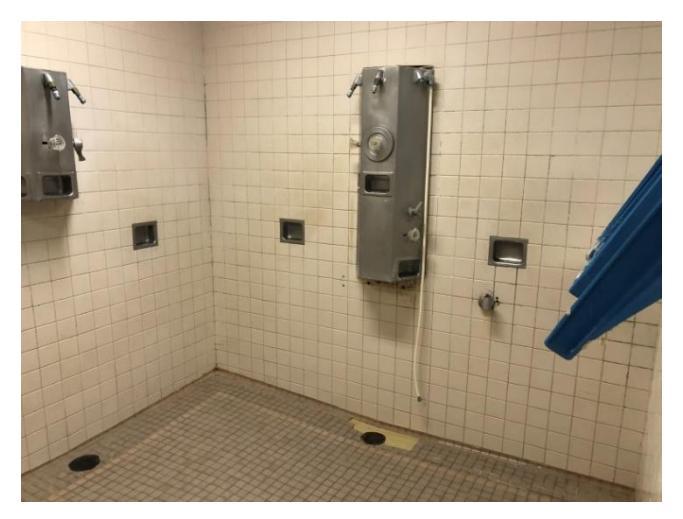
The inmate population for these housing units is about double what they were designed for, so the showers are in constant use during the day which puts extra stress on the sanitary piping system, ventilation, and exhaust systems, and often leads to clogs in the piping. See Photo HU7&8-M2.

Photo HU7&8-M2: Typical Showers

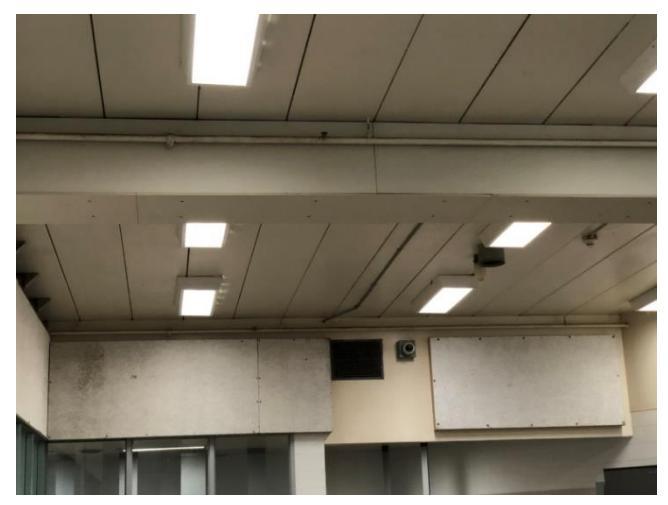
Photo HU7&8-M3: Exposed Fire Sprinkler Piping and Heads

The piping needs to be installed in a ligature-resistant manner in housing units. It is recommended to replace the exposed fire sprinkler piping and heads and install a manufactured soffit concealment system made from painted steel. The probable project cost for this scope of work is \$156,000 per building or \$312,000 for both buildings.

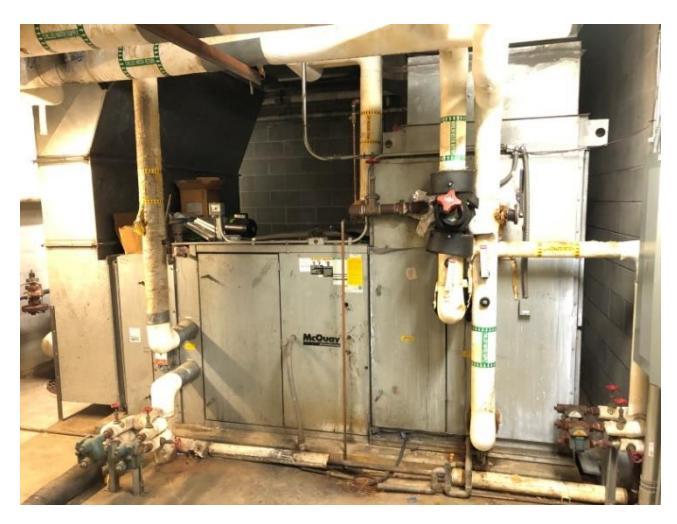
Photo HU7&8-M4: Typical Existing AHU

The AHUs are both constant volume with ducted supply and return air systems, steam heating coils, and chilled water coils. See Photo HU7&8-M4 for a typical existing AHU. Ventilation air is provided via outdoor air intake

hoods mounted on the roof. The housing units are humid and have moisture damage on walls and ceilings.

The HVAC systems are original from 1998 which makes them about 23 years old. According to ASHRAE, most fans, coils, pumps, and controls have a median service life of about 20 years. As a result, the existing equipment is operating at about 3 years beyond its expected useful life and needs to be replaced. The building occupancy has doubled since 1998 and the HVAC systems are not keeping up with current demands. The AHUs also have no redundancy on their air-side so, if the single supply fan for each system should fail, portions of the building would be without HVAC until it can be repaired.

It is recommended to replace the existing HVAC equipment, clean and reuse ducts, install new security supply air registers and return air grilles, and to upgrade the building to a full digital Building Automation System (BAS). The new AHU will be provided with a fan array which is composed of multiple direct drive fans which can automatically speed up to provide redundancy in the event that one fan should fail. The AHUs will also include MERV 13 filters, UV lights at the cooling coils, and humidifiers to provide improved indoor air quality for the occupants. The exhaust fans will be replaced with larger capacity exhaust fans. The probable project cost for this scope of work is \$1,360,000 per building or \$2,720,000 for both buildings.

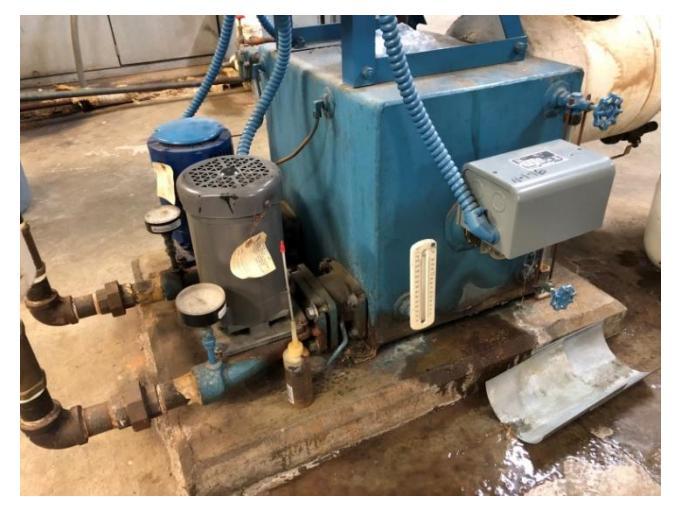
The steam condensate return pump was observed to be leaking. See Photo HU7&8-M5.

Photo HU7&8-M5: Leaking Steam Condensate Return Pump

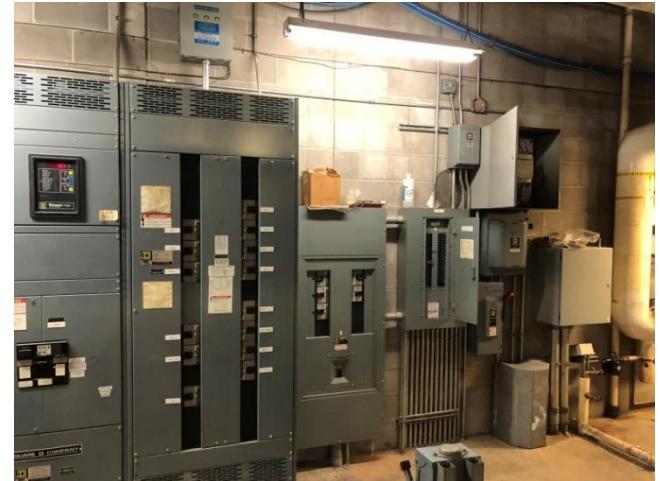
Photo HU7&8-E1: Main Electrical Service

The power distribution system is a mixture of original building equipment and some newer replacement equipment. See Photo HU7&8-E1. The original building equipment is in good operational condition, but is getting within a few years of reaching its end of useful service life. Convenience receptacle mounting heights are not compliant with modern ADA standards.

Equipment original to the building should be replaced as it approaches its end of useful life. The probable project cost for this scope of work is \$432,500 per building or \$865,000 for both buildings.

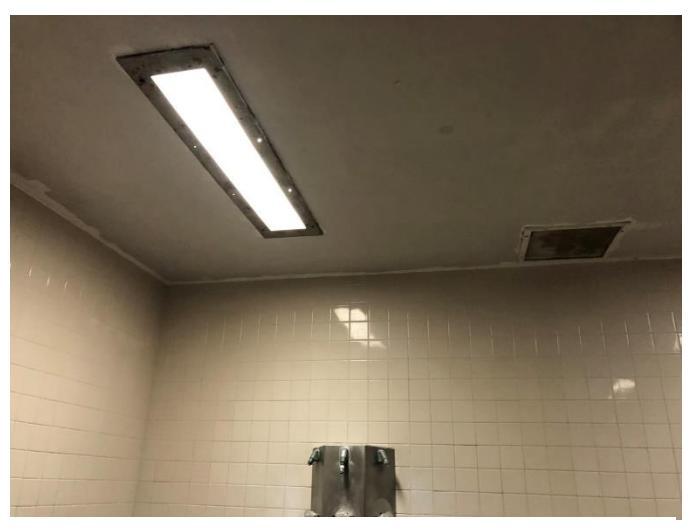
Lighting throughout the building is fluorescent type. See Photo HU7&8-E2. In areas where inmates are present, the fixtures are confinement rated type. All of the fixtures appear to date to the original building construction and are in need of replacement.

Photo HU7&8-E2: Rusted Lighting Fixture in Shower Area

Lighting throughout the building is serving beyond its useful service life and needs to be replaced. The probable project cost for this scope of work is \$722,500 per building or \$1,445,000 for both buildings.

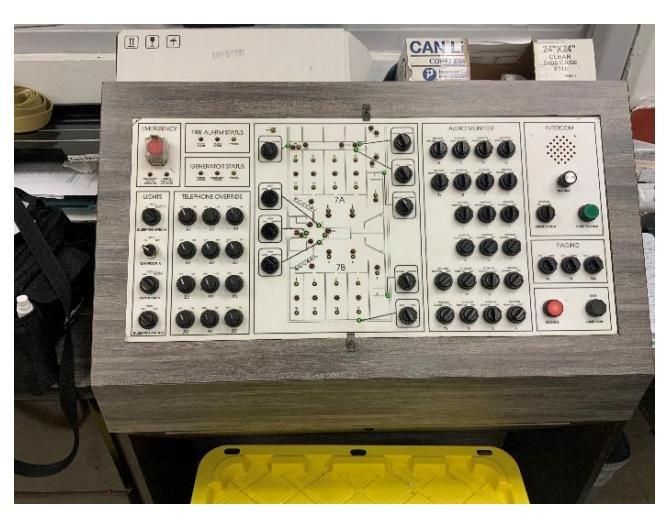
Photo HU7&8-SEC1: Existing Control Panel

Both control locations use obsolete control panels to control and monitor security devices in their areas. Control panels consist of rotary switches and old type LED indicators installed on composite board (plastic/steel) with text engraved on their surface. Both panels are installed on desk mounted turrets. The system does not have capability to transfer control to any other control location. The existing doors are hard wired into door control relay boards and controlled via Crestron Professional Media Controller. The door control equipment is installed in wall mounted cabinets in Security Equipment Closet 125. The Security Equipment Closet is conveniently located between two housings.

The replacement of the existing control panels and the existing relays should be considered as a high priority considering the age and present condition of the existing door control equipment. New door control systems shall consist of a single PLC and two touch screen control station. New PLC based head-end equipment (included but not limited to CPU, Ethernet communication modules, I/O modules, power supplies, relays, etc.)

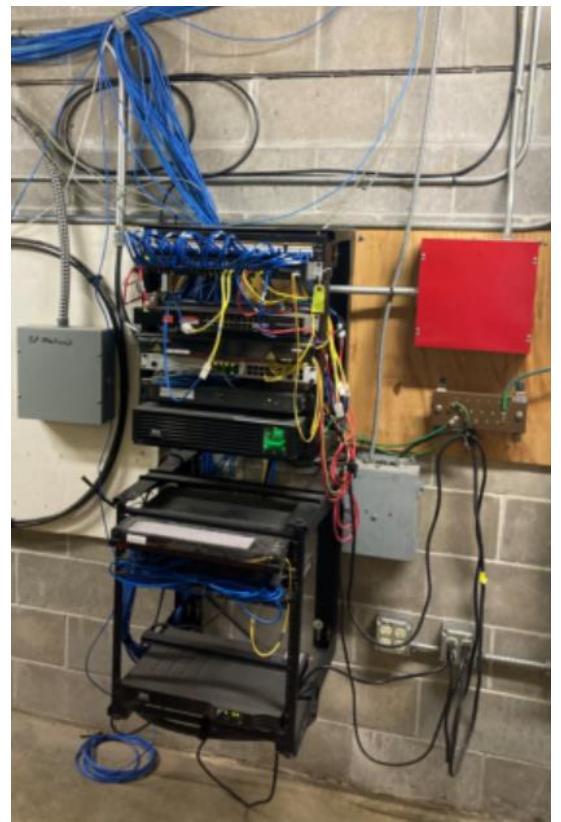
Photo HU7&8-T1: Existing Telecom Cabinet

The existing telecommunications racks in mechanical room 126 are in a shared space with other mechanical equipment and have no cooling. BICSI standards recommend that the telecommunications equipment cabinets should be control against unauthorized access. It is recommended that the existing telecommunications wall mounted racks be replaced with a telecommunication lockable wall mounted cabinet that has integrated cooling for the equipment. The replacement of this cabinet would require down time for the network it serves and a level of risk that existing equipment or cabling may get damaged during the move. The probable project cost for this scope of work is \$40,000 per building or \$80,000 for both buildings.

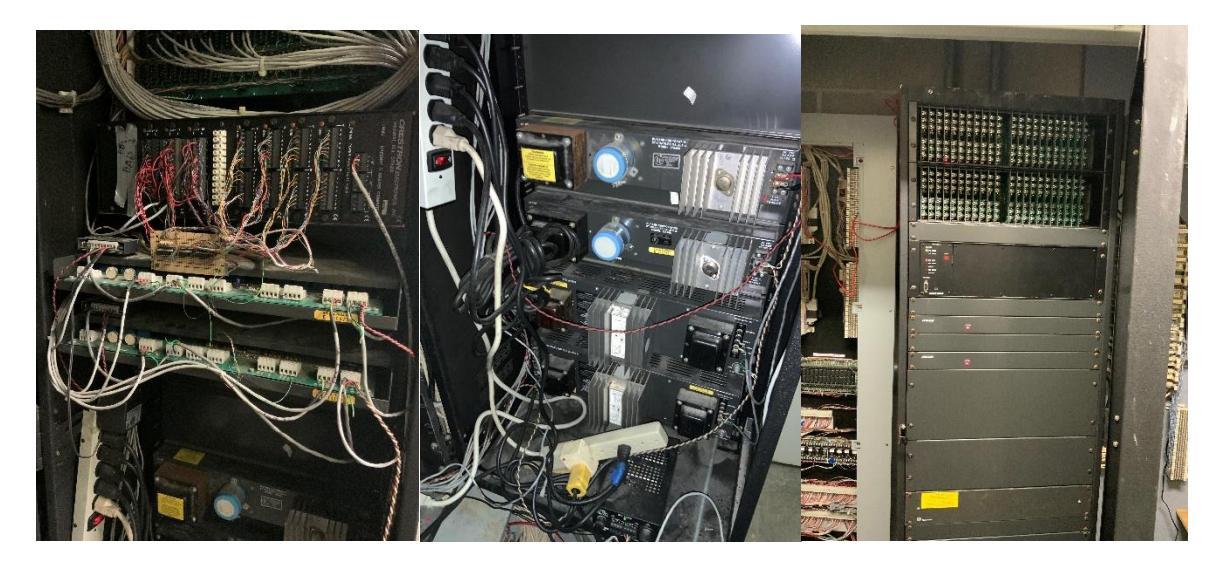
Photo HU7&8-SEC3: Existing Intercom and Paging System Head-End Equipment

The existing intercom and paging system for HU7 and HU8 is not integrated with the door control system equipment. The system uses Dukane relay boards for field devices (intercoms and paging speakers) interface with Crestron Professional Media Controller. Dukane amplifiers are used for intercoms and paging speakers' amplification.

The existing intercom and paging system head-end equipment shall be replaced with the new digital intercom and paging system. All existing intercom and paging system field devices and their associated wiring should be reused (intercom stations, paging speakers and call buttons). The Intercom system would be integrated into the new touch screen control system. The probable project cost for this scope of work is \$23,000 per building or \$46,000 for both buildings.

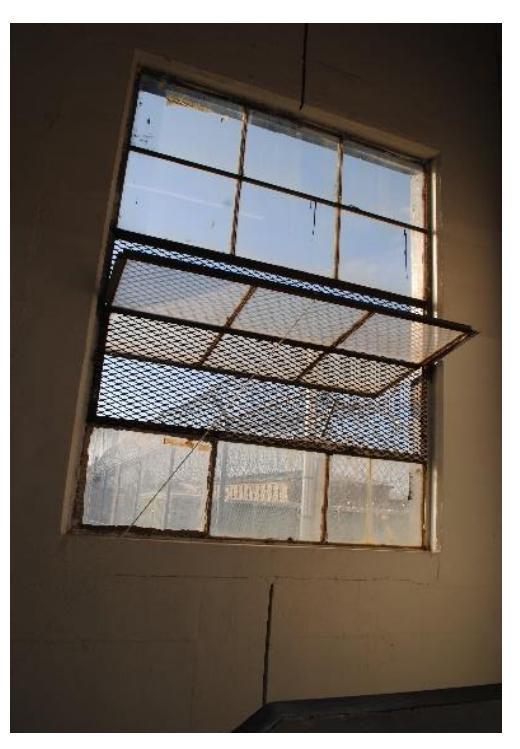
Photo LAUN-A1: Typical Window in Laundry Building

There is a lower-level basement with concrete walls and floors. The structure of the floor above is concrete. All the exterior windows are original steel frame single pane windows. It was noted that the exterior of the building had several cracks that need to be tuckpointed. The roof had a few minor leaks at penetrations.

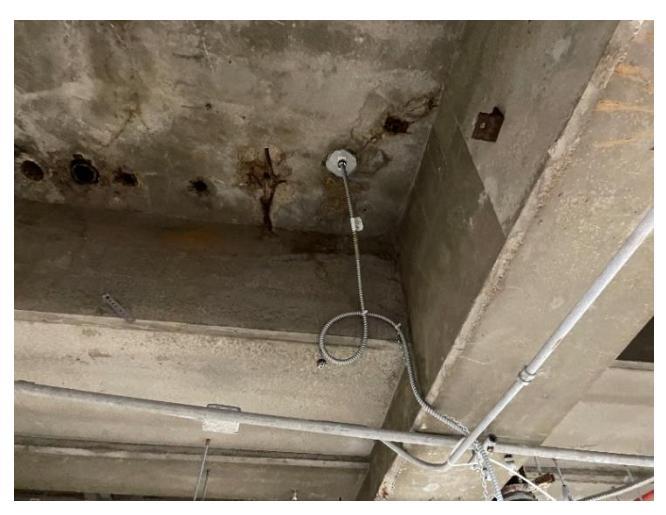
Photo LAUN-S1: Spalled Concrete at Floor Penetrations

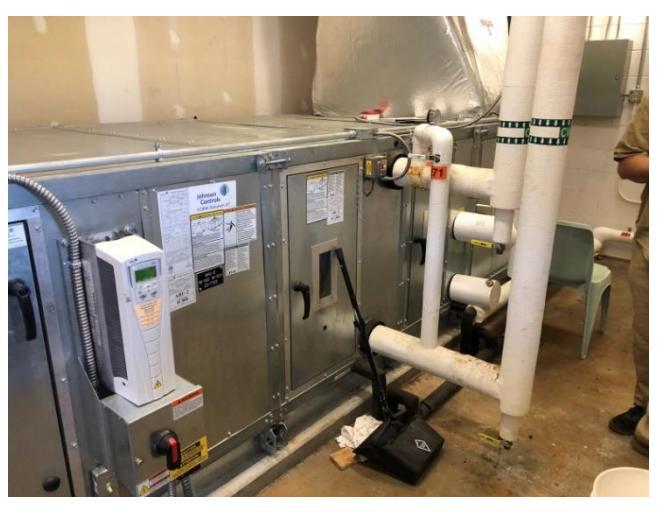
Photo LAUN-M1: Typical Existing AHU

The AHUs have ducted supply and return air systems, heating hot water heating coils, and chilled water coils. See Photo LAUN-M1 for a typical existing AHU. Ventilation air is provided via outdoor air wall louvers. The occupants note that when there is a thunderstorm outside that the variable frequency controller (VFC) for the supply fan of the north AHU, trips off.

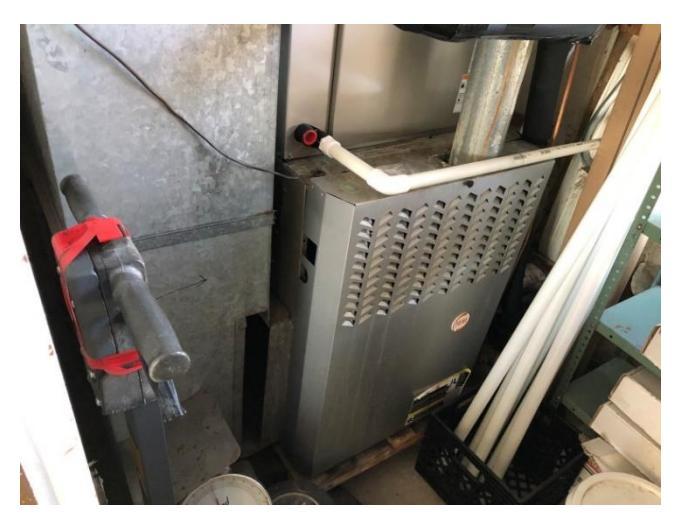
Photo LIB-M1: Typical Existing Gas Furnace

The HVAC system is composed of two natural gas furnaces, two Air-Cooled Condensing Units (ACCUs) with one from 1998 and the other one brand new this summer, two thermostats, above ceiling supply air ductwork serving ceiling diffusers, a return air ceiling plenum, and one restroom exhaust fan. The furnaces are both over 20 years old and have a DX refrigerant cooling coil. See Photo LIB-M1.
