# Nebraska State Penitentiary Useful Life Engineering Study

Lincoln, Nebraska

Alvine No. 2021 8777 January 2022

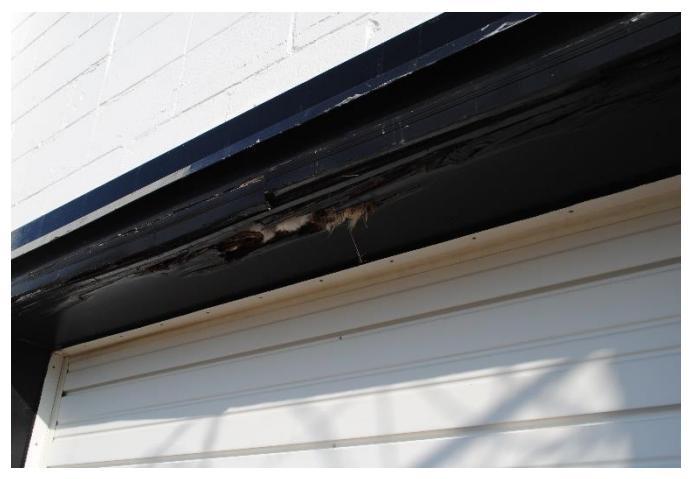
Photo PEB-A1: Overhead Door Damage at Pre-Employment Building.

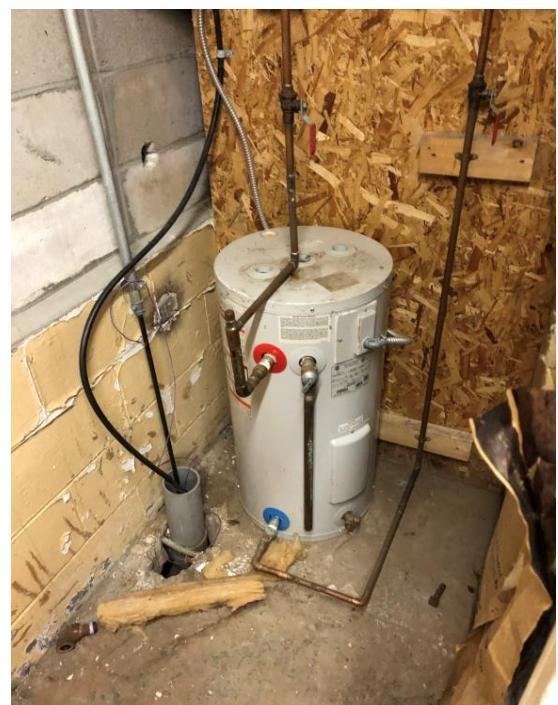
A gas water heater exists which is about 8 years old. See Photo PEB-M1. The hot water piping insulation is missing on all of the piping.

Photo PEB-M1: Existing Electric Water Heater

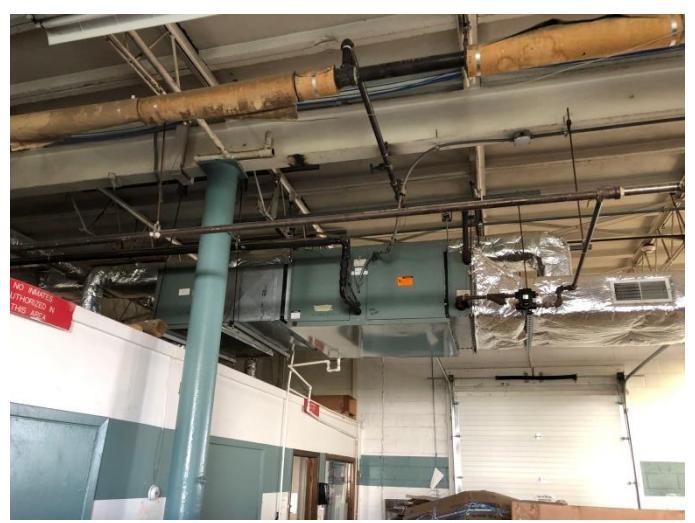
The steam unit heaters were reported to not be functional. There is not an outdoor air louver or roof hood for ventilation purposes, but there are operable windows.

According to ASHRAE, fan coil units have a median service life of 20 years and ACCUs have a median service life of about 15 to 20 years. As a result, the existing fan coil unit and associated ACCU in the recycling center are operating beyond their expected useful life. The other systems in this building are similar in age and condition except for the system serving Prison Fellowship and ABC Construction which is from 2019.

Photo PEB-M2: Existing Fan Coil Unit with Steam Heating Coil

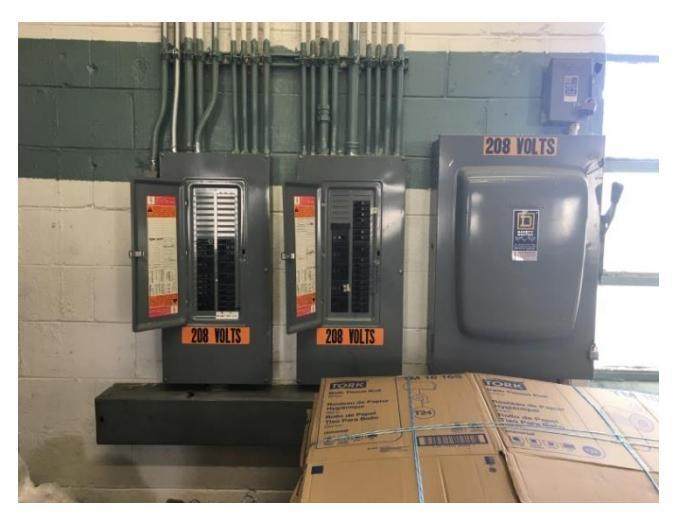
This building has an electrical distribution panel in three of the four separate use spaces. See Photos PEB-E1,

PEB-E2, and PEB-E3. Each of the panels is older vintage, serving beyond its useful service life. In general, convenience receptacle mounting heights are not compliant with modern ADA standards.

Photo PEB-E1: Electrical Panels in Recycling Area

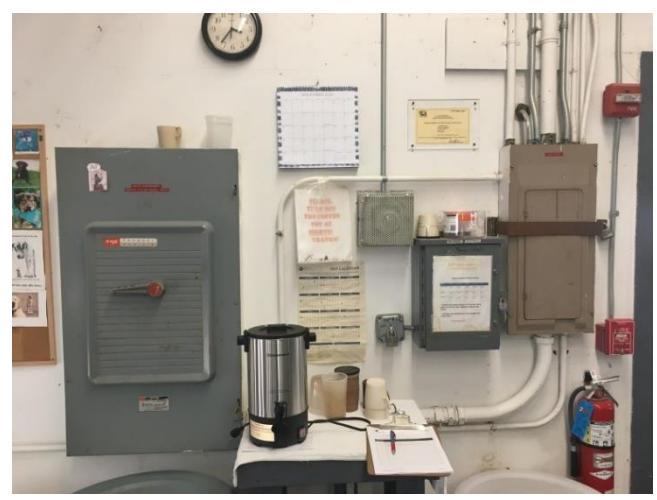
Photo PEB-E3: Electrical Panel in Canine Area

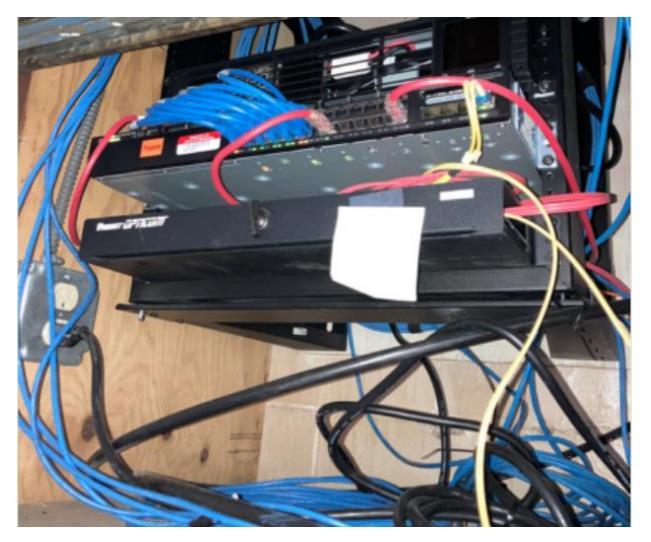
There is an existing wall mount telecommunication rack located in Office 116 that serves data for the entire building. The building is served by a 24-strand, single mode fiber optic cable that runs back to the telecommunications rack located in the basement telecommunications room of the Laundry building. The horizontal data cabling serving the building is all Category 6 copper cabling, which is in line with current industry standards for horizontal copper cabling. There is a UPS within the telecommunications rack that supports the telecommunication network. The telecommunications cabinet is not properly grounded per BICSI standards.

Photo PEB-T1: Existing Telecom Cabinet

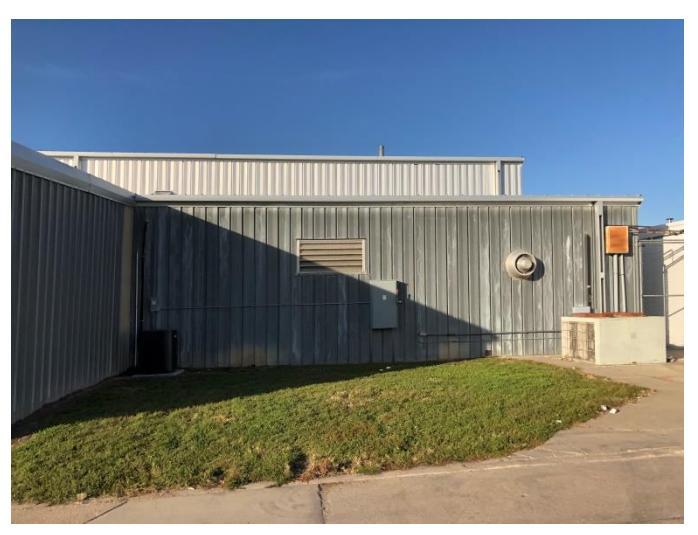
The PVB is a pre-manufactured metal building that is close to 50 years old. This is typically the end of the useful life of these types of structures. The roof is leaking in a few areas and insulation at the roof appears to be coming down in some spots. The exterior

Photo PVB-1: Private Venture Building

walls are aged and dented in areas and are not easily replaceable. A lean-to addition was added to house a metal detector for inmates coming and going to the building. This addition needs to be painted and the roof needs to be replaced.

The PVB has reached the end of its useful life. The building is a pre-manufactured metal building that is close to 50 years old, an age where these types of buildings begin to fail even in the best environments. This type of construction is not recommended as a permanent solution in a correctional environment and the building shows it. The roof leaks, the interior walls have several cracks, and the lack of storage has led to areas above offices to be used for storage that should not be used. The lean-to addition for the metal detector is deteriorating and would need to be painted with a new roof. The toilet rooms do not meet current ADA and it would be difficult to upgrade these areas to meet code. The probable project cost for this scope of work is \$5,100,000.

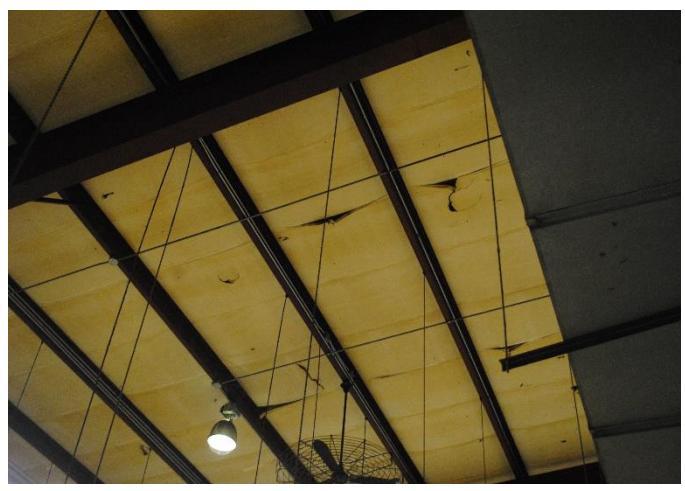
Photo PVB-A1: Tears in Insulation at Ceiling

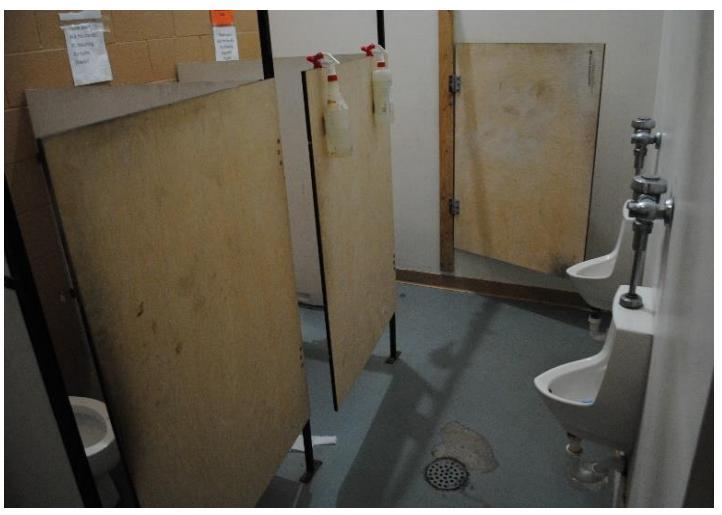
Photo PVB-A2: Non-ADA Compliant Toilets

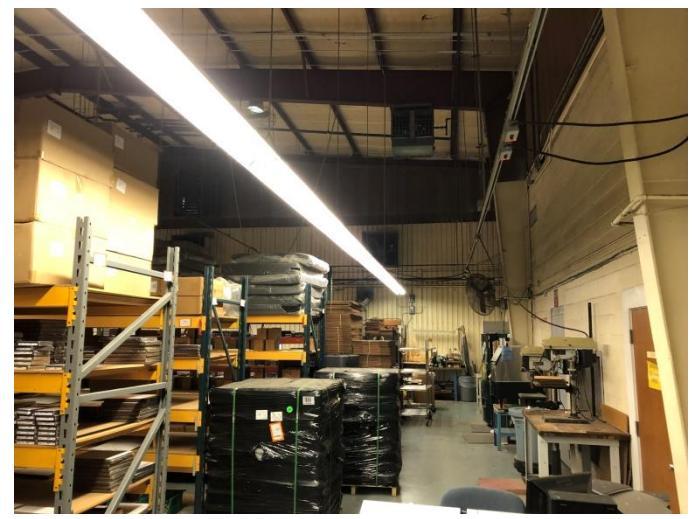
No plumbing fixtures or water heaters were observed. Natural gas piping exists to serve four unit heaters, but the unit heaters are disconnected. See Photo PVB-M1.

Photo PVB-M1: Gas Piping to Unit Heater

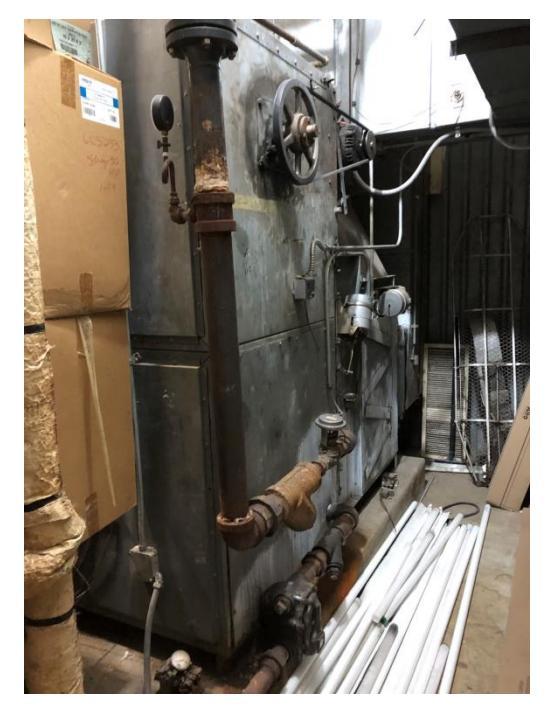
According to ASHRAE, AHUs have a median service life of about 20 years. As a result, the existing fan coil unit and associated ACCU in the recycling center are operating beyond the expected useful life.

Photo PVB-M2: Existing AHU

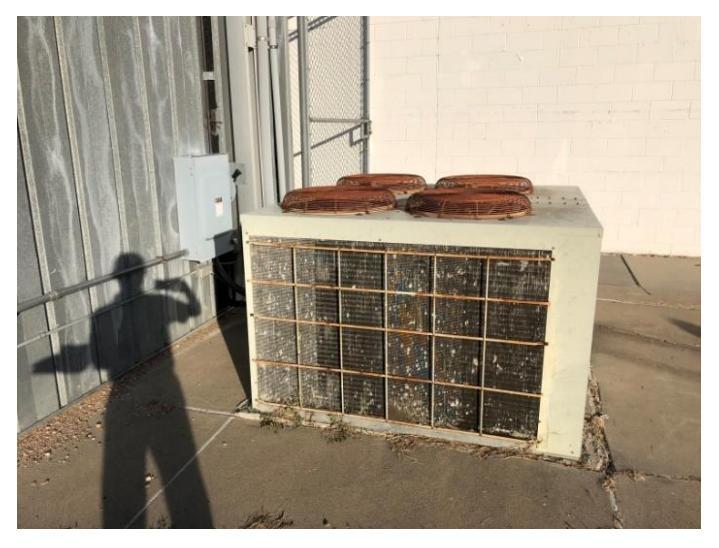
Photo PVB-M3: Existing Abandoned ACCU

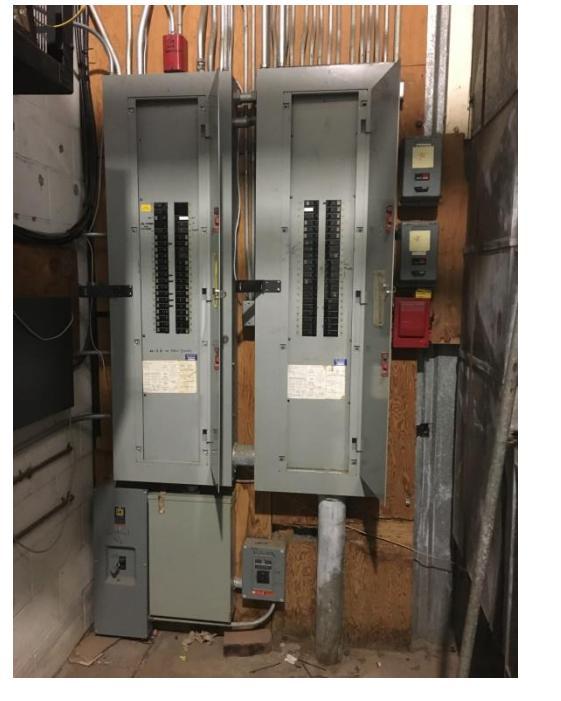
Photo PVB-E1: Main Electrical Panels

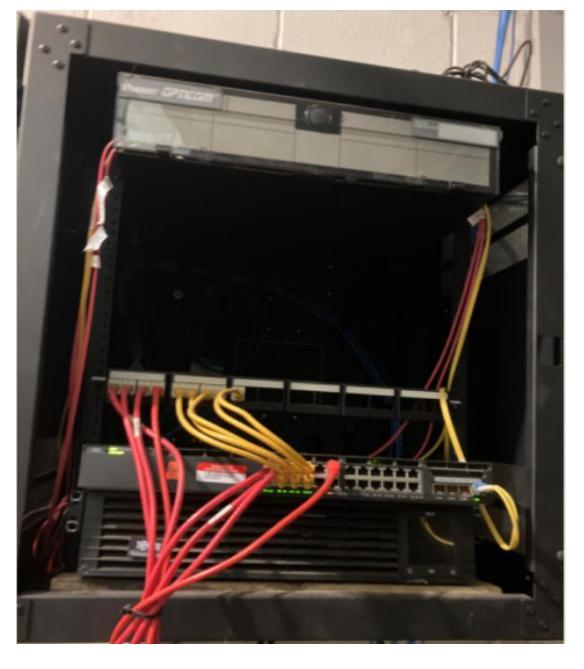
There is an existing lockable wall mount telecommunication cabinet located in Mechanical 110 that serves data for the entire building. The building is served by a 24-strand, single mode fiber optic cable that runs back to the telecommunications rack located in the basement telecommunications room of the Laundry building. The horizontal data cabling serving the building is all Category 6 copper cabling, which is in line with current industry standards for horizontal copper cabling. There is an UPS within the telecommunications rack that supports the telecommunication network. The telecommunications cabinet is not properly grounded per BICSI standards.

Photo PVB-T1: Existing Telecom Cabinet

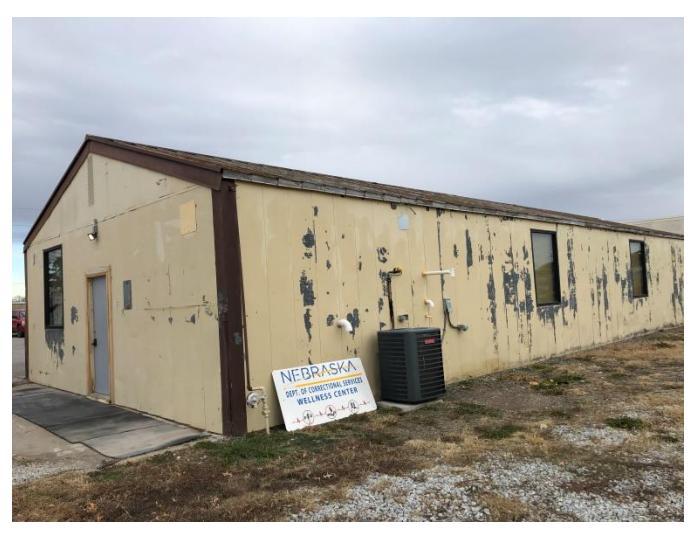
The WELL is a pre-engineered metal building. The roof is metal panel and original to the building. The windows and doors are all hollow metal and single pane. The building sits on slab on grade. The exterior paint is peeling, the roof leaks, and the windows do not meet current energy standards.

Photo WELL-1: Wellness Center

The building roof leaks, and the windows do not meet current standards for energy code. The paint is peeling on the metal panels and gutters. Sealant at the windows is dry and cracked. If the building is to continue being used, new windows and a new roof with gutter and downspouts is recommended, and all the exterior walls should be repainted.

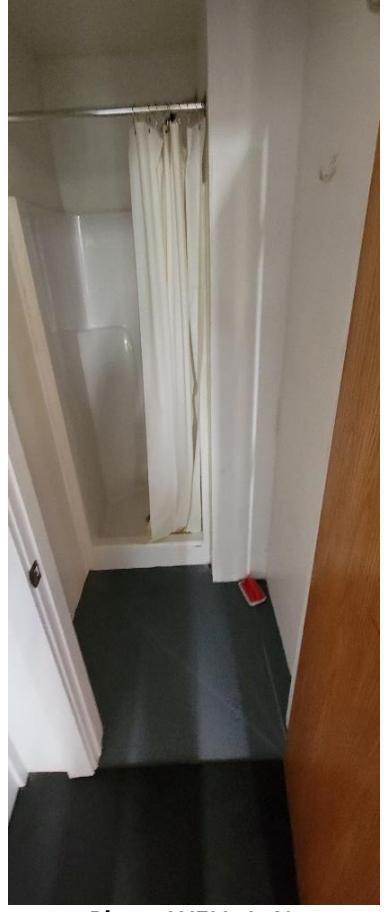
The WELL was built pre-ADA. The toilet and shower do not meet current standards.

Photo WELL-1: Non-ADA Compliant Shower at Wellness

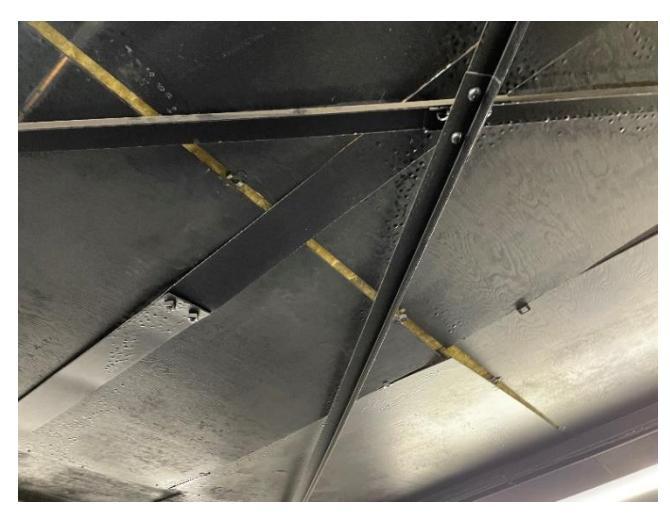
The WELL is a PEMB. A make-shift ceiling consisting of plywood sheets connected with H-clips at various locations around their edges was observed. The ceiling is sagging in some locations.

Photo WELL-S1: Sagging Ceiling

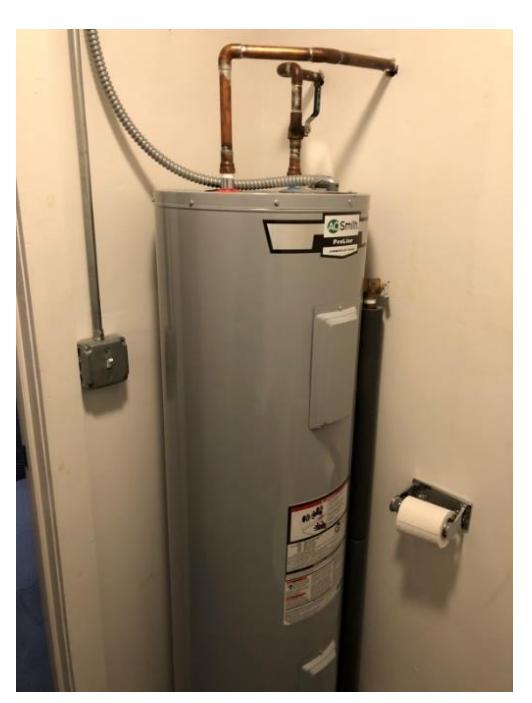
Photo WELL-M1: Existing Gas Water Heater

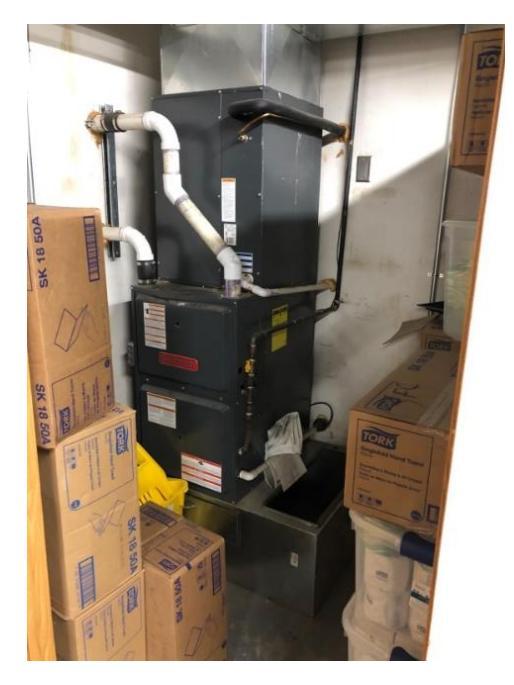
According to ASHRAE, most fans and coils have a median service life of about 20 years while the ACCU has a median service life of about 15 to 20 years. As a result, the furnaces and the ACCUs have remaining useful service life.

Photo WELL-M2: Typical Existing Gas Furnace

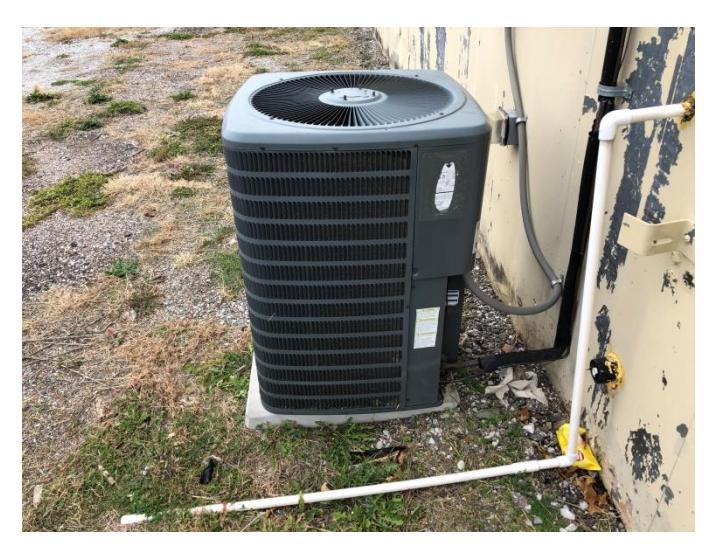
The ACCUs are about five years old and the cooling coil condensate spills onto grade outside near the ACCUs. See Photo WELL-M3. There is not an outdoor air louver or hood for ventilation purposes and the windows are not operable so, there are no means to provide ventilation air to the occupants of the building in a controlled manner.

Photo WELL-M3: Typical Existing ACCU

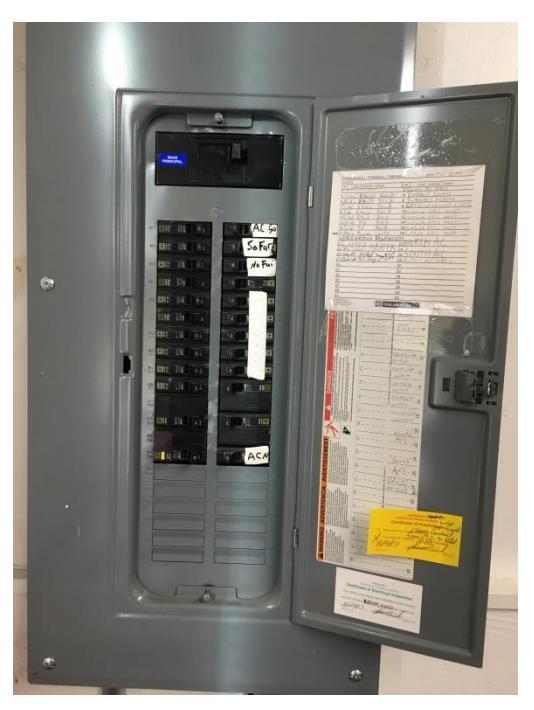
The power distribution system appears to be relatively new and in good condition. See Photo WELL-E1.

Photo WELL-E1: Main Electrical Panel

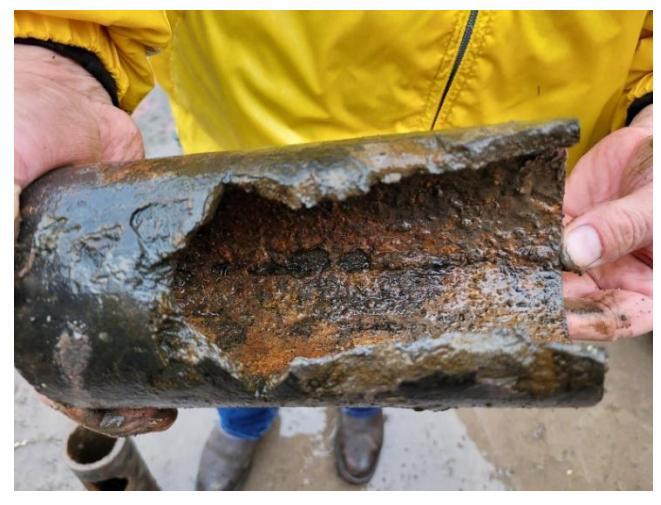
The NSP has experienced 16 breaks in the site domestic cold water piping over the past two years. The most recent breaks happened in October 2021 with three of them occurring at one time. This made the local news since the NSP domestic cold water systems had to be shut down for several days to isolate the leaking piping so, emergency repairs could be made. One of these most recent breaks was in the 67-year old piping located just to the south of HU6 as shown in Photo DW&FP-1.

From review of the trenches and broken main sections it is apparent that the predominant water main material type is Ductile Iron\and or Cast Iron. These pipes were not wrapped in polywrap (thin plastic liner), which has been a standard for many years. The purpose of polywrap is to

Photo DW&FP-1: Domestic Cold Water Pipe Break Near Housing Unit No. 6

protect the pipe from corrosion. Soils in this area of Lincoln are highly corrosive. From review of recent pipe sections that have been repaired it is apparent that corrosivity of the water main pipe infrastructure within this complex is a major issue.

Water main pressures in this section of Lincoln are consistently around 100psi which is quite high and good for fire suppression, but weakened pipes are more susceptible to failure under such high pressures.

It is recommended to provide full replacement of 7,000 linear feet of pipe over the next several years. Incidental demolition and replacement of sidewalks and pavement will be required and is included in this scope of work. The probable project cost for this scope of work is \$2,050,000.

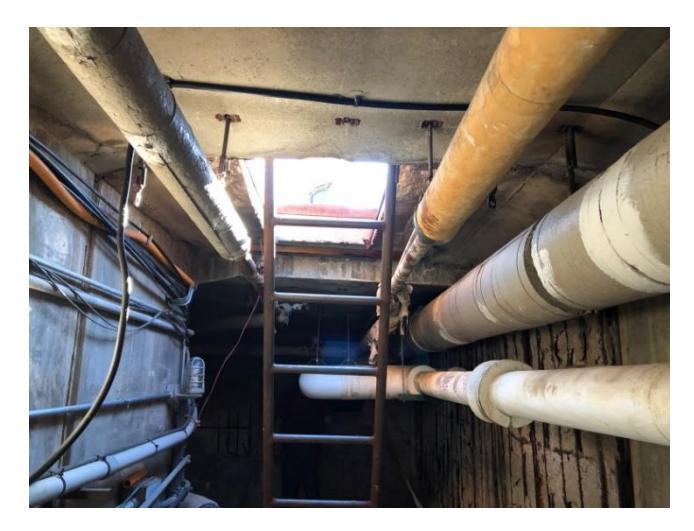
The south side of the campus has site domestic hot water piping installed in the utility tunnels to serve a variety of buildings from two centralized hot water heaters as shown in Photo DW&FP-2. The first steam hot water heater is located in the basement of HU6 and the second one is located in the basement of the SOAP. This piping was primarily installed between the 1950s and 1982.

Photo DW&FP-2: Domestic Hot Water Piping (Top Left) in Tunnel SW of Chapel

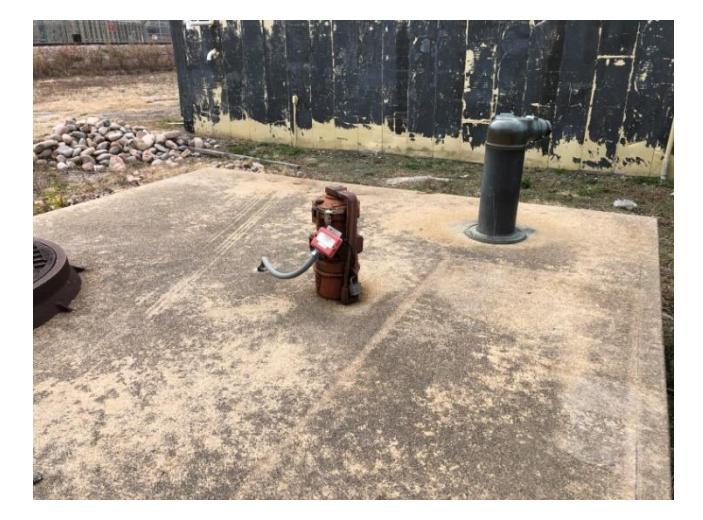
The campus has site fire protection water piping installed to serve several, but not all of the buildings. The fire protection water taps off of the site domestic cold water piping outside of each building and then routes to a post indicator valve (PIV) before heading to the building's fire service entrance. The PIV is a manually controlled valve which is normally locked open and is monitored for position status by the campus's fire alarm system. One PIV is found by the WELL and is installed so, that it's handle barely clears the top of a concrete lid as shown in Photo DW&FP-3.

Photo DW&FP-3: Post Indicator Valve Near Central Warehouse

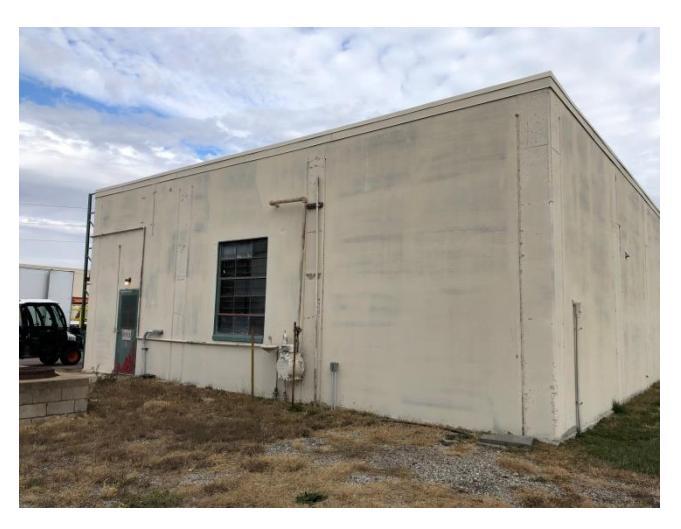
A very old gas meter is noted to exist at the Central Warehouse (CW) as shown in Photo NG-1.

Photo NG-1: NG Meter at CW

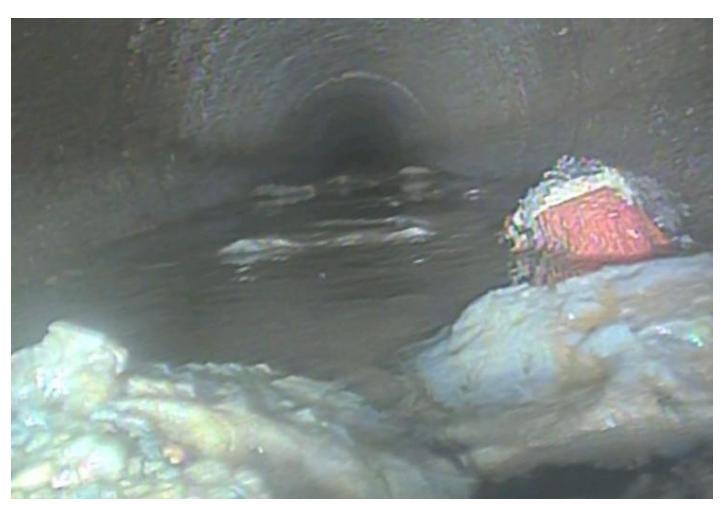
A large amount of debris was found in this piping as shown in Photo SAN-1.

Photo SAN-1: Debris Found in SAN Piping

The required repairs to sanitary sewer pipes do not necessarily require the piping to be fully excavated and replaced. There are methods for inserting new materials within aging or deteriorating gravity sewer pipes such as cured in place pipe (CIPP). However much of this piping is significantly obstructed with debris and the pipe is old enough that there is concern that with traditional water jetting methods the pipe would be further weakened or destroyed.

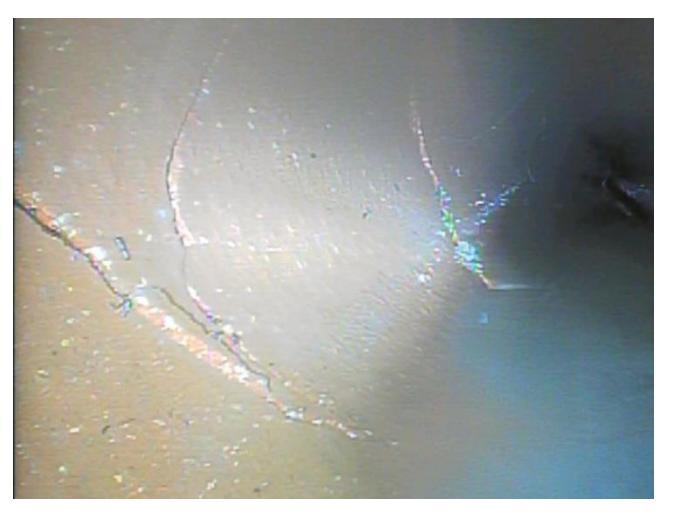
Photo SAN-3: Fractures Found in SAN Piping

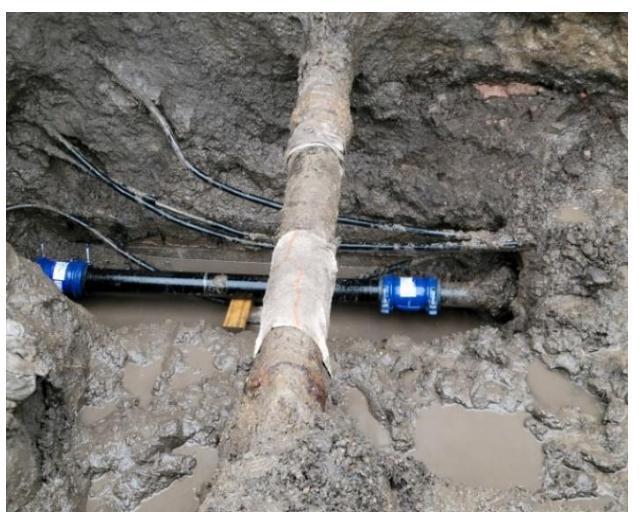
In October 2021, three water main breaks occurred. When the piping was excavated for repair, existing storm sewer piping was also observed such as that shown in Photo STORM-1.

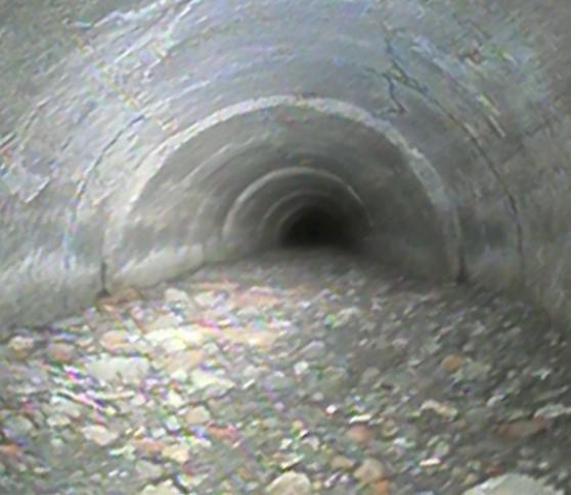
A representative sample of site storm piping was investigated with a video camera, and the report for that work is located in the Site Sanitary Sewer and Storm Drainage Systems Investigation Report located in Appendix K. Large debris was found in this piping near the PEB as shown in Photo STORM-2.

Photo STORM-2: Debris Found in STORM Piping which will Obstruct Water Flow

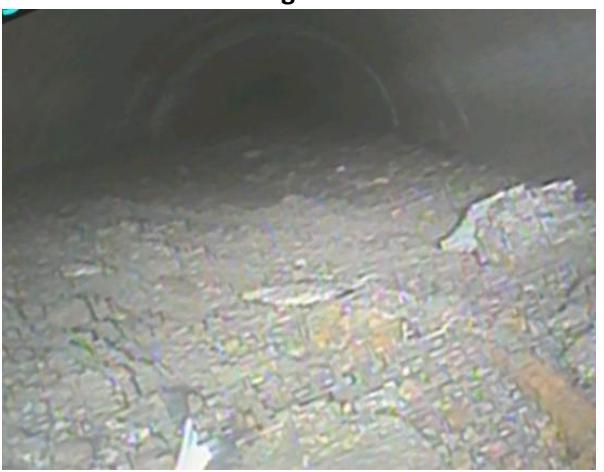
Photo STORM-3: Debris Found in STORM Piping which will Obstruct Water Flow

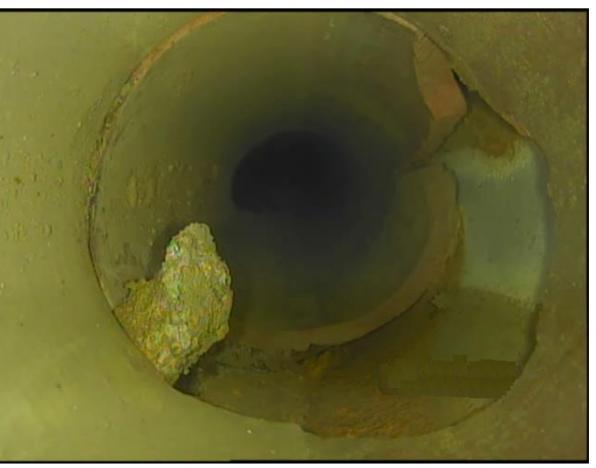
Photo STORM-4: Severely Broken STORM Piping which Needs Immediate Replacement

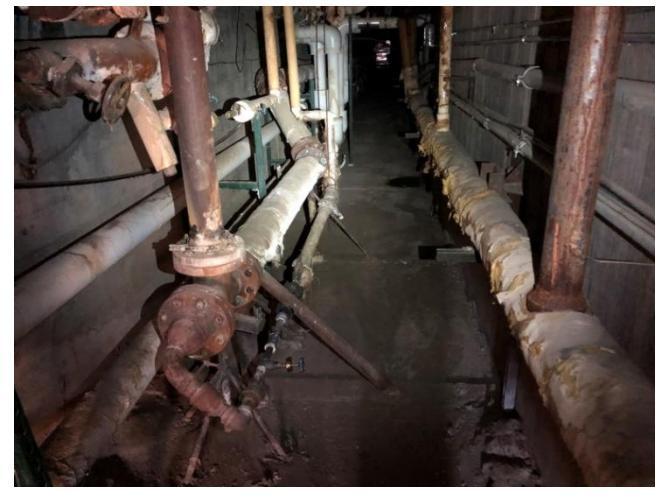
In general, the steam and steam condensate pipe insulation in the utility tunnels and chases is in bad shape, falling off the piping, or missing altogether. Humidity in the tunnels is contributing to insulation failures and to external corrosion of the piping. Humidity is coming

from seasonal changes, site storm drainage issues, ground moisture, and from leaking steam piping systems. Evidence of steam piping leaks was observed during a tour of the tunnels where it was noted that the air temperatures were very high and humid in sections of the tunnels.

Photo STM-1: Steam Piping in Tunnel West of Chapel

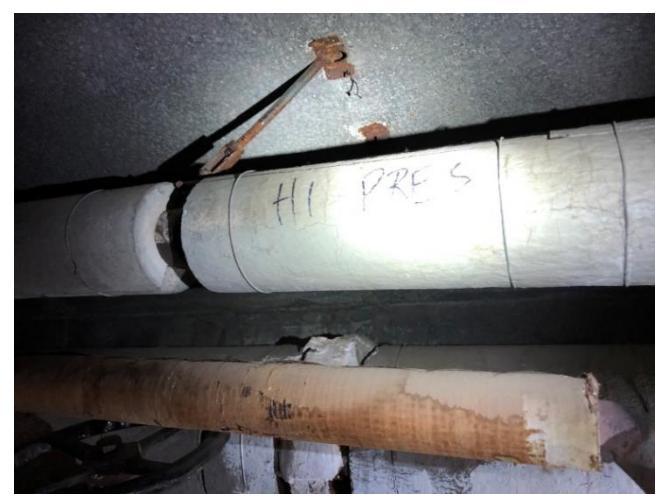
Photo STM-2: Bent Steam Pipe Hanger in Tunnel West of Chapel

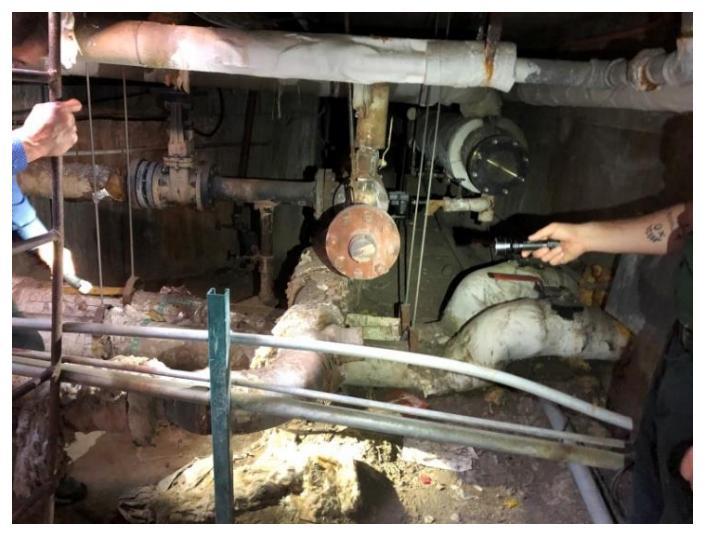
About half of the chilled water piping is located in the tunnels, while the other half of the chilled water piping is direct buried. In general, the chilled water pipe insulation in the utility tunnels is in bad shape, falling off the piping, or missing altogether as shown in Photo CWS-1.

Humidity in the tunnels is contributing to insulation failures and to external corrosion of the piping. Humidity is coming from seasonal changes, site storm drainage issues, ground moisture, and from leaking steam piping systems.

Photo CWS-1: Chilled Water Piping (Left to Right, Down Low) in Tunnel NE of Laundry

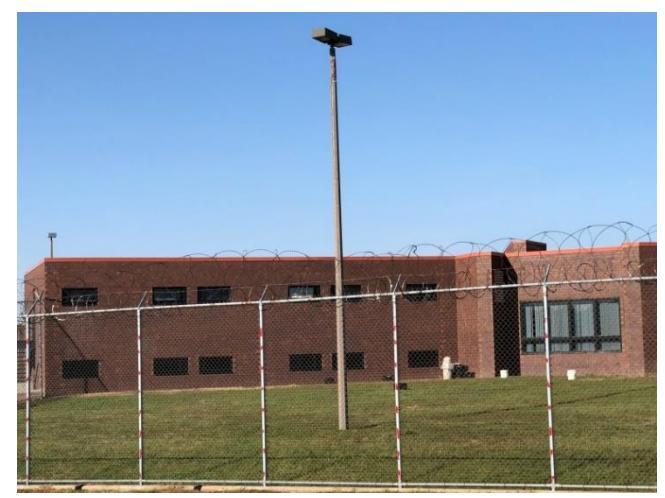
Photo LTG-1: Concrete Light Pole South of Housing Unit No. 5

compromised. The concrete poles are generally in poor condition and in need of replacement. Many of these poles have developed stress fractures in the concrete which has allowed moisture to enter the poles and cause spalling, cracking, and failure. See Photos LTG-1, LTG-2, and LTG-3. This is a serious immediate safety issue due to a concrete pole failing and falling over. In addition, pieces of concrete spalling and falling off the poles create a safety hazard. The broken concrete presents a danger from falling as well as the potential for use as a weapon if it were picked up by an inmate.

### LTG-1: Replace Concrete Light Poles

Concrete high-mast lighting poles are deteriorating and are in poor condition. These deficient poles present safety and security hazards. These poles need to be replaced with new, steel poles and modern LED lighting fixtures. The probable project cost for this scope of work is \$700,000.

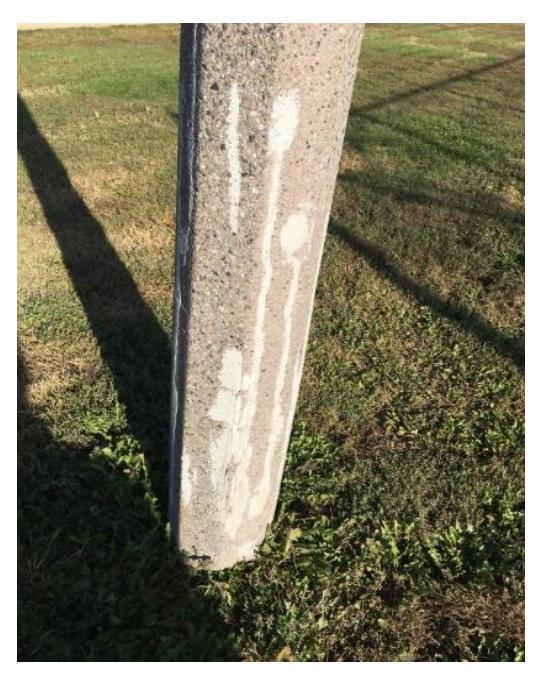
Photo LTG-3: Image of Concrete Light Pole North of Laundry Facility

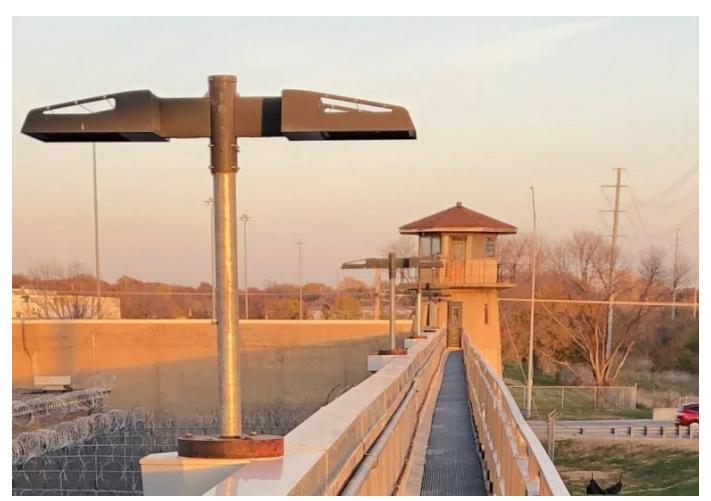
Security lighting mounted on the exterior original prison walls is LED and appears to be in generally good, serviceable condition. See Photo LTG-4.

Photo LTG-4: Security Lighting at Wall Between Guard Tower 5 and Guard Tower 6

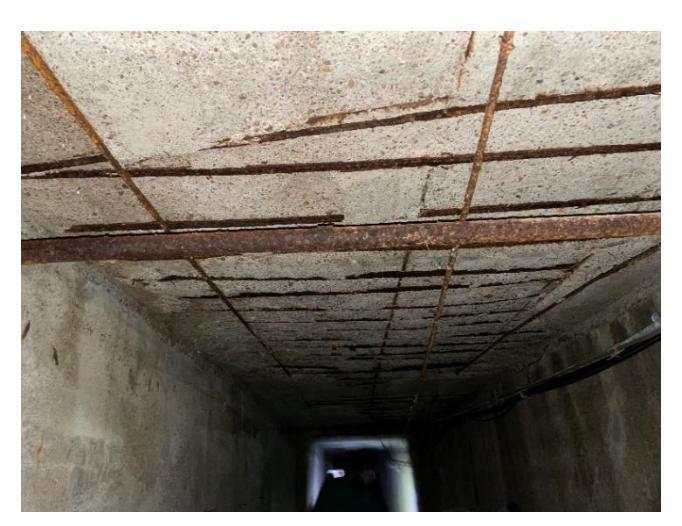
Some of the walkable UT's were assessed, the condition of which varied. Approximately 400 linear feet of tunnel was observed. Of this, approximately 150 linear feet of the tunnel lid requires replacement. See Photo UT-S1. Approximately 40 feet of the observed wall requires repair or replacement. See Photo UT-S2. This sample tunnel observation results in approximately 38 percent of the lid needing replaced and 5 percent of the walls required repair or replacement. The tunnels are approximately 8-feet wide and 8-feet tall. The tunnel structure under the road between CFACT and Chapel is in such poor condition that recent construction work in that area required smaller than normal truckloads of debris, and lightly loaded material trucks in an effort to prevent tunnel collapse. This added significant time and cost to the work performed.

Photo UT-S1: Deteriorated Tunnel Lid

### UT-S1: Tunnel Lid and Wall Deterioration

The deteriorated tunnel lid and walls require replacement. This is laborious, requiring controlled demolition to protect active piping in the tunnel, temporary shoring, new forming and new concrete and reinforcing. Given all of these and the work environment, it is difficult to determine repair costs. It is our understanding that there is approximately 2,000 linear feet of tunnel. Using the damaged percentage areas noted above, that suggests approximately 6,000 sf of tunnel lid and 2,000 sf of tunnel wall need repaired or replaced. The probable project cost for this scope of work is \$560,000.

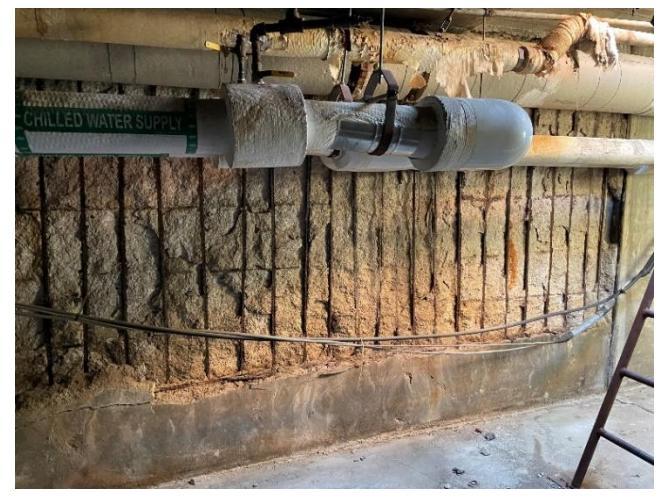
Photo UT-S2: Deteriorated Tunnel Wall

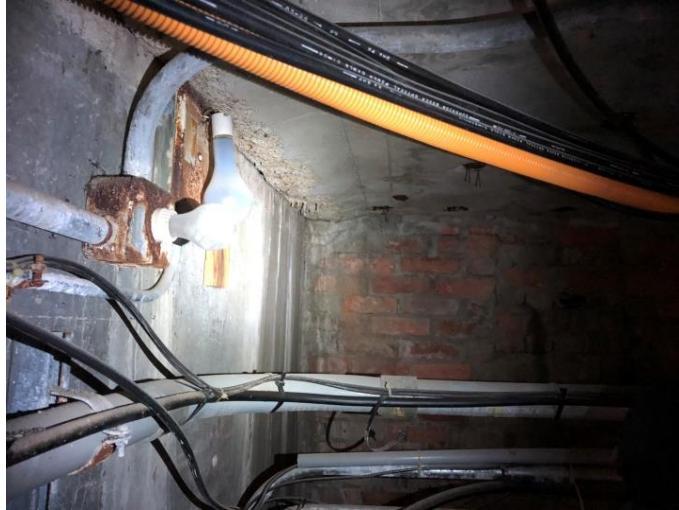
Lighting in Utility Tunnels is installed inconsistently. Numerous locations where lighting is installed have damaged fixtures; many of them are not operational. Some of the fixtures are not suitable for use in a damp tunnel. See Photos UT-E1 and UT-E2. Lighting needs to be applied consistently throughout the tunnel system to provide a safe working environment for facility maintenance staff and contractors.

Photo UT-E2: Representative Photo of Rusted Tunnel Lighting. Neither Fixture is Operational

### UT-E1: Tunnel System Lighting Replacement

Tunnel lighting is installed inconsistently and is mostly non-operational. This lighting needs to be replaced with modern LED fixtures rated for use in a tunnel. The probable project cost for this scope of work is \$115,000.

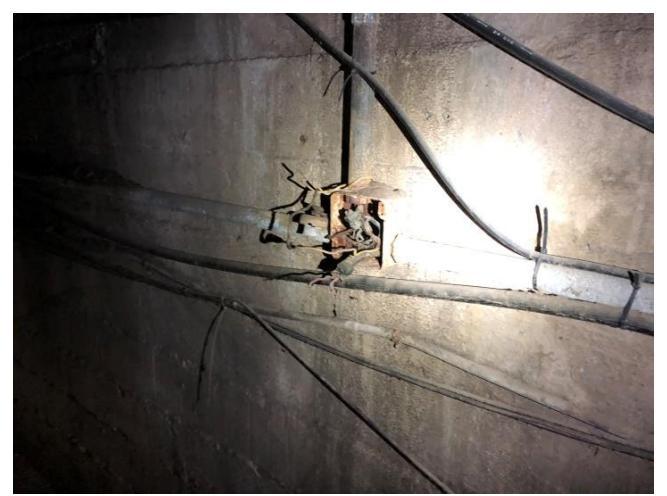
There are locations in the tunnel system where there are open junction boxes with wires protruding from the box. This creates a dangerous condition for working in the tunnels. This is also a National Electrical Code violation. See Photo UT-E3. These locations need to be repaired to provide a safe working environment for facility maintenance staff and contractors.

Photo UT-E3: Representative Photo of Rusted Electrical Box with Exposed Conductors

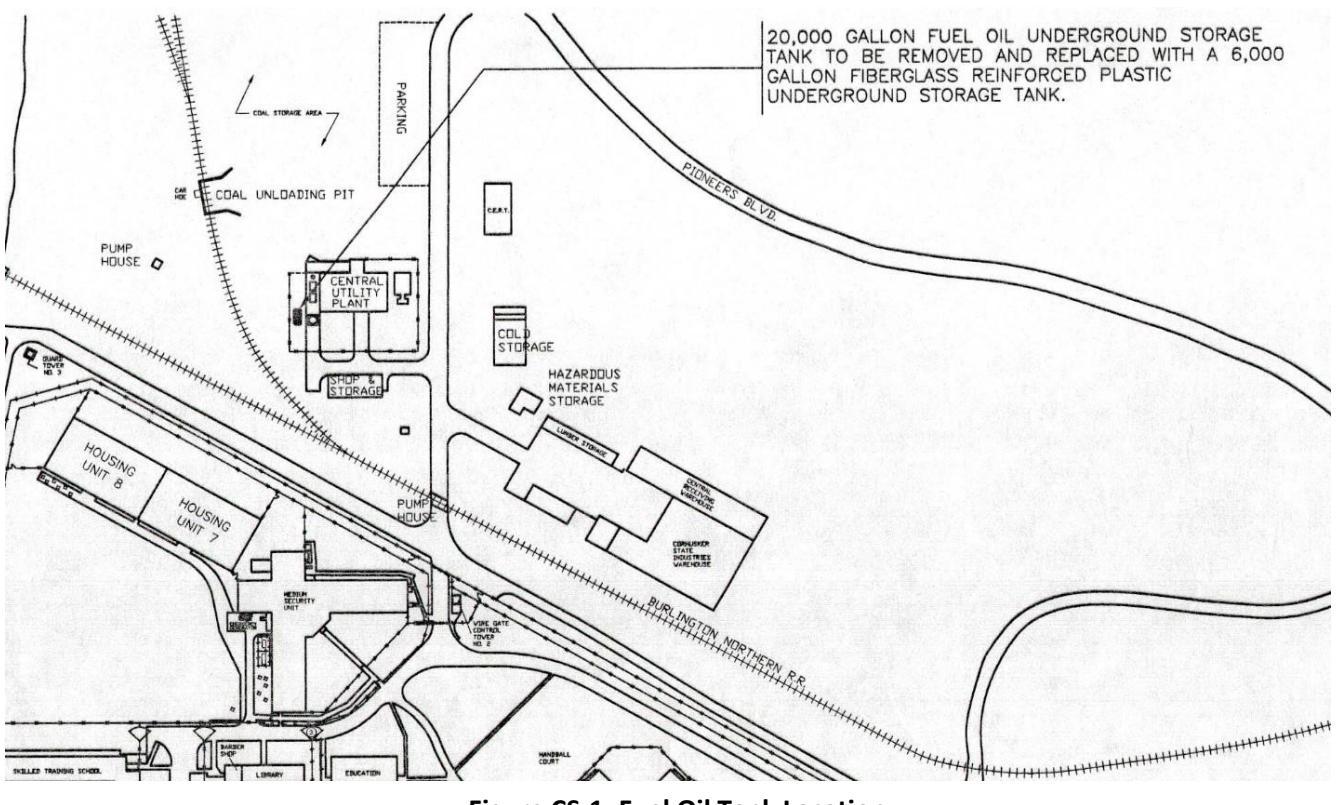
Figure CS-1: Fuel Oil Tank Location

When the OCUP was constructed in 1980 there was a 20,000 gallon underground storage tank on the south side of the plant. Then in 1998 the original 20,000 gallon underground storage tank was removed and replaced with a new 6,000 gallon fiberglass underground storage tank. Since the new District Energy Center has been constructed the old CUP has been repurposed and the underground storage tank is no longer useful. The State Fire Marshal has required that the tank be emptied. NSP Maintenance also directed that the tank be removed. Soils around the old tank area should be tested and removed if found to be contaminated by past fuel spills or leaks.

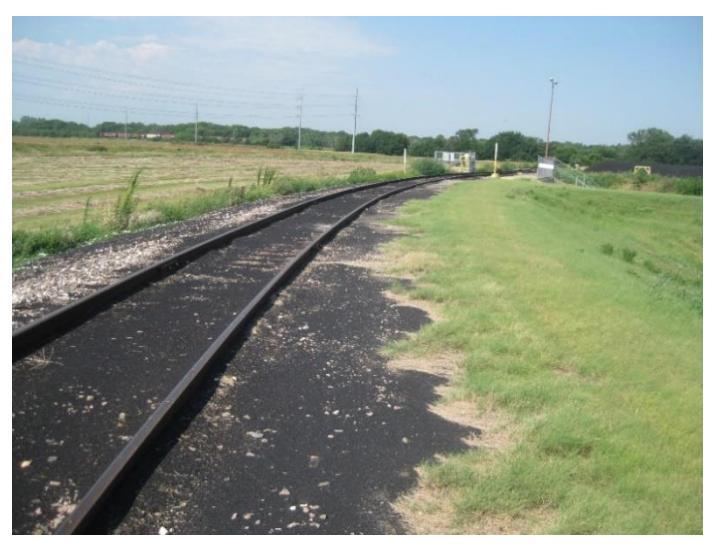
Photo CS-1: Coal Along Railroad Tracks

There are two piles of coal remaining on site that should be disposed of. The volume of coal was estimated as 2000 Cubic Yards. Disposal of waste coal is regulated by the Nebraska Department of Energy & Environment (NDEE). The NDEE considers waste coal to be special waste. Waste coal may be disposed of in permitted municipal solid waste landfill or buried at the site. Burial on site is the preferred disposal method. Burial on site must have NDEE approval as required by Title 132. A disposal trench or pit must be excavated 4 to 10 feet deep. Trench or pits must be lined with 20-ml plastic liner sheet. Then the coal that is deposited must be covered with 20-Mil plastic liner sheet and covered with a minimum of 2 feet of earth material. Although NDEE would prefer it be buried on site we feel it would be better for any future site development to remove it from site and dispose of it at a permitted landfill. The existing rail tracks no longer serve a function now that the new District Energy Center plant has been constructed in 2018. To facilitate the Off Loading structure removal and coal waste cleanup it would be wise to remove all of the railroad tracks and regrade the area.

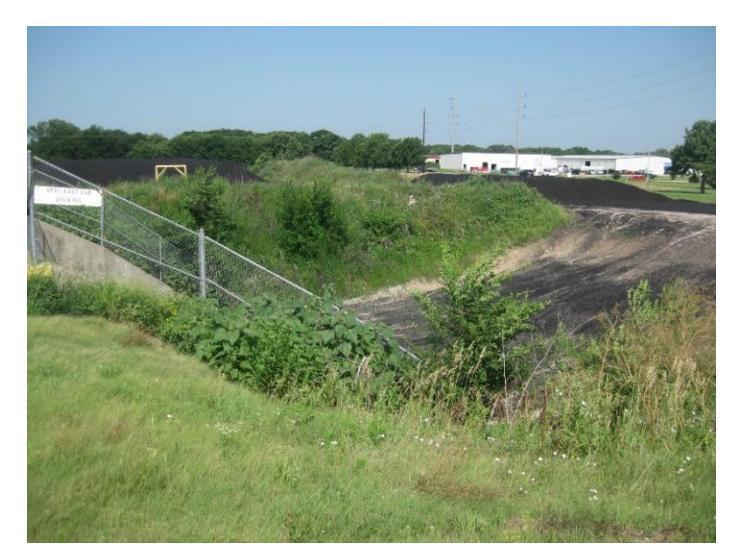
by belly dump to a temp storage area below a structure that is no longer of value. The area at the bottom of the structure ponds a significant amount of water with nowhere to drain. It is assumed when operations were previously ongoing this low area may have been pumped out, but no visible pumps were apparent at the time of our review. This ponding of water can become stagnant and a possible mosquito breeding ground and health hazard. There is also another storm sewer pipe draining to the area that should be rerouted. The structure could be left in place and the sump area filled in with compacted soil.

Photo CS-2: Coal Off Loading Area

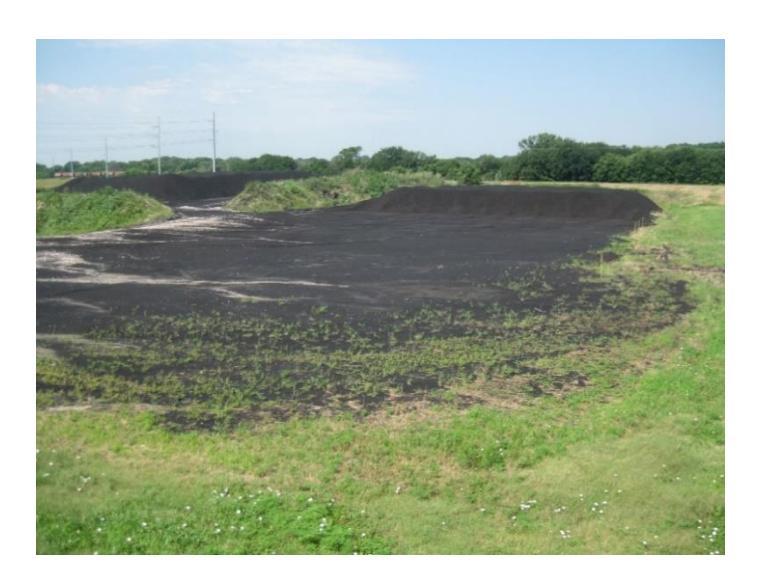
Photo CS-3: Coal Pile
